GI-2021-05-SCG-56-02-ABC

Post-Inspection Written Preliminary Findings

Inspection Name: 2021 SED NW SOUTH COAST DISTRIBUTION AUDIT

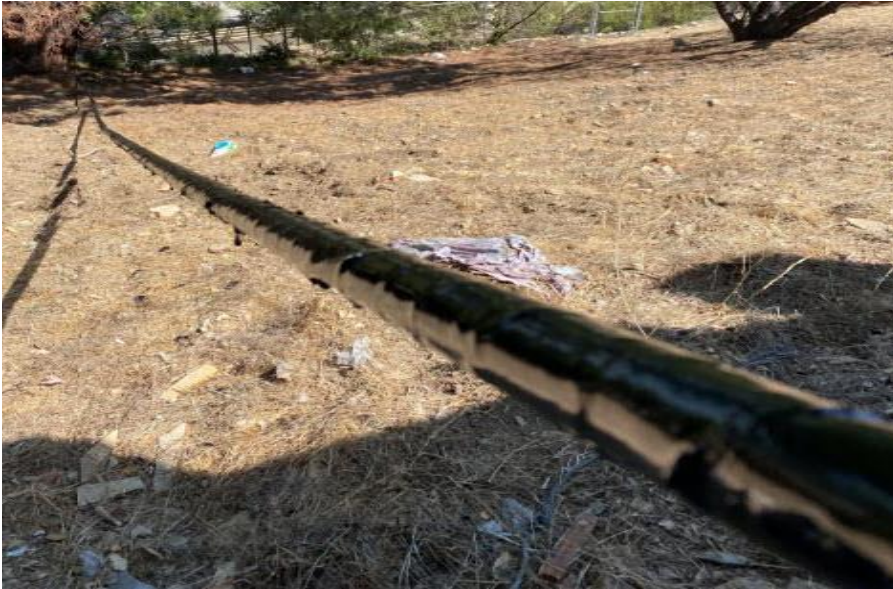
Issue During the field inspection of the South Coast facilities, SED observed that exposed pipe
Summary: at/or near ██████ Mulholland Dr, Los Angeles had cracked pipe wrap and showed signs of atmospheric corrosion at several spots.

SED finds SoCalGas in violation of G.O. 112-F, Reference Title 49 CFR, Part 192, §192.479(b) for failing to adequately protect its pipeline from atmospheric corrosion.

SoCalGas disagrees with SED's statement that the pipe showed signs of atmospheric corrosion. The pipe was found to have surface rust that was addressed by re-wrapping the pipe. The aboveground steel pipe has been removed, as of 11/29/2021 on order 540000477506.

SoCalGas acknowledges that the wrap on this service was cracked and sent a crew out to re-wrap the pipe on 09/16/21 on order 5200002797780. The picture below shows the completed work:

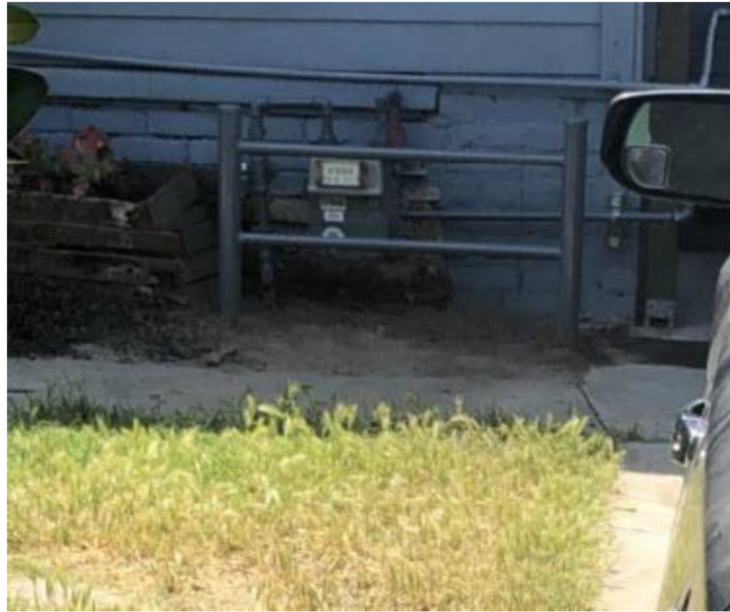
Issue Summary: Meters and service regulators located at [REDACTED] & [REDACTED] 55th Place, [REDACTED] 57th St, are not protected from vehicular damage that may be anticipated. Meter at [REDACTED] Federal Ave, Los Angeles, located in a pit (curb box) was found half-way buried in the dirt. To ensure that SoCalGas meters and service regulators are protected from damage, SoCalGas should take appropriate actions, repair, and maintain the facilities to demonstrate compliance with Title 49, CFR Parts 192.353(a) & Part 192.355(b)(3).

SoCalGas acknowledges that the meter and service regulator located at [REDACTED] W. 55th Street, which is SoCalGas's address of record, not [REDACTED] 55th Place, was exposed to vehicular traffic. A meter guard was installed at [REDACTED] W. 55th St. on 05/26/21, on order 540000452392. A picture of the meter guard is shown below:

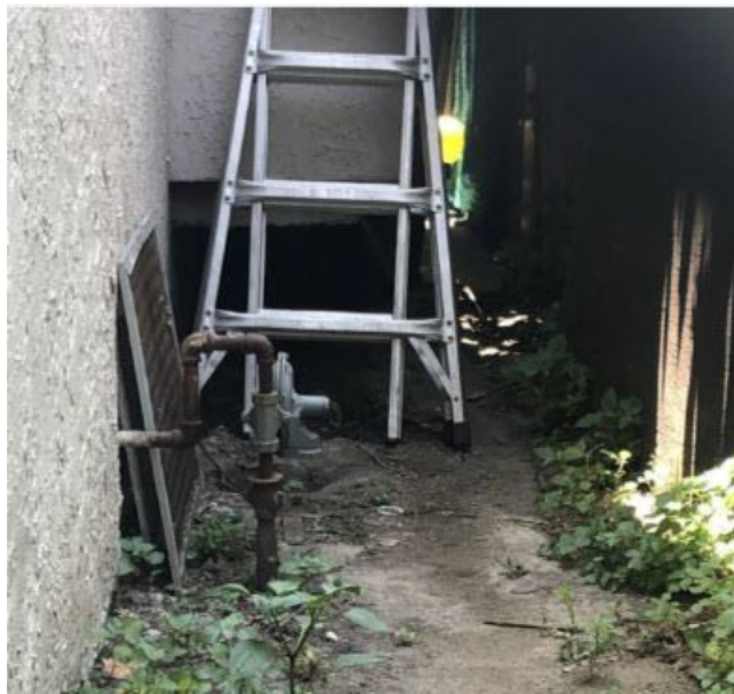
SoCalGas would disagree with SED's assessment that the meter set assembly at [REDACTED] W. 55th, which is SoCalGas' address of record, not [REDACTED] 55th Place, is exposed to vehicular traffic. The meter set assembly is an underset on a side of the house with no vehicular or pedestrian traffic in the area. A picture of the meter set assembly location is shown below:
