CALIFORNIA PUBLIC UTILITIES COMMISSION
Safety and Enforcement Division
Wildfire Safety and Enforcement Division

Incident Investigation Report

Incident Number: E20210825-01 (Mule Fire)

Regulated Utility Facilities Involved: Girvan 1101, 12kV Circuit

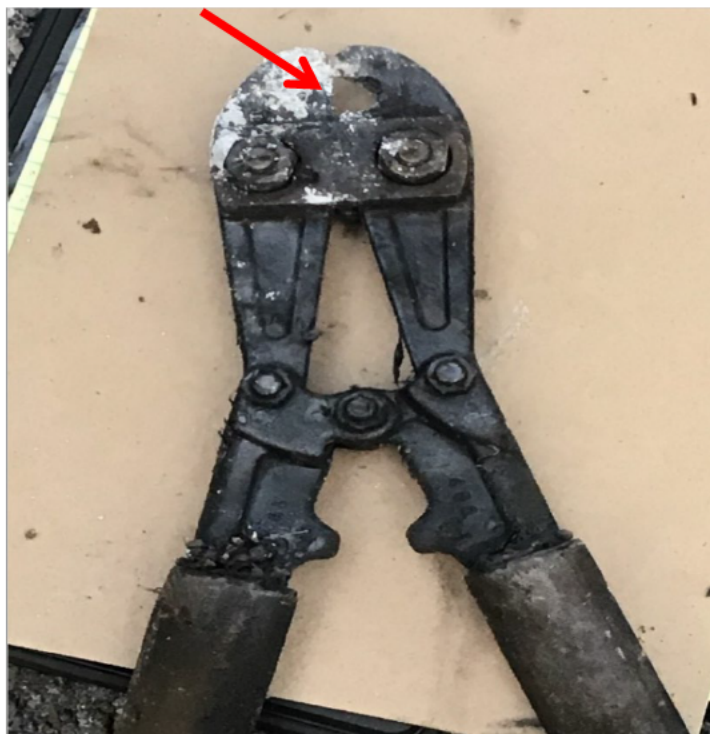
Figure 2: Bolt bite style cutters that made contact. The hole in the cutters (red arrow) was damaged when the cutter electrically connected the energized conductor and neutral.

The ACE report states that the journeyman lineman held the cutter with his right hand and rested the other handle on his shoulder, while holding the energized conductor in his left hand. This position did not allow the journeyman lineman to maintain control of the cutter, which resulted in the cutter slipping and contacting the neutral line. This unsafe and careless action started the Mule Fire. The CAL FIRE report confirms that the journeyman lineman that performed the work stated he was careless. This action violates Utility Standard: TD-1464S, Section 2.7.3.

Additionally, the journeyman lineman was unable to properly control the cutter to prevent it from contacting the neutral and the energized conductor at the same time. This is a violation of Section 2.05 of the Red Book, which states that contact must be avoided. While it was an accident, the journeyman lineman failed to recognize the danger and take appropriate precautions to avoid contact between the neutral, energized wire and the cutter. As a result, SED finds PG&E did not follow its internal procedures and accepted good practice. This is a violation of GO 95, Rule 31.1.

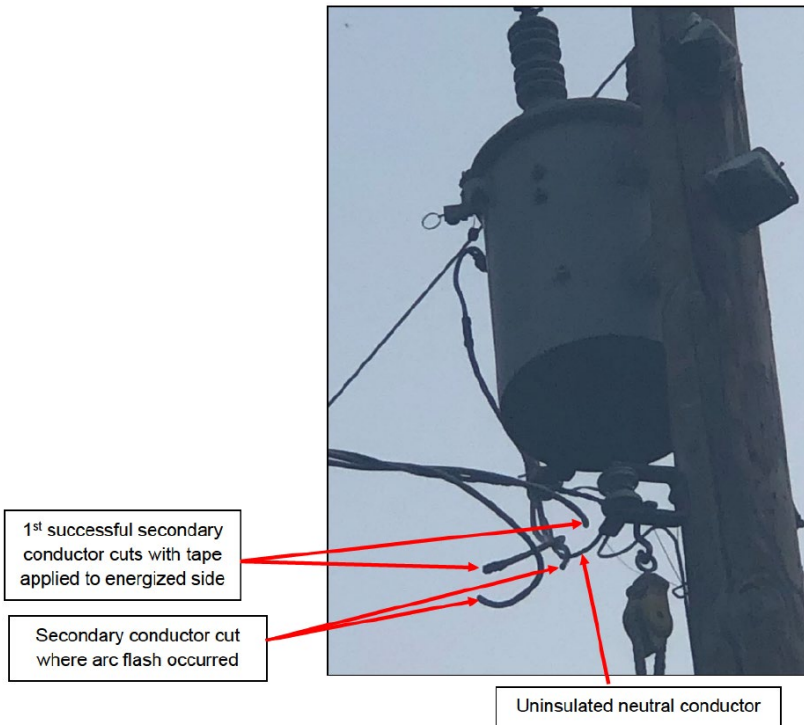
Figure 3: Transformer with cut service drop with annotation by PG&E.

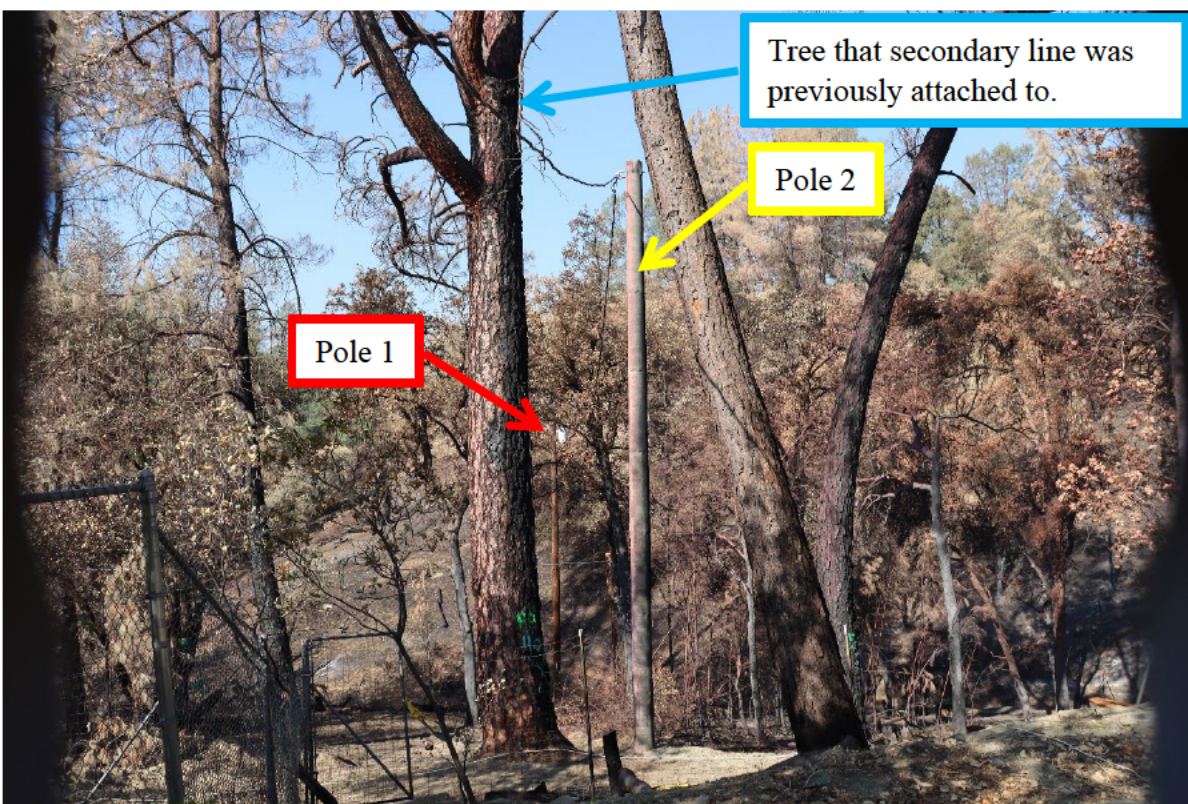
Figure 4: Photo standing near house looking toward distribution line. Red arrow points to Pole 1, yellow arrow points to Pole 2, and the blue arrow points to the tree that the secondary line had previously been attached to.

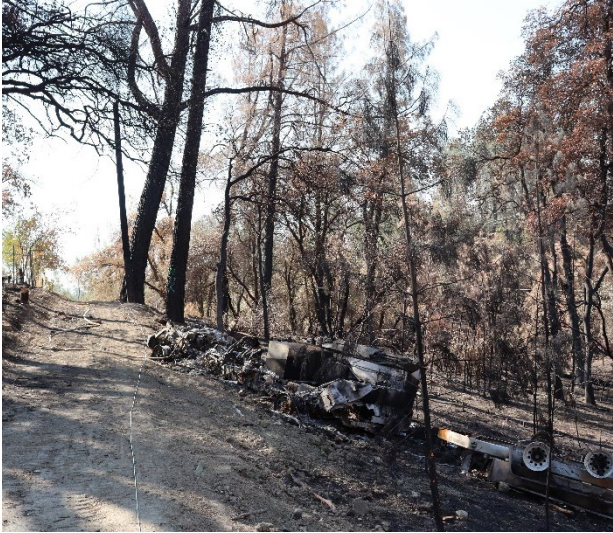
Figure 5: Abandoned remnants of contractor's truck and water buffalo

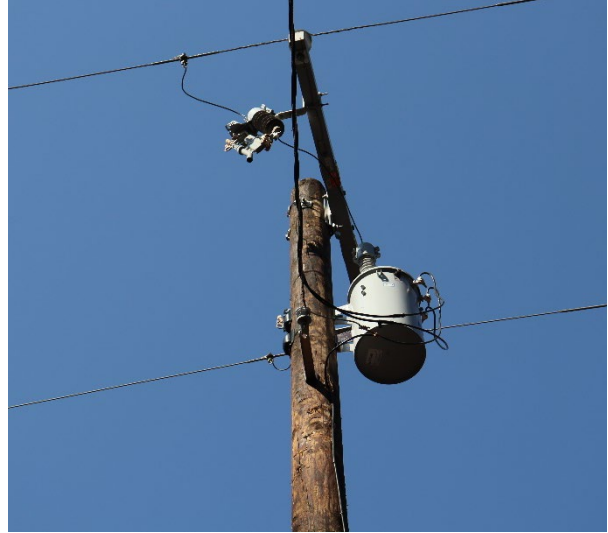
Figure 6: New pole (Pole 1) and transformer

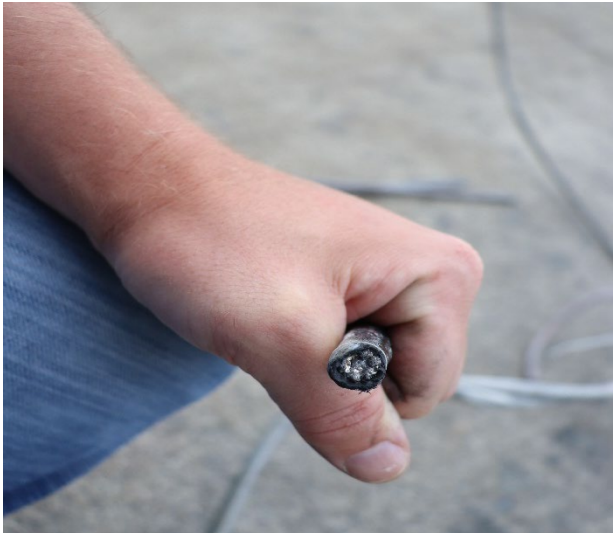
SED reviewed the evidence PG&E collected from the Incident Location. The collected evidence consisted of the transformer, insulators, two poles, molding, and sections of the secondary line. PG&E did not preserve the transformer's fuses, so SED was unable to observe them. SED focused its investigation on the secondary line which consisted of two insulated conductors and a neutral. The secondary line showed signs of an arc flash that showered molten metal. The first conductor cut was still taped at one end. The second conductor was disfigured where it had been cut (Figure 7 and Figure 8).

Figure 7: Disfigured conductor (supply side)

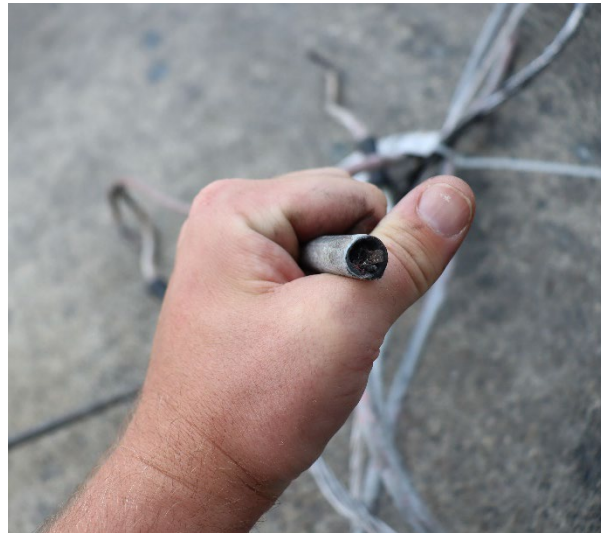
Figure 8: Disfigured conductor (load side)

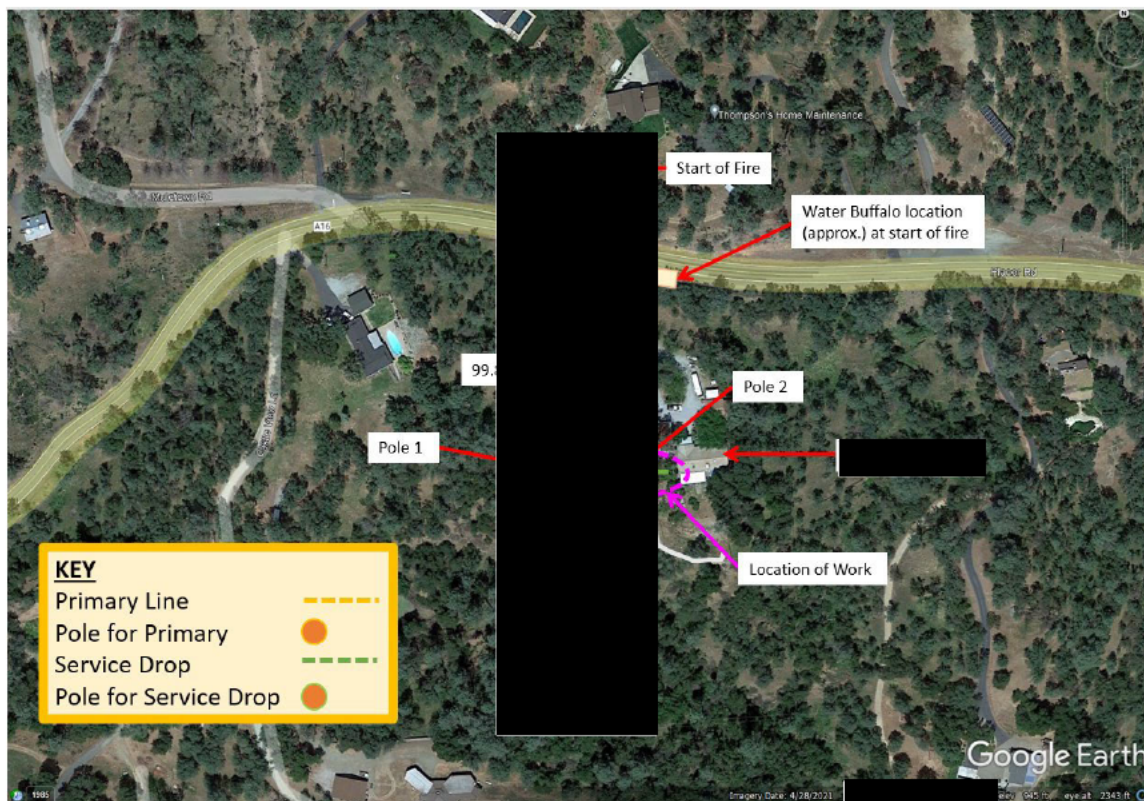
Figure 9: Sketch showing the distance from Pole 1 to the street, the location of the Water Buffalo at the start of the fire and the location where work was performed

TD-1464S Revision 5, Section 5.2.1 required that there be at least 120 gallons of water at the jobsite with at least 200 feet of hose with 40 psi at the nozzle in R4 conditions. The water buffalo met or exceed the requirements for 120 gallons of water and 200 feet of hose. At the start of the Mule Fire, the contractor parked the water buffalo on the street approximately 292 feet away from where work was being performed. The contractor did not perform work in the vicinity of the water buffalo; all of the work performed was in the vicinity of Pole 1 and Pole 2 as shown in Figure 9. Access to the jobsite was limited due to a variety of obstructions including a narrow access path, sloped ground, trees, fences and other debris. Consequently, the water buffalo could not have been used to fight any potential ignitions resulting from the work from where it was parked, due to both the hose not being long enough and the obstructions. As a result, the workers needed to move the water buffalo to fight the fire. SED concludes that the water buffalo was not properly placed at the jobsite in violation of PG&E’s own procedures. PG&E’s ACE report confirms SED’s conclusion that the water buffalo was not positioned correctly.⁵⁰ SED finds that PG&E failed to follow its own procedures which constitutes a failure to follow accepted good practice while performing work, a violation of GO 95, Rule 31.1.
