PUBLIC UTILITIES COMMISSION

SA2021-915

SUBJECT: Substation Audit of Sacramento Municipal Utility District (SMUD)

CPUC SUBSTATION AUDIT FINDINGS
Sacramento Municipal Utility District
November 15 - 19, 2021

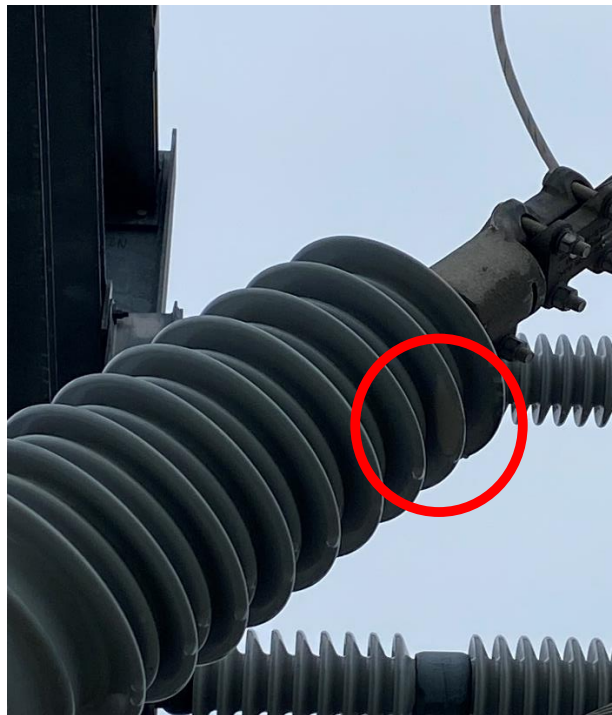
1. Powerline – Elkhorn Substation

1.1) Chipped insulator on C phase of Breaker 7710.

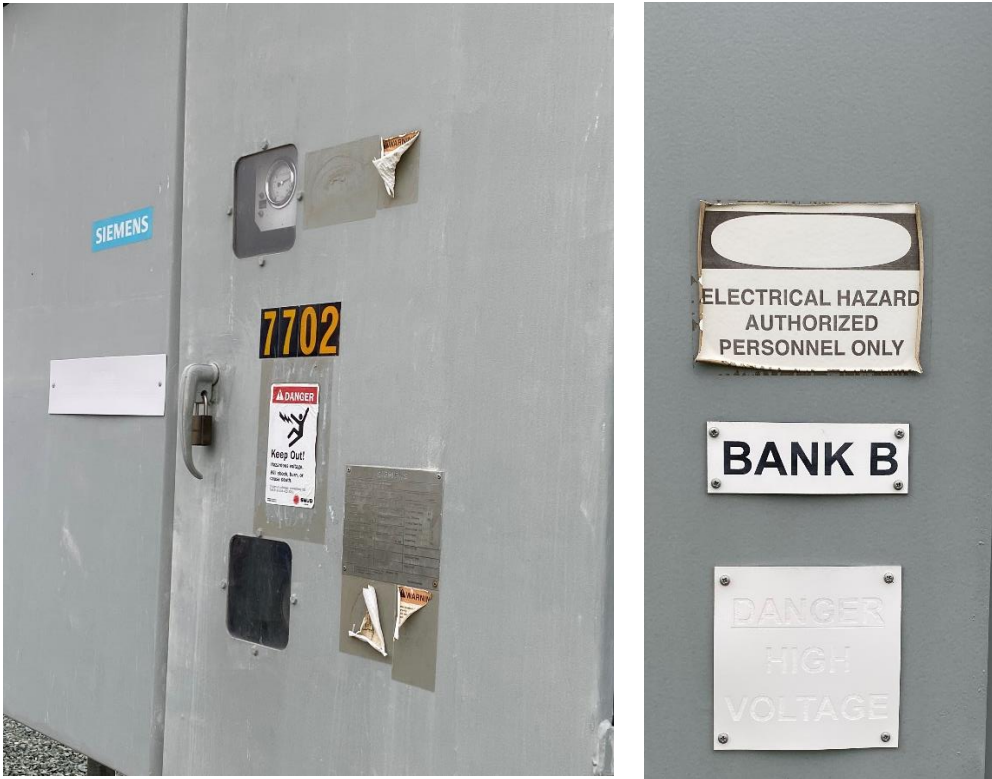
1.2) Warning stickers faded and peeling throughout substation

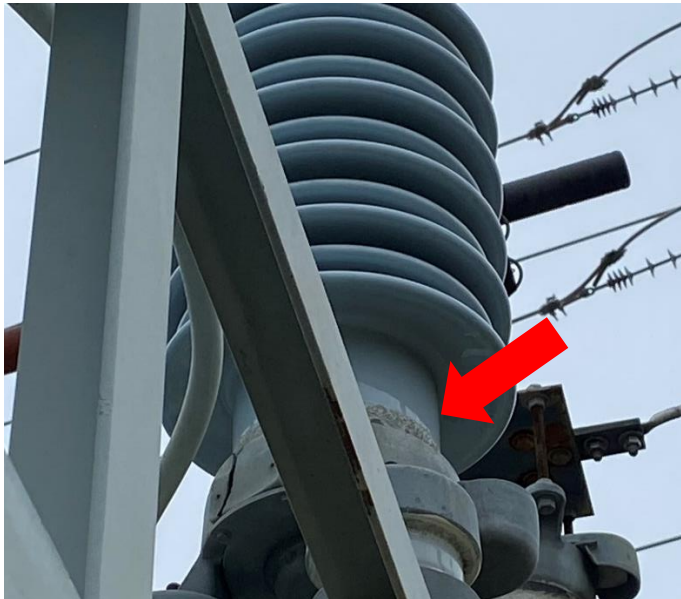
2. North Market – Sports Substation

2.1) Center phase bushing on Transformer Bank 2 is damaged

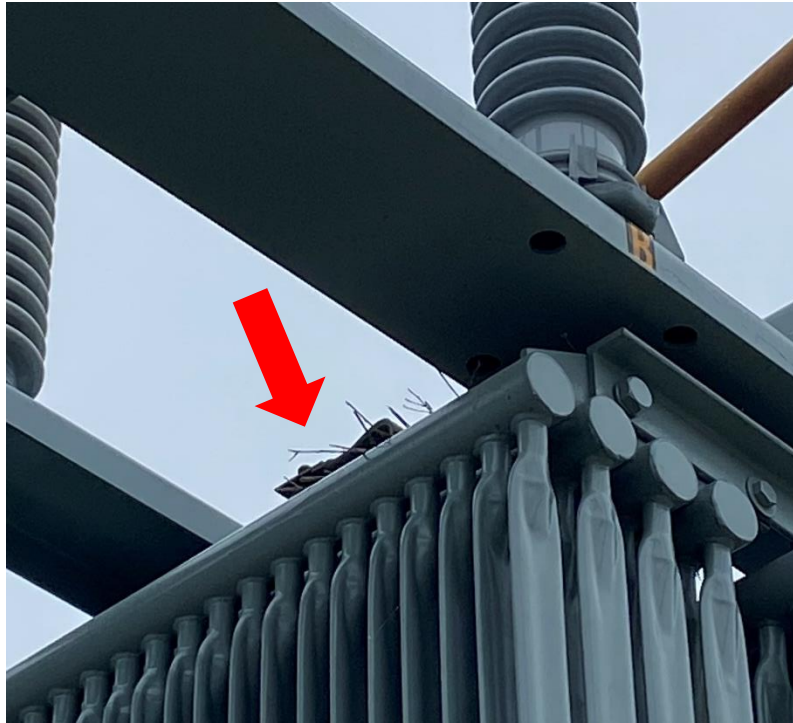
2.2) Birds nest in Transformer Bank 1 radiator.

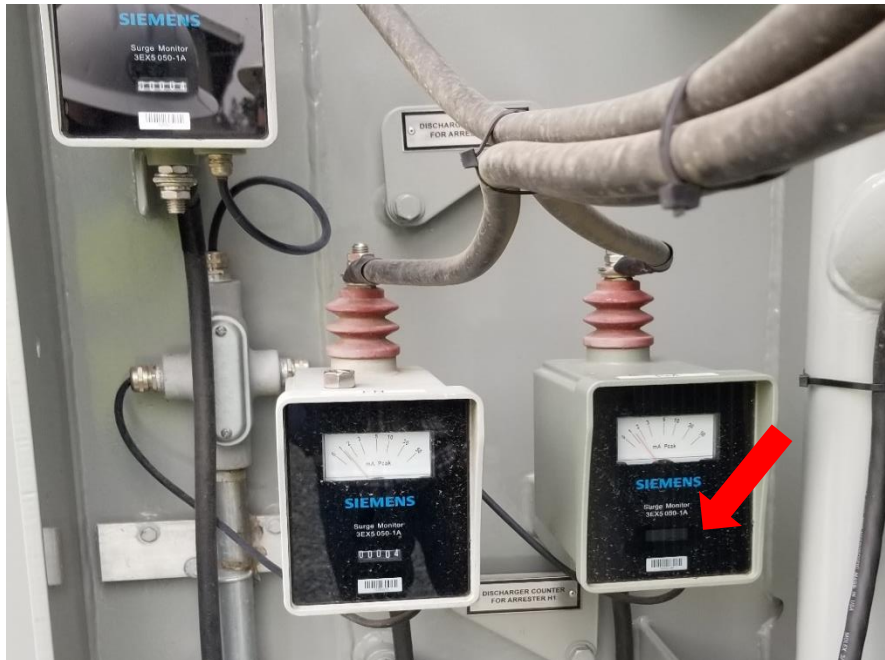
3. Truxel Substation

The Surge Monitor counter is illegible.

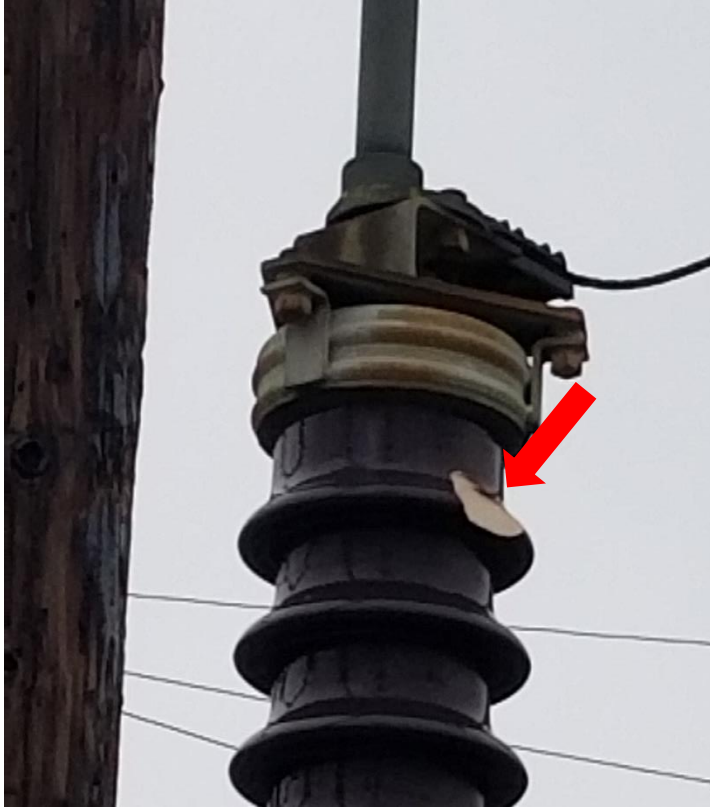
4. El Camino Substation

4.1) Chipped insulator on Transformer Bank 1.

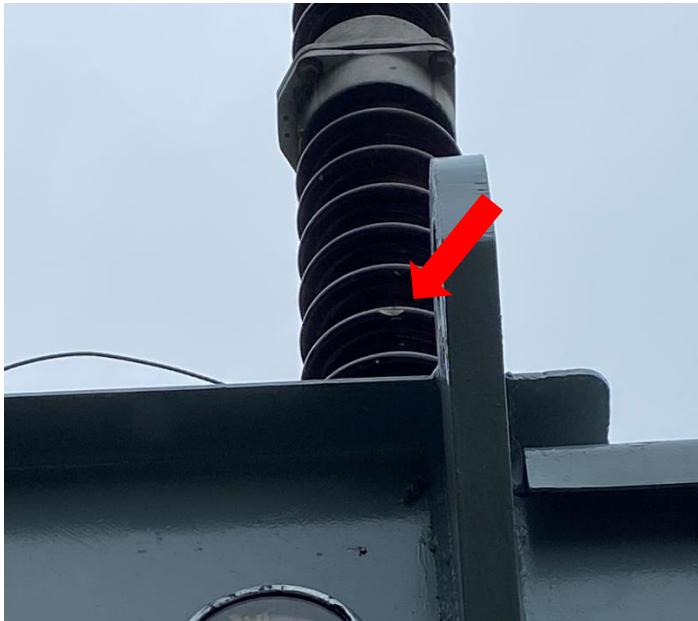
4.2) Chipped insulator on Transformer Bank 2.

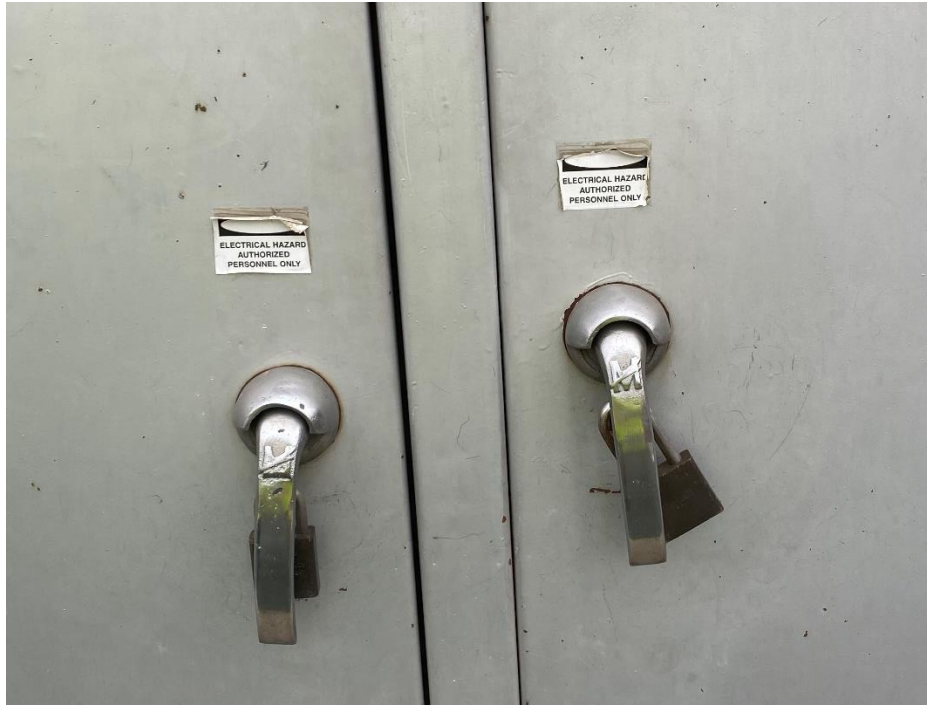
5. Frienza – Albatross Substation

Warning stickers on Transformer Bank 1 are faded and peeling.

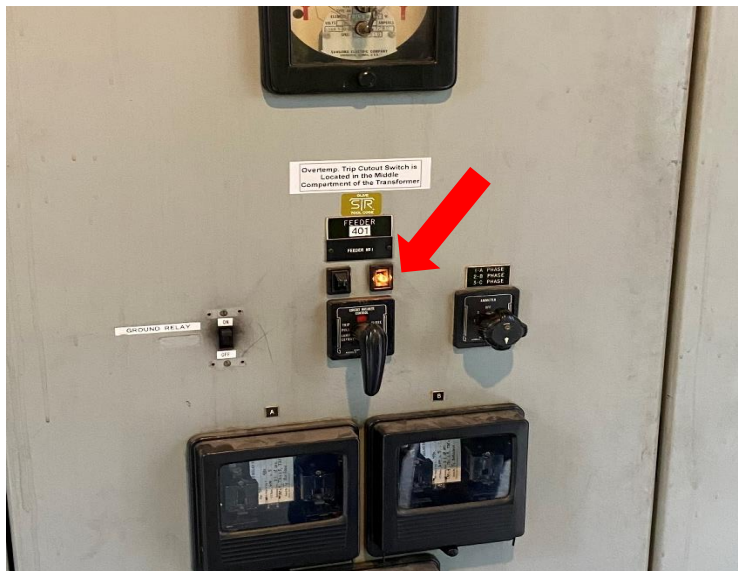
6. Country Club Center 2 Substation

Missing light cover on Feeder 401 in the control house.

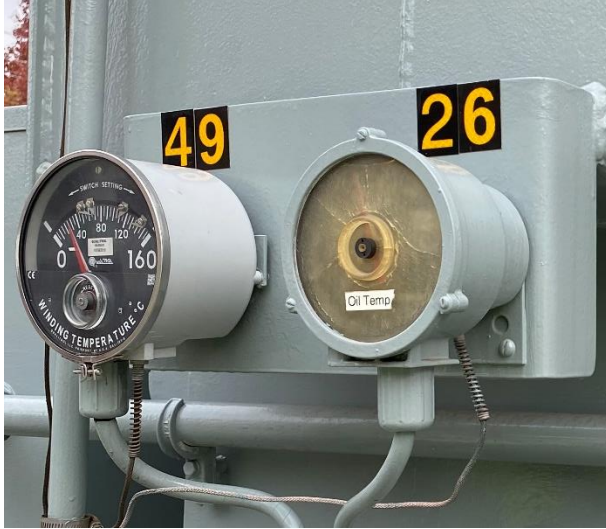
7. Northrop Substation

The oil temperature gauge on Transformer Bank 2 is damaged and illegible.

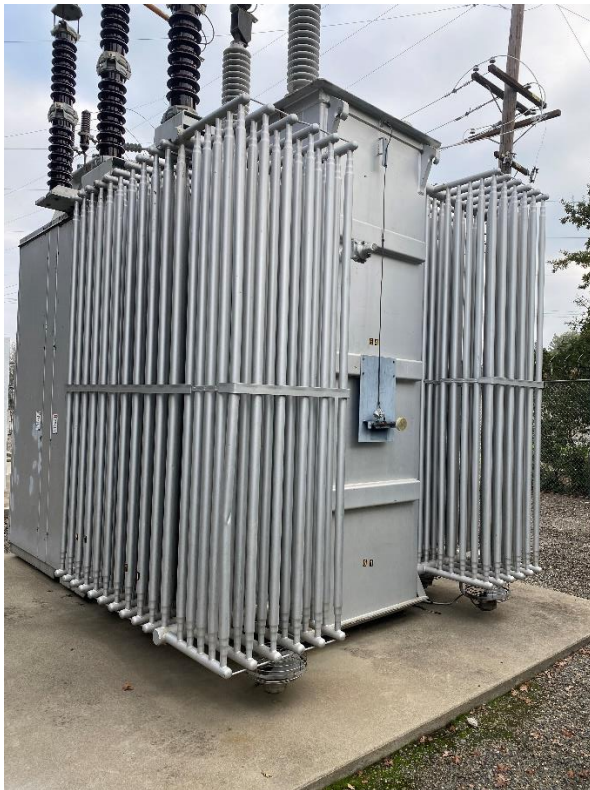
8. Fruitridge – South Land Park Substation

Transformer Bank 1 has no secondary containment.

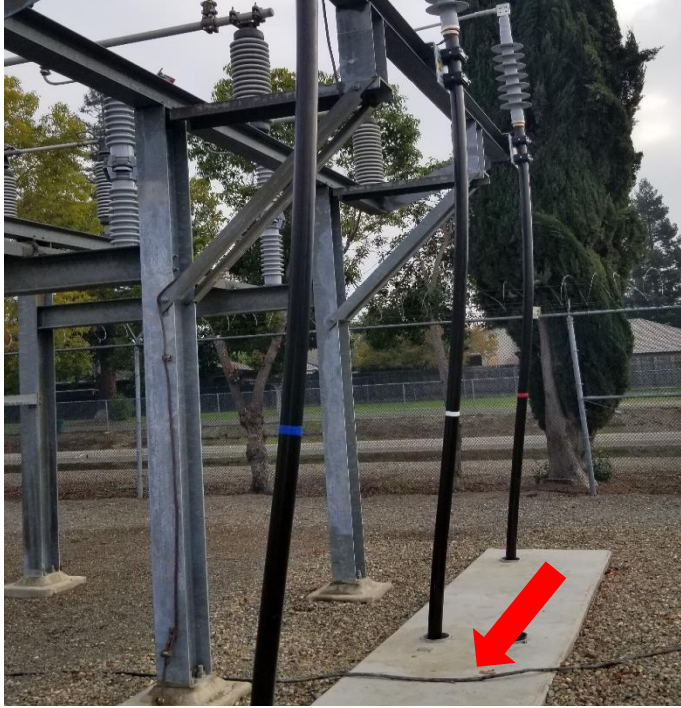
9. Havenside – Canal Substation

There is an auxiliary power cable laying on the ground creating a trip hazard near a 69 kV riser.

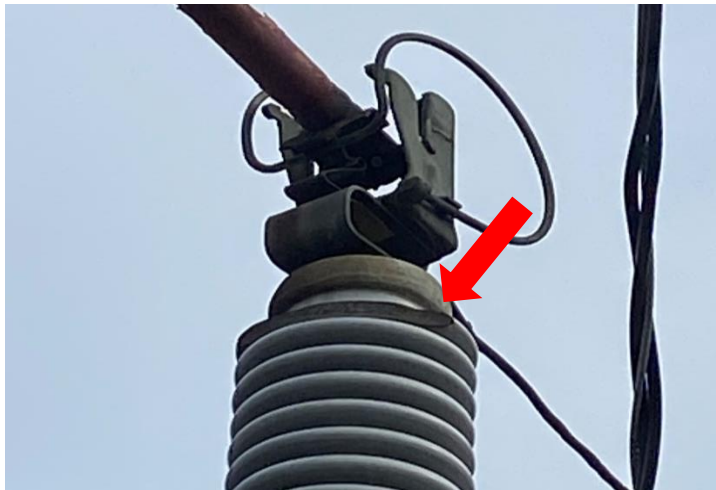
10. Meadowview – Freeport Substation

Chipped insulator on the A phase of Transformer Bank 2.

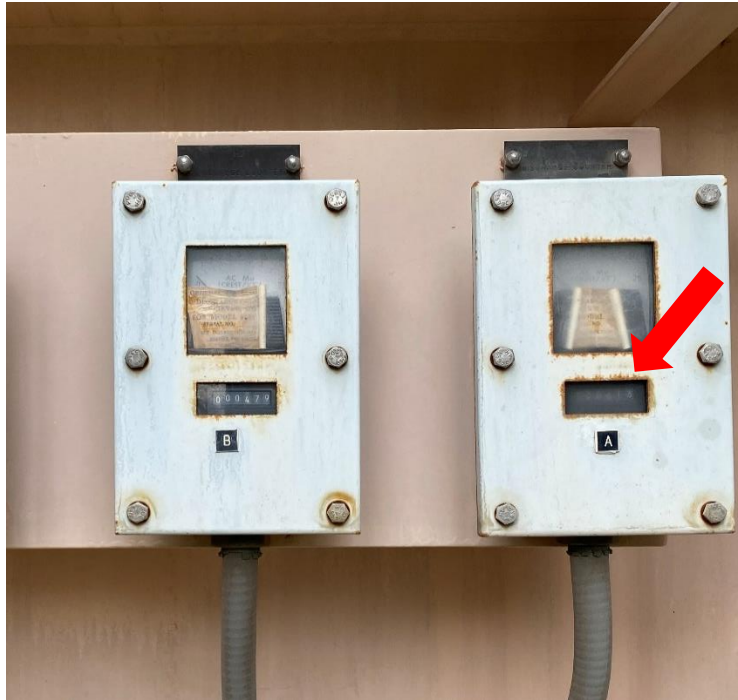
11. Don Julio – Lorac Vista Substation

The A phase discharge counter is illegible.

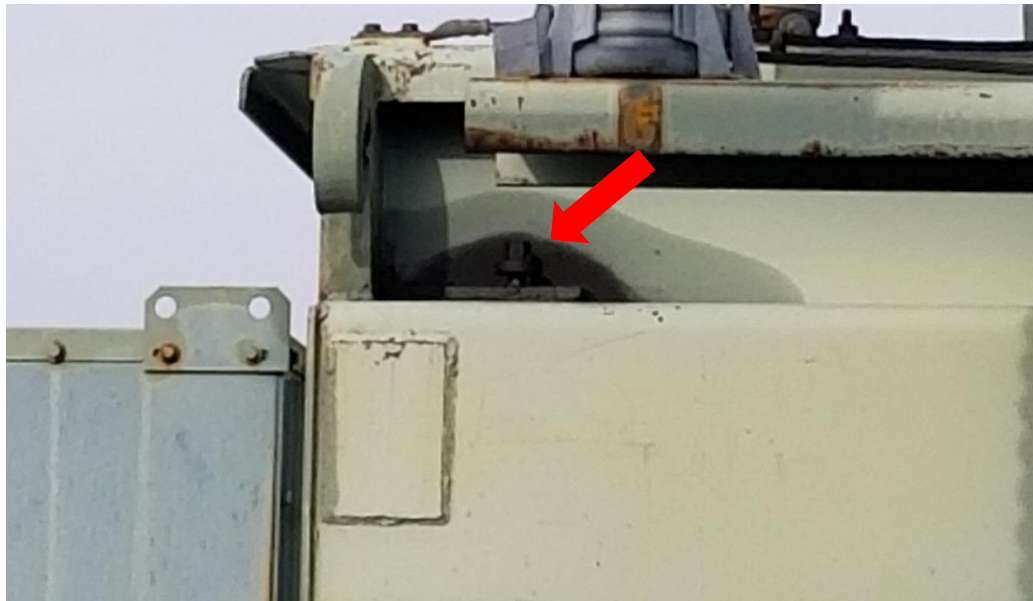
12. Don Julio – Elkhorn Substation

Transformer Bank 1 is weeping from rib near the top of the transformer.

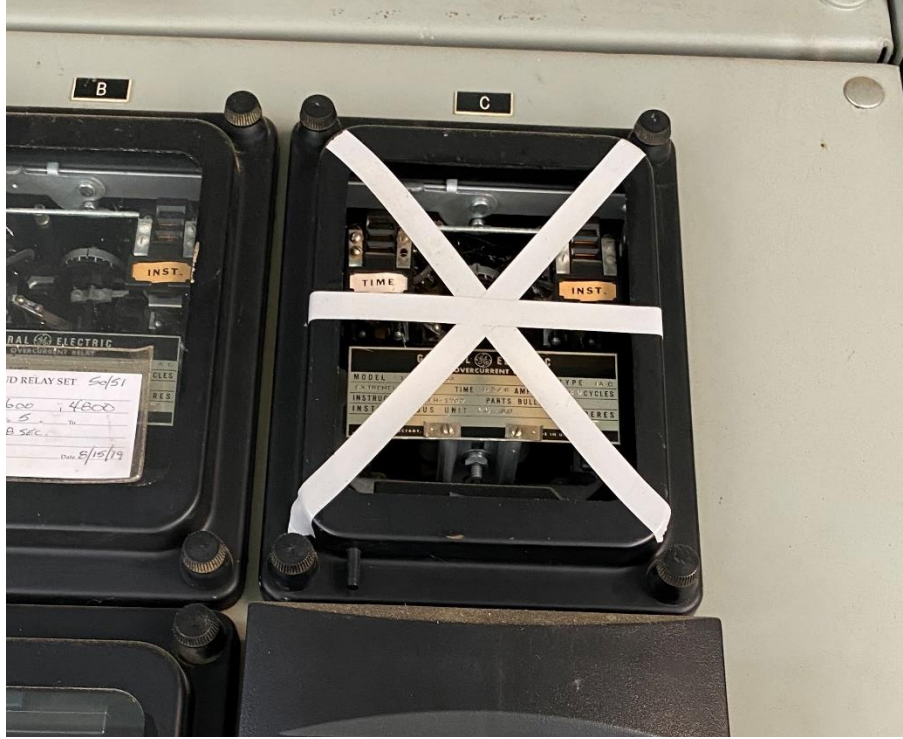
13. Kalamazoo – San Juan Substation

Feeder 1201 C phase relay is missing its cover.

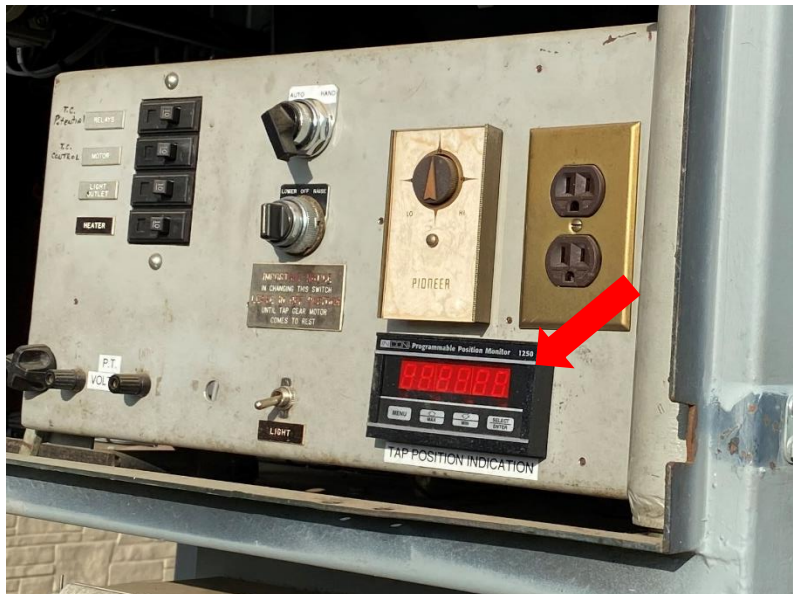
14. Galt Substation

Load tap changer digital position display was not working.

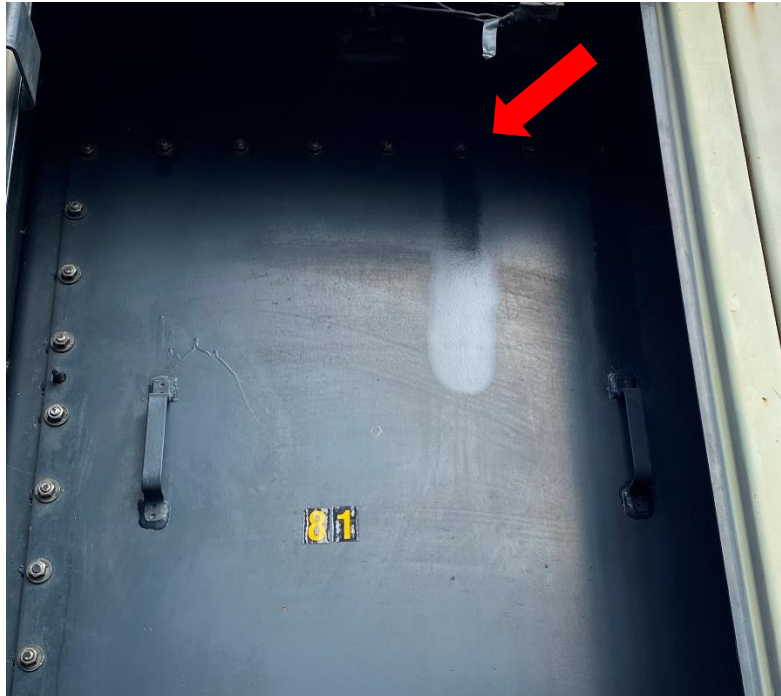
15. Twin Cities Substation

Oil weep on from Transformer Bank 1 LTC oil tank.

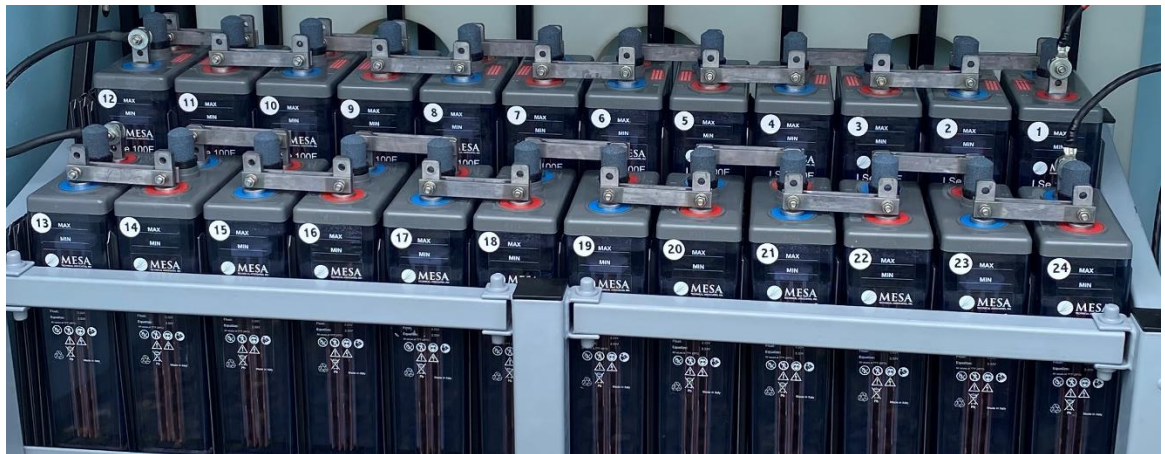
16. Laguna Springs – Sirocco

16.1) Batteries 7-14, 17, 20, 23, and 24 were filled above the max fill line.

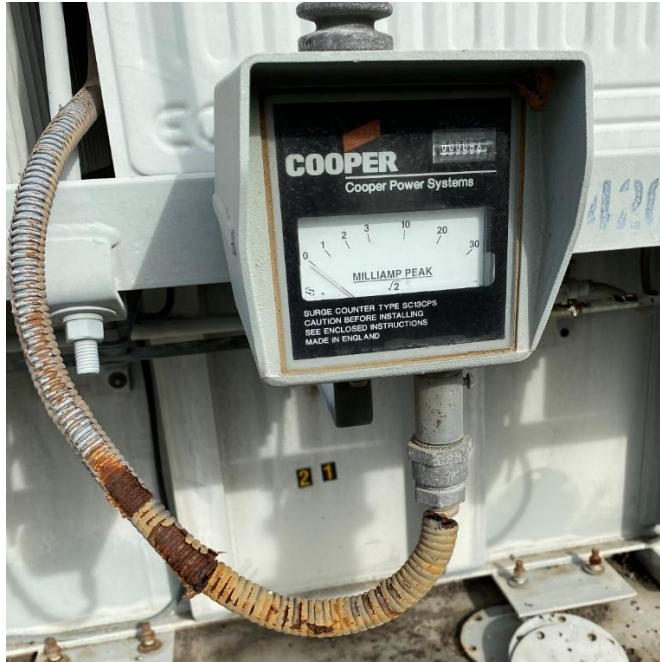
16.2) The conduit for one of the surge counters was heavily corroded and exposing the wire within.

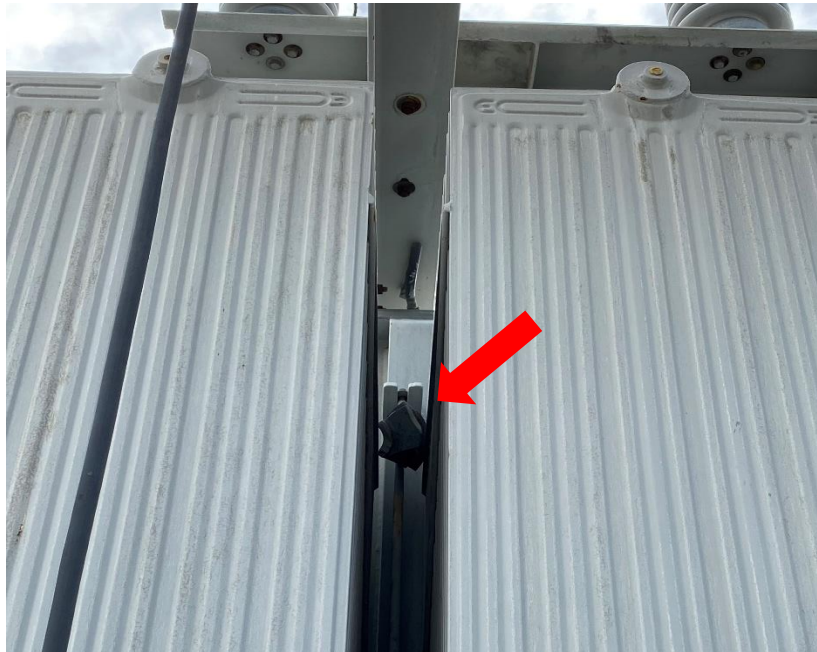
17. Bruceville - Poppy Ridge

There are pieces of broken insulators inside the transformer radiator fins.
