SA2021-922

**SUBJECT:** Substation Audit of PG&E's Martin Substation Headquarters

**CPUC SUBSTATION AUDIT FINDINGS**  
**PG&E MARTIN HEADQUARTERS**  
**July 19 - 23, 2021**

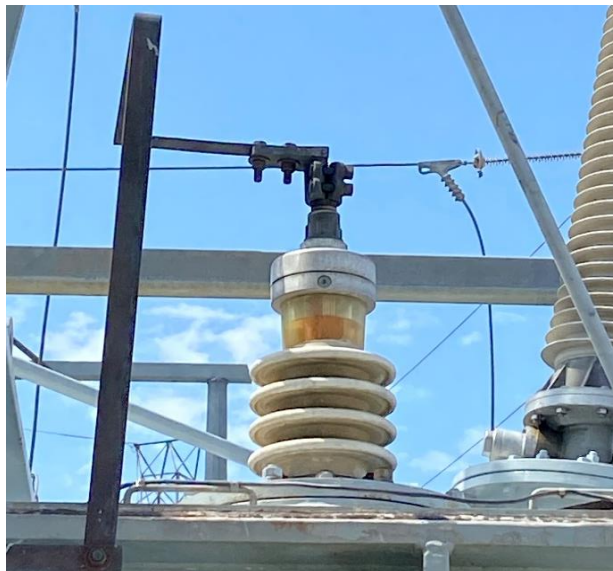
*“In bushings with glass oil reservoirs, visually check the oil to ensure it is not abnormally discolored. Also, watch the oil for erratic movement. This could be an indication of undesirable corona activity caused by a vacuum in the reservoir.”*

H30 bushing that was half-filled with oil at Shunt Reactor Bank 3 while the other bushings of the shunt reactor were filled.

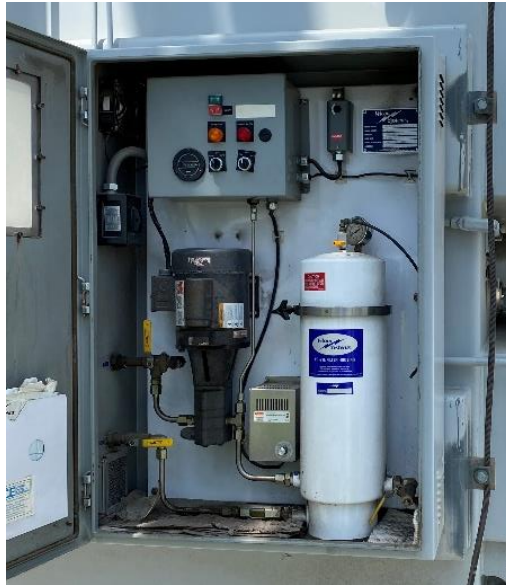
- a. One of the cooling fans was not working at Bank 2.
- b. The oil filtration pump was not working at Bank 2.

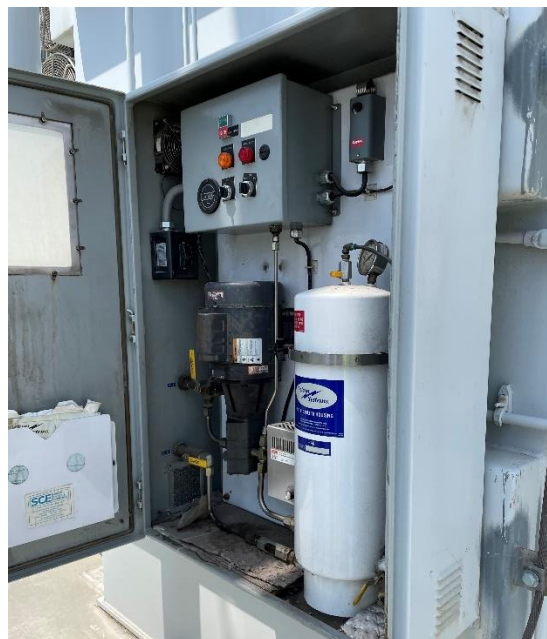
- c. Oil filtration pump at Bank 2 was leaking inside cabinet.

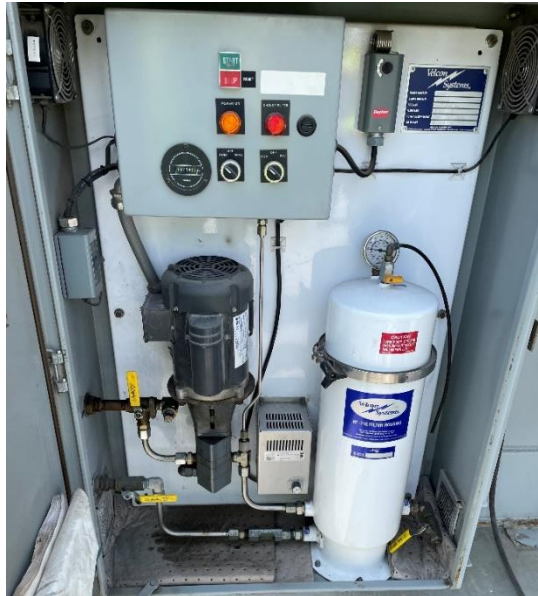
- d. Oil leak was found at pump of Bank 1.

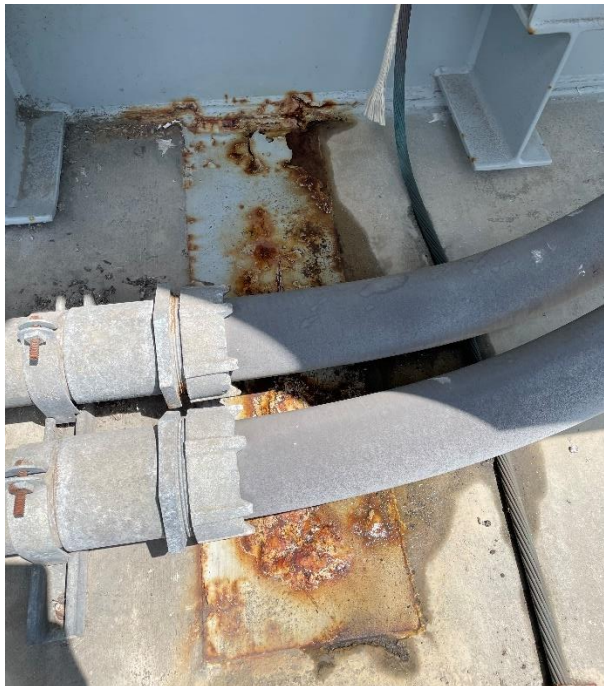
Corrosion at the base of Bank 1.

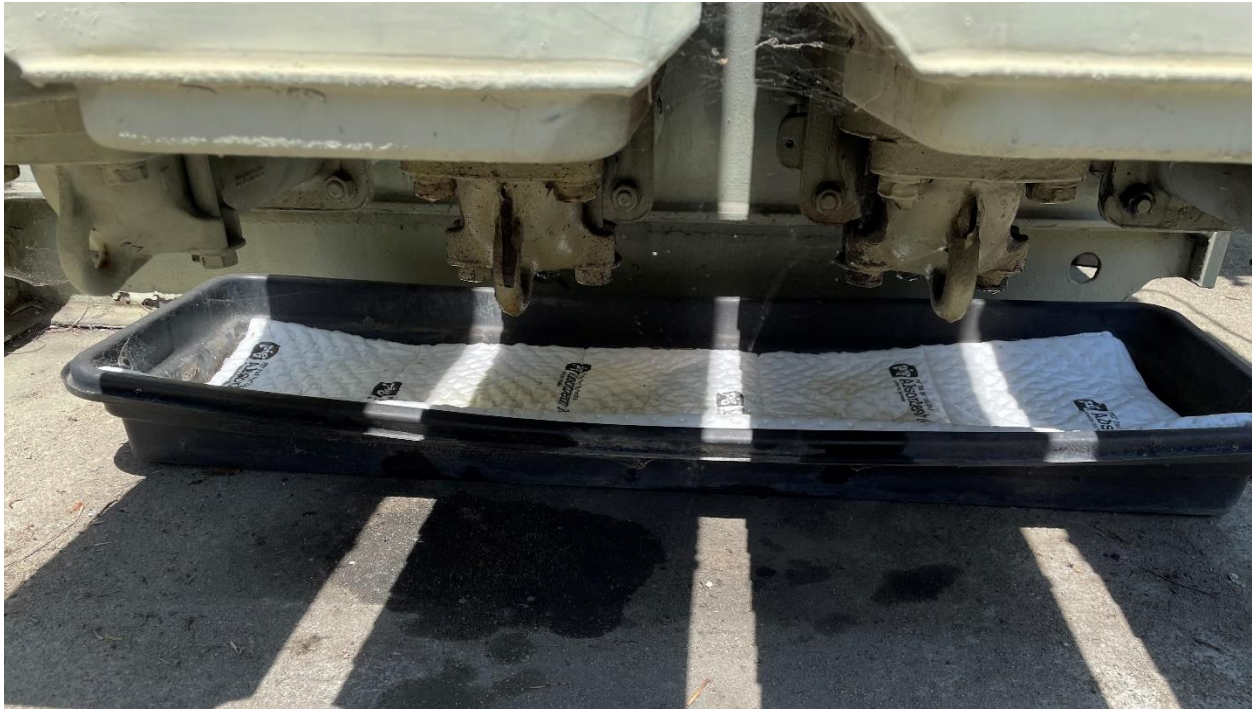
Oil was leaking from the radiator of Bank 2.

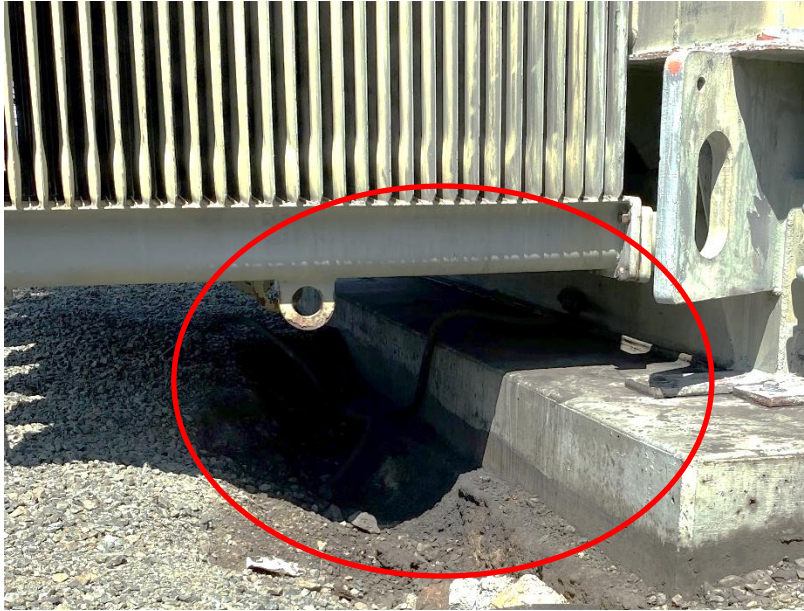
Detached ground wire under the radiator of Bank 6.

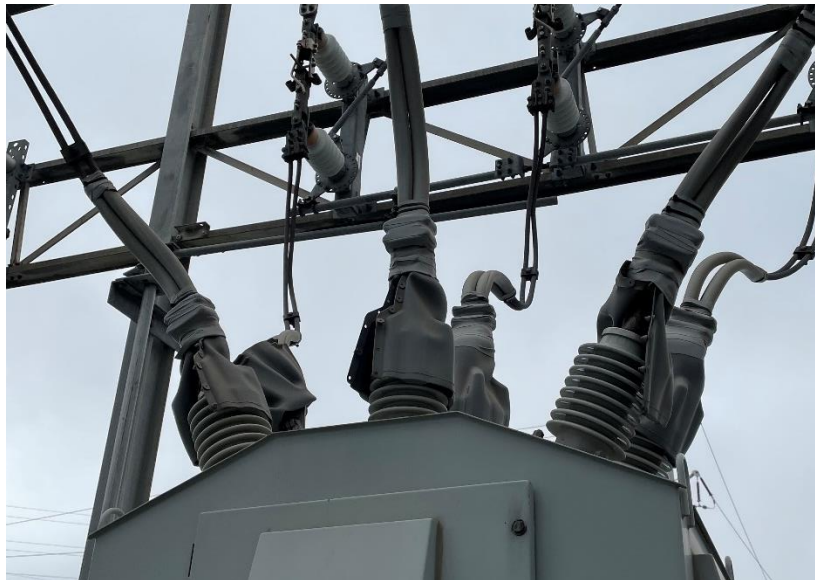
- a. Animal guard was coming off at Circuit Breaker (CB) 1106/2.

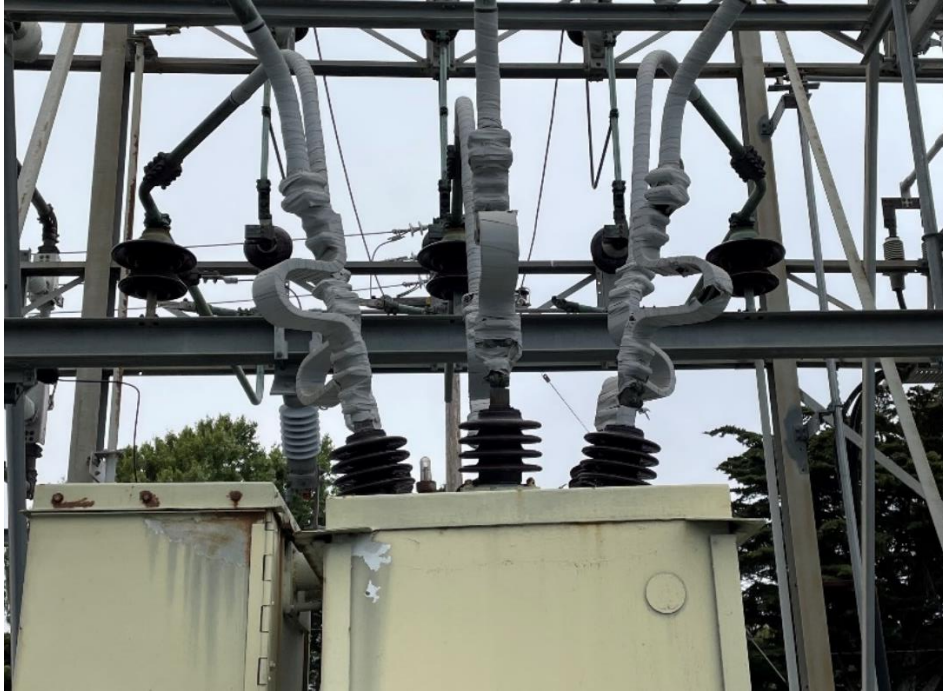
b. Animal guard was coming off at CB 1108/2.

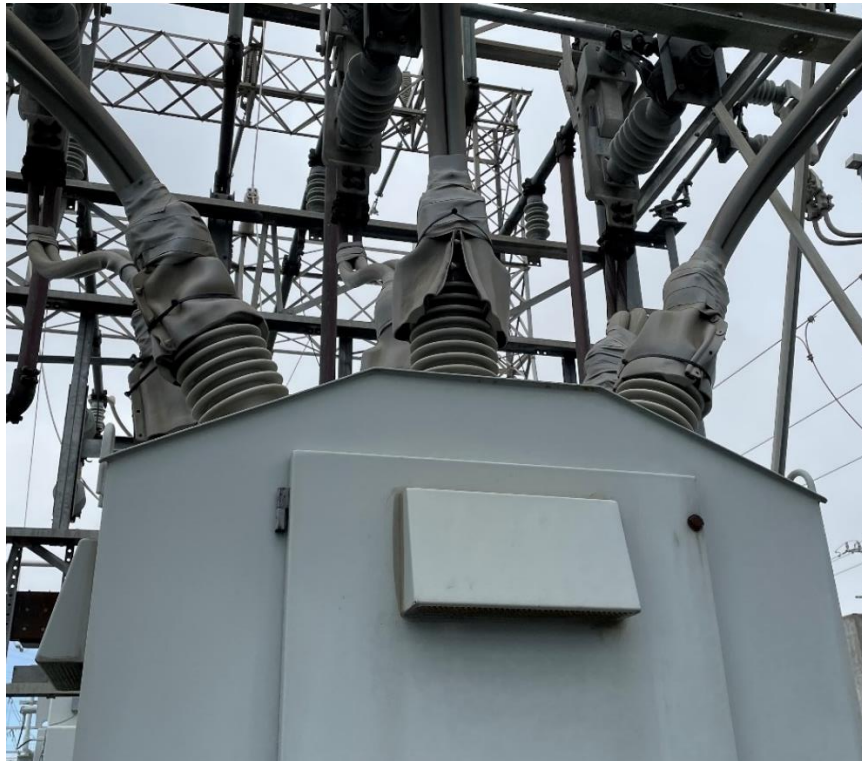
c. Animal guard was coming off at CB 1400/2.

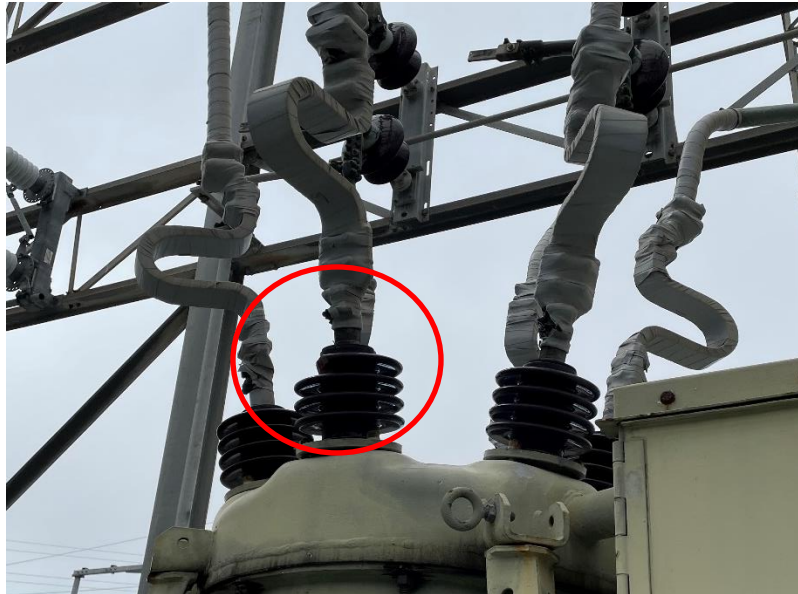
Insulator chipped at CB 1108/2.

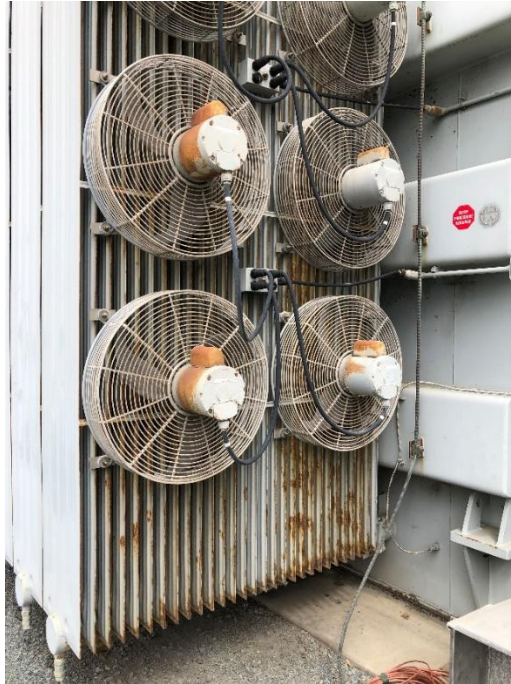
Radiator fins showed atmospheric corrosion and need painting at Bank 5.

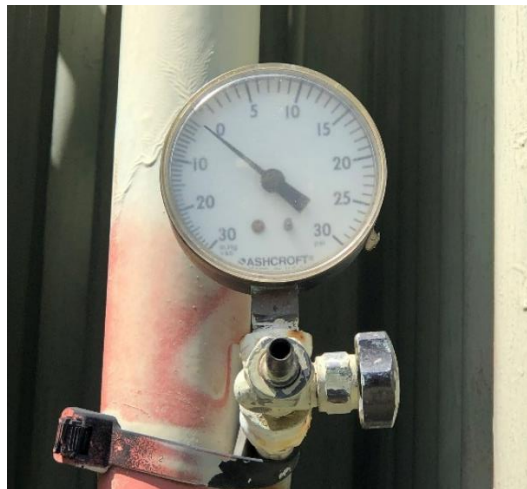
Low nitrogen pressure at Bank 2.

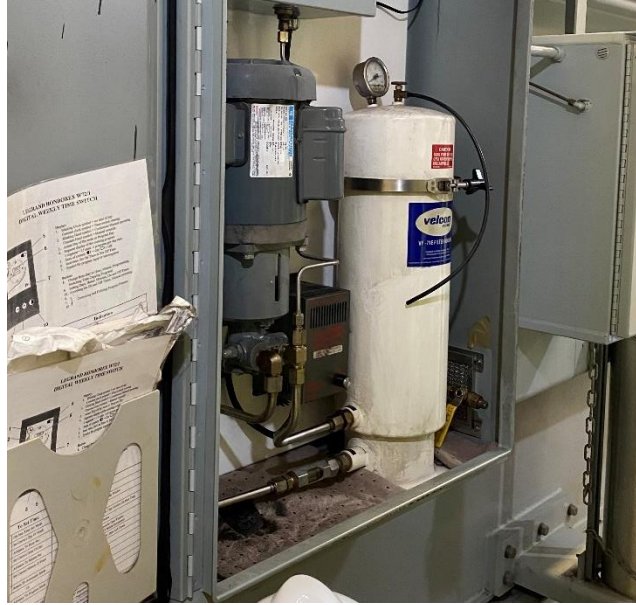
- a. Oil leak at the oil filtration system of Bank 2.

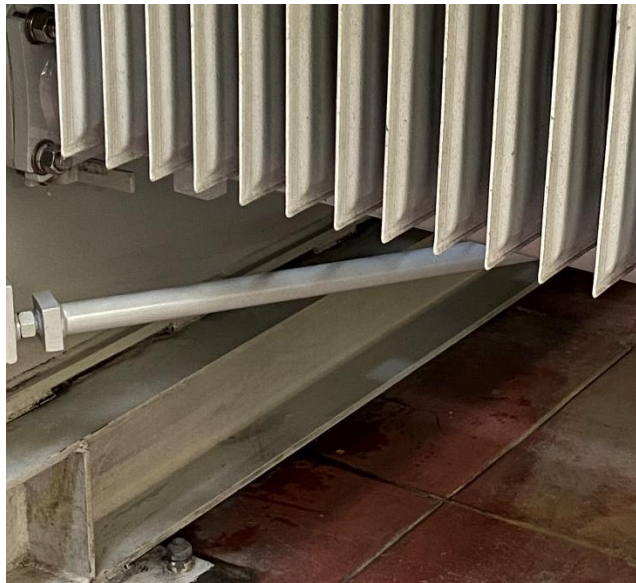
- b. Oil leak on the radiator flange of Bank 2.

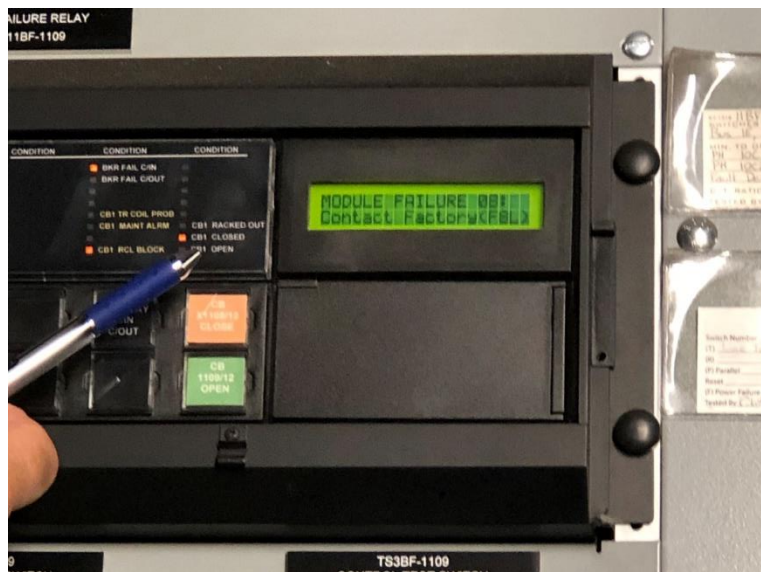
a. Module failure reading at Breaker Failure Relay Device 1109/12.

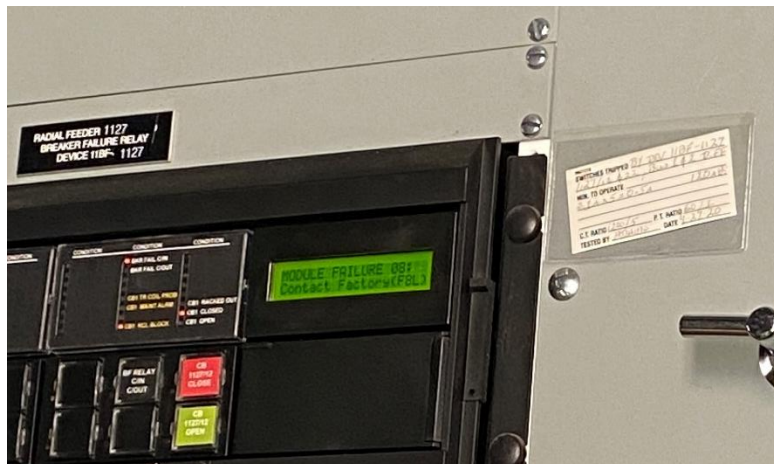
b. Module failure reading at Breaker Failure Relay Device 1127/12.

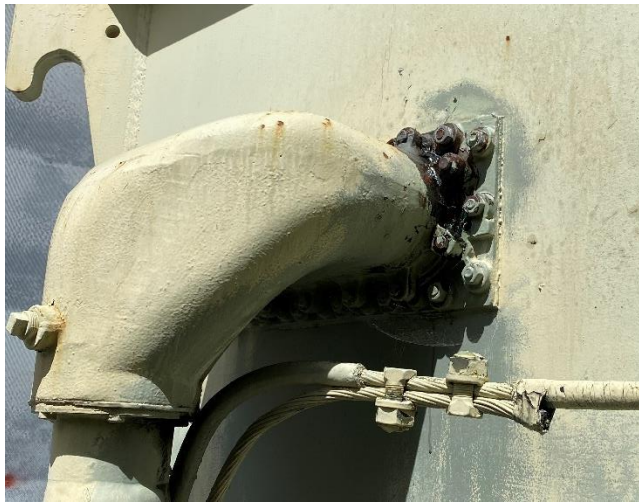
Oil leak at Bank 2.

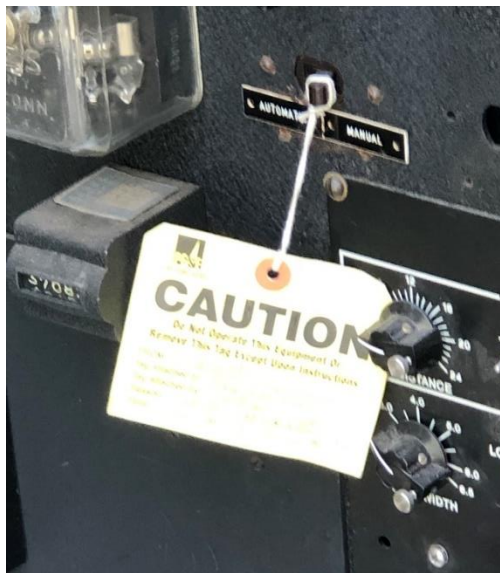
- 14. LTC has been out of service since 2017 on Bank 1.

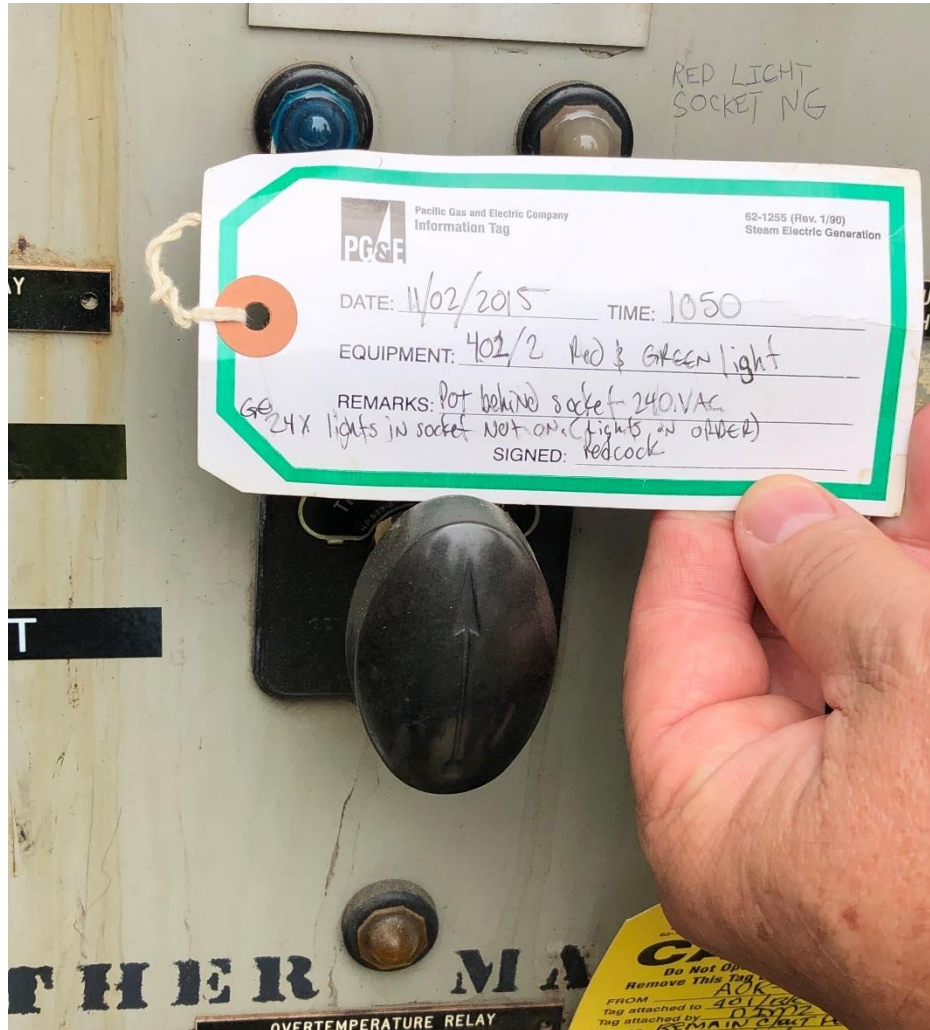
The status indicator light was out at 402/2. Service tag is dated 11/2/2015.

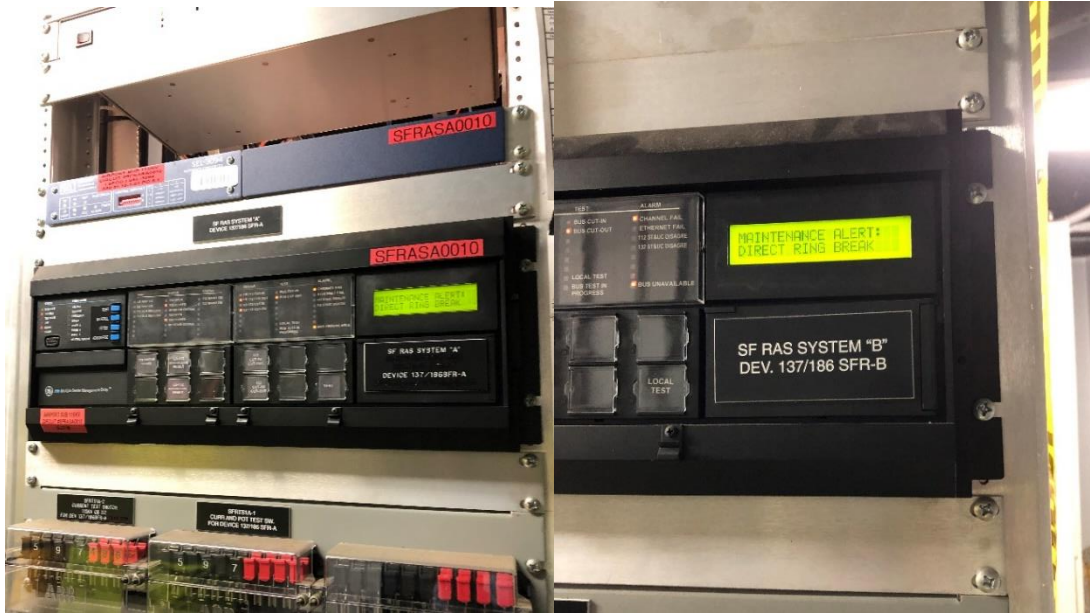
There was a “Maintenance Alert” on RAS system A and B.

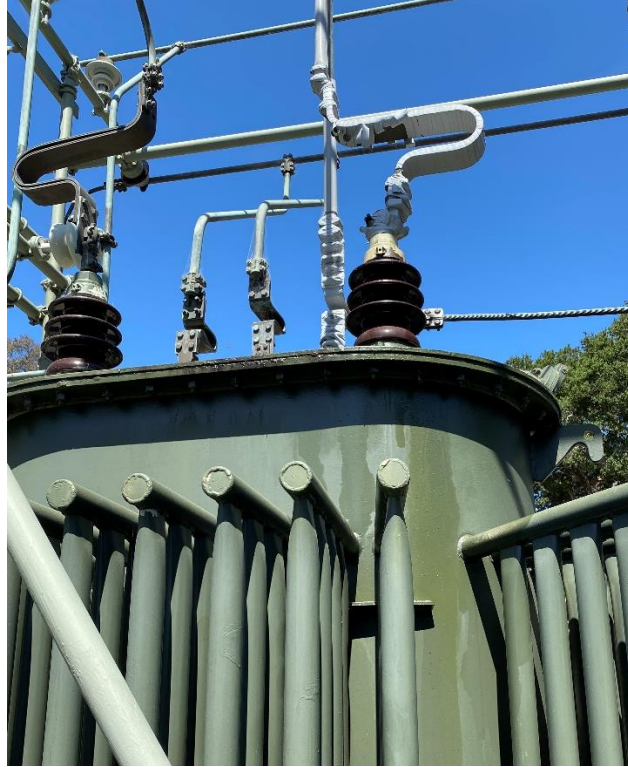
- a. Oil leak from bushing on Bank 2C.

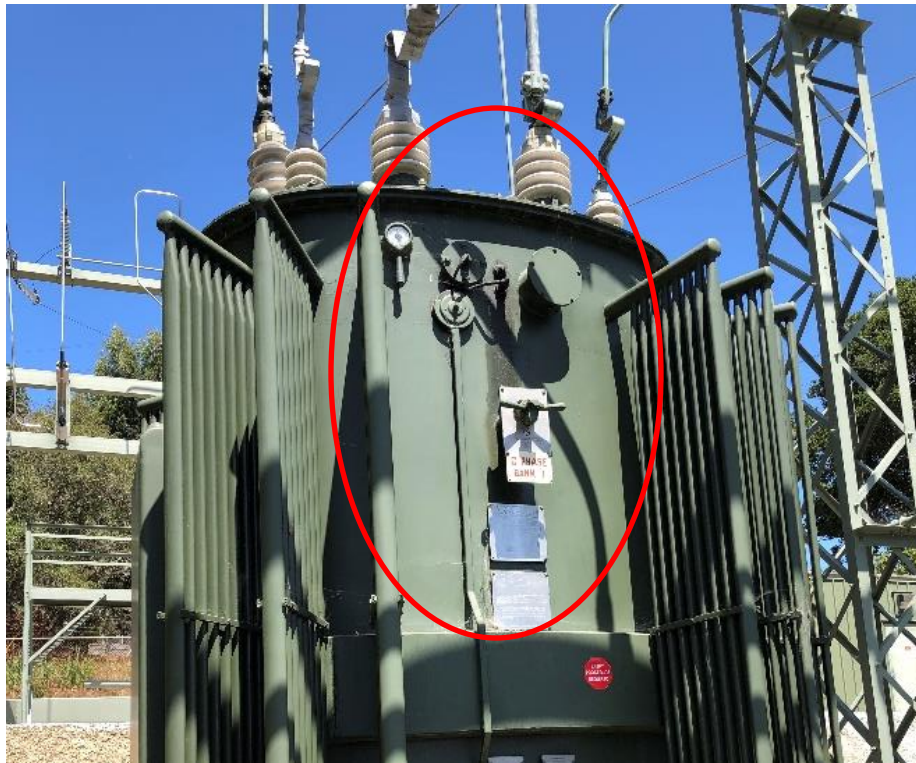
b. Oil leak at the temperature probe of Bank 1C.

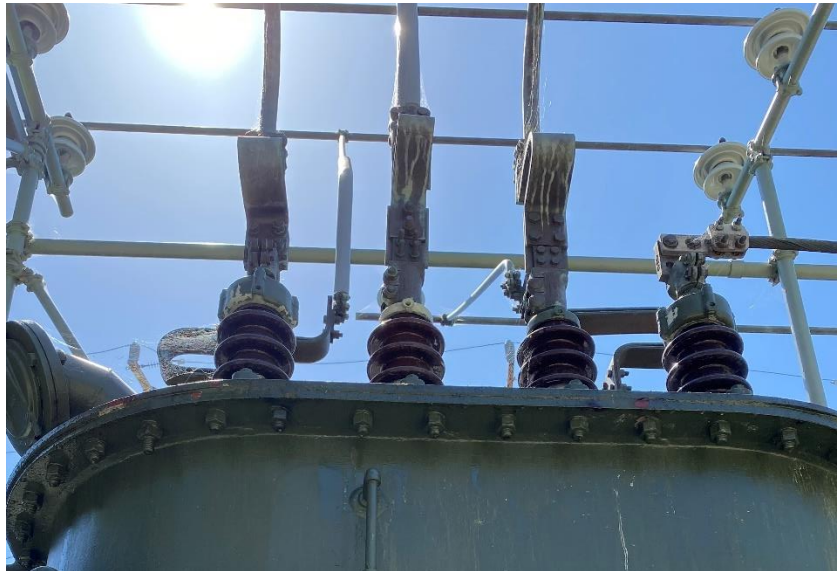
- a. Animal guard was missing on Bank 2A.

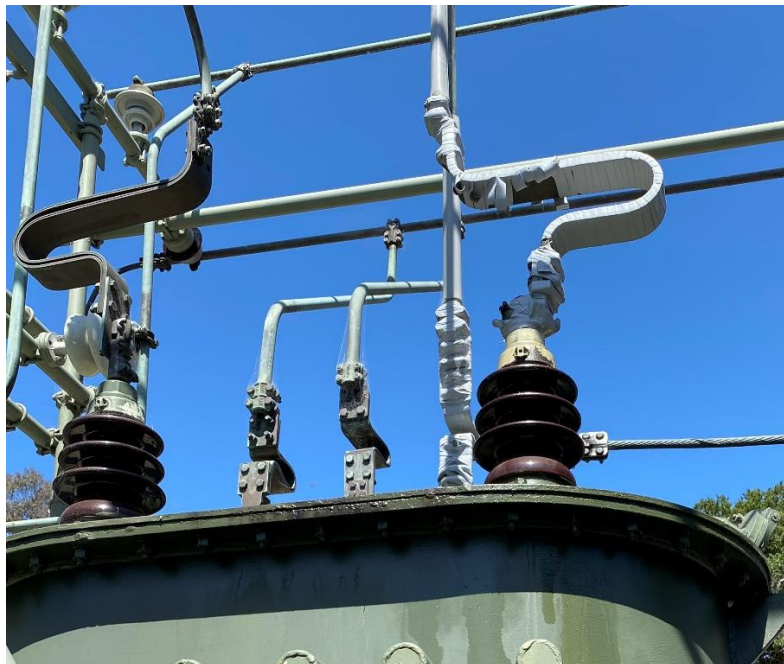
- b. Animal guard was degrading on Bank 2C.

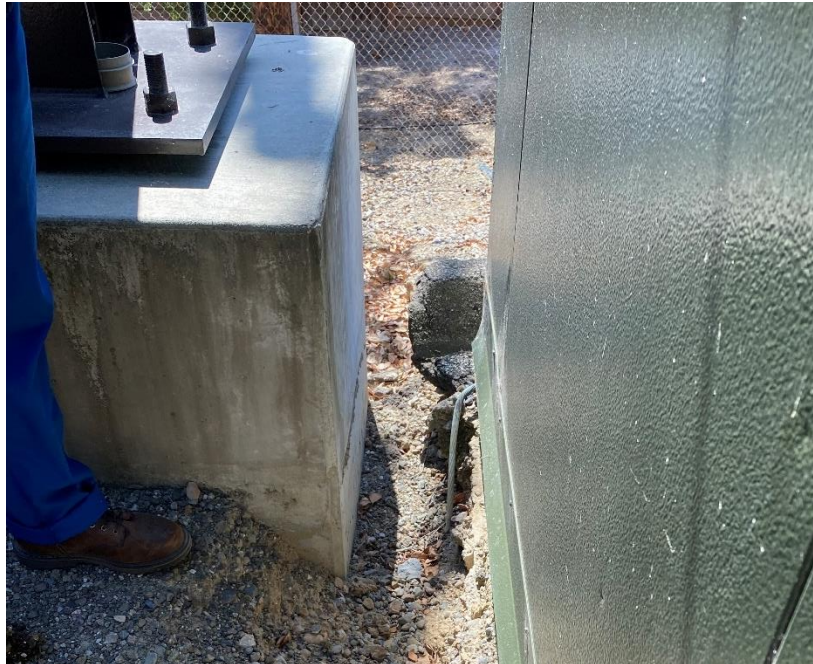
Oil containment berm was broken due to erosion next to control room behind Bank 2.

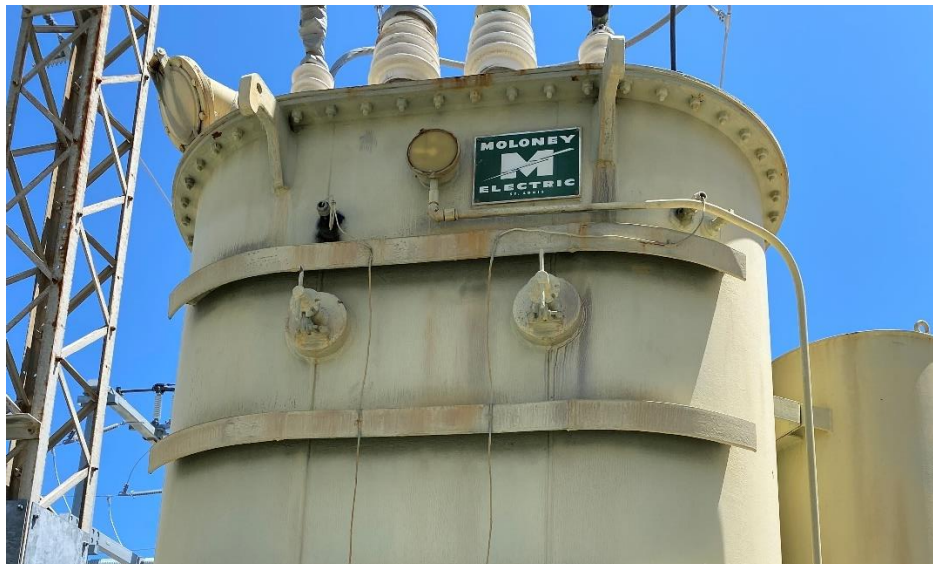
Oil weep at the temperature probe of Bank 1A.

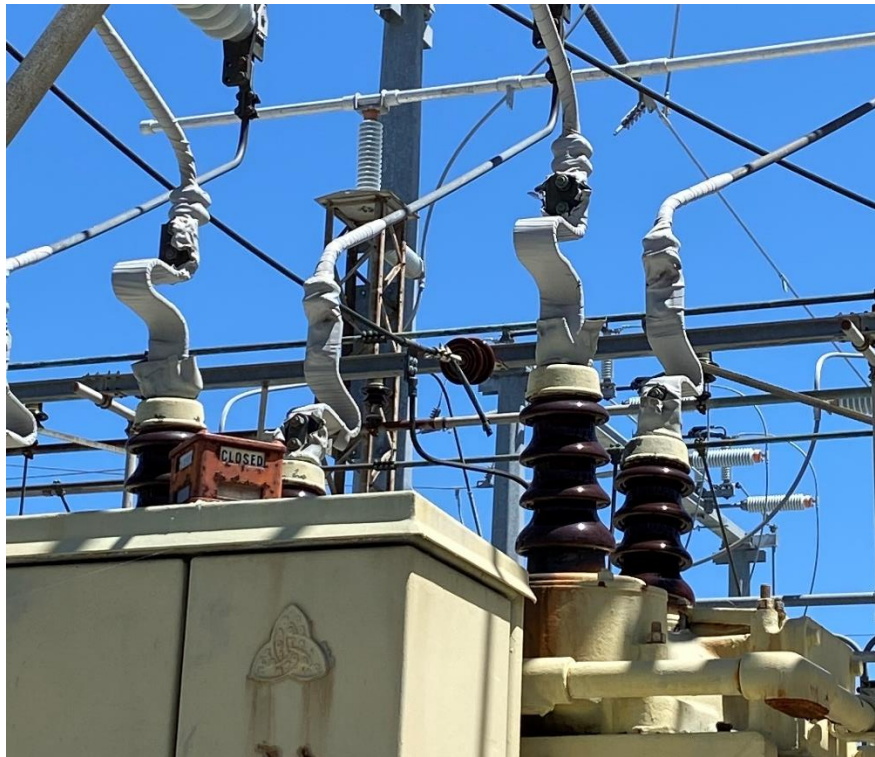
The animal guard was degrading at CB 1101/2.

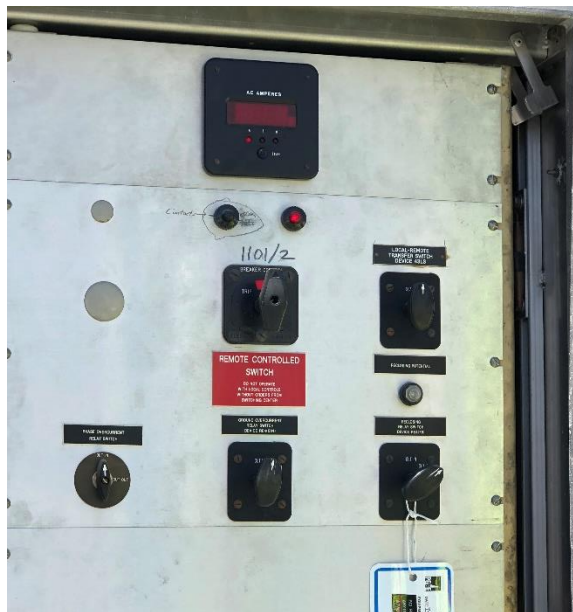
Illegible amp meter at CB 1101/2.

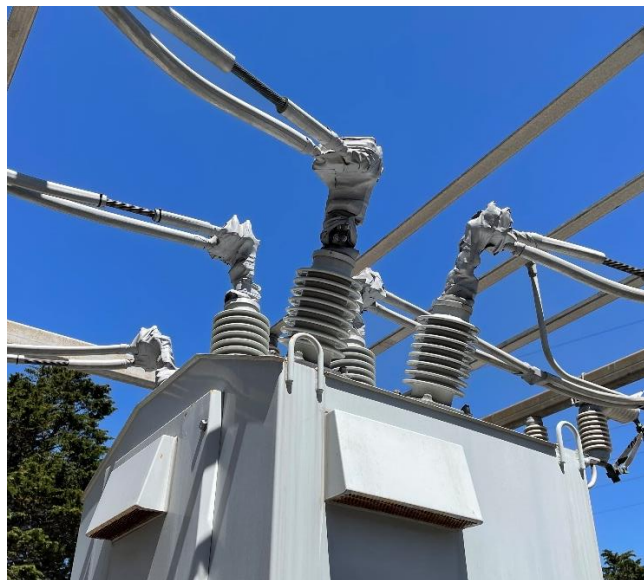
Animal guard degrading on CB 1103/2.

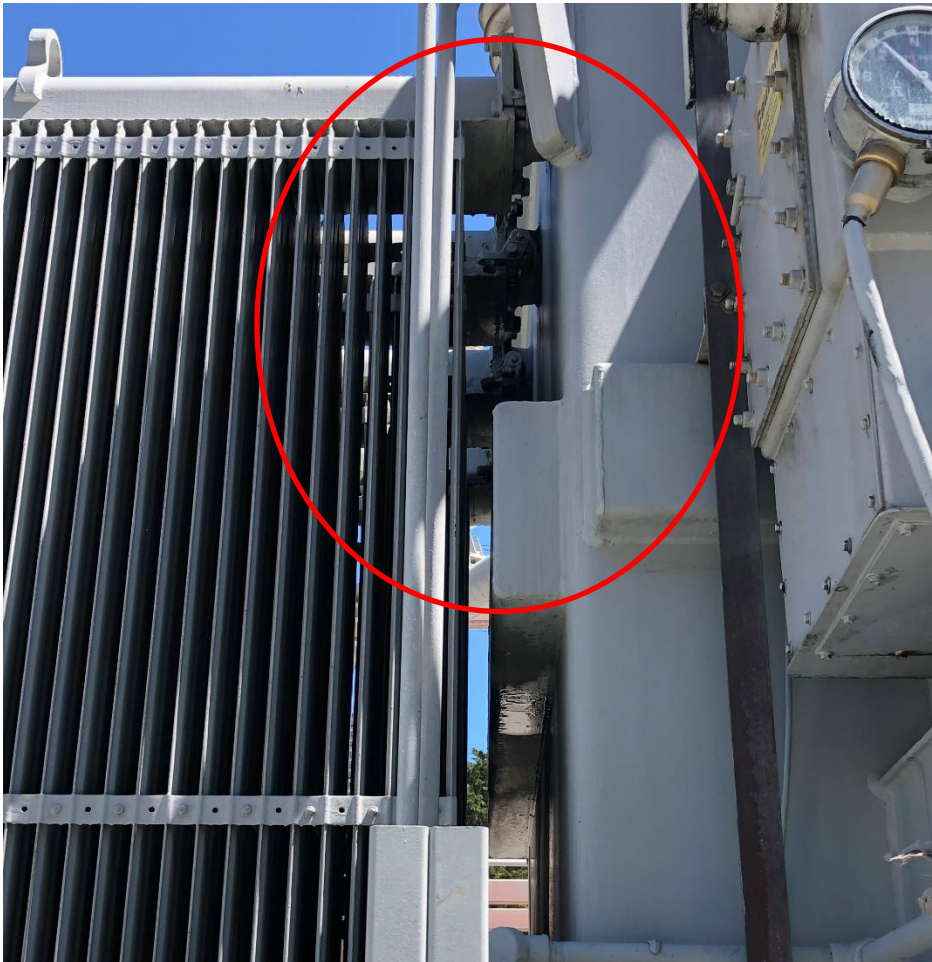
Oil leaking from the flange near tank and position indicator probe at Bank 1.

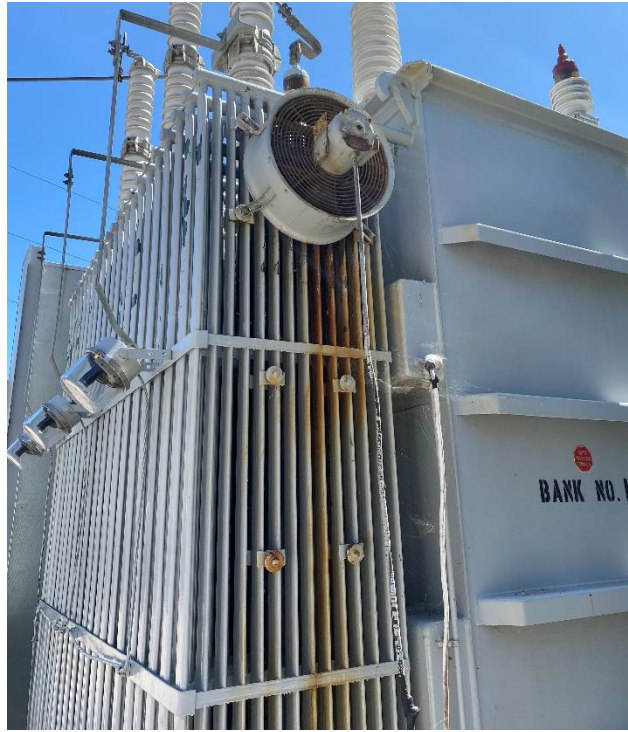
- a. Severe corrosion found on radiator fin of Bank 1.

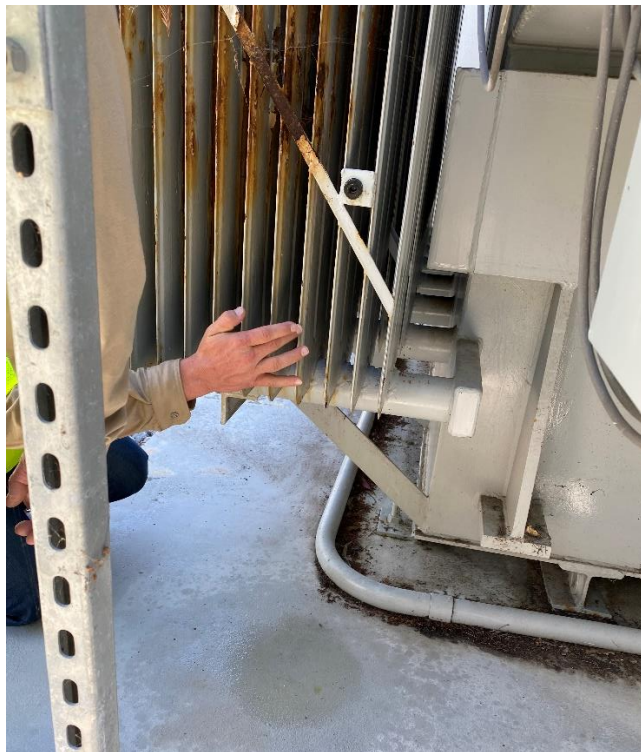
- b. Oil leak and corrosion found on radiator of Bank 2.
