## PUBLIC UTILITIES COMMISSION

**SUBJECT: Generation Audit of Mustang Two Solar – Audit Number GA2023-03MS**

## I. Findings Requiring Corrective Action

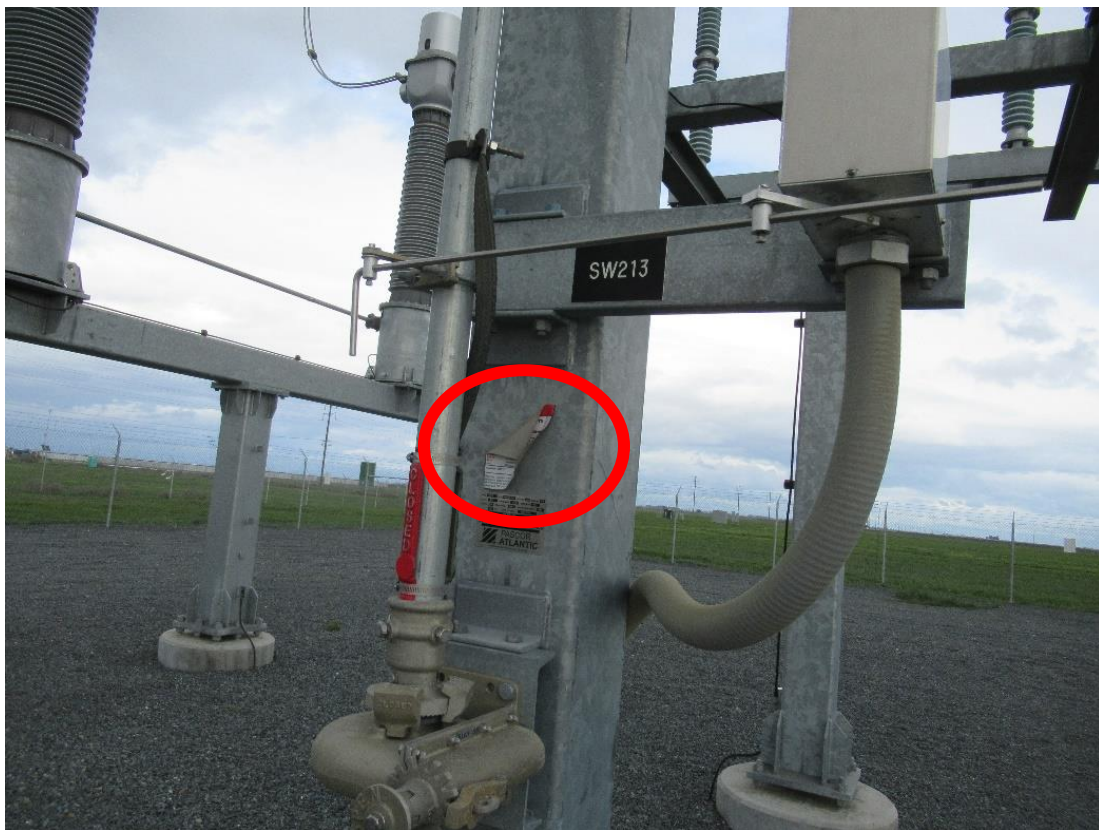
### **Finding 1: ESRB staff observed a peeling arc flash warning sticker near switch SW 213 in substation and missing safety and identification (ID) stickers on 2 inverters.**

ESRB staff observed an Arc Flash sticker that was peeling near switch SW 213 in the Plant substation. ESRB staff also observed missing High Voltage signs, Arc Flash stickers, and identification stickers. The Plant needs to ensure that all inverters have these ID and safety signs/labels. These ID signs are important for the quick identification of equipment, and they help hasten repairs or maintenance being completed. The safety signs help inform employees, contractors, and visitors who may be unfamiliar with the equipment and its inherent dangers.

Figure 1: Peeling Arc Flash Label

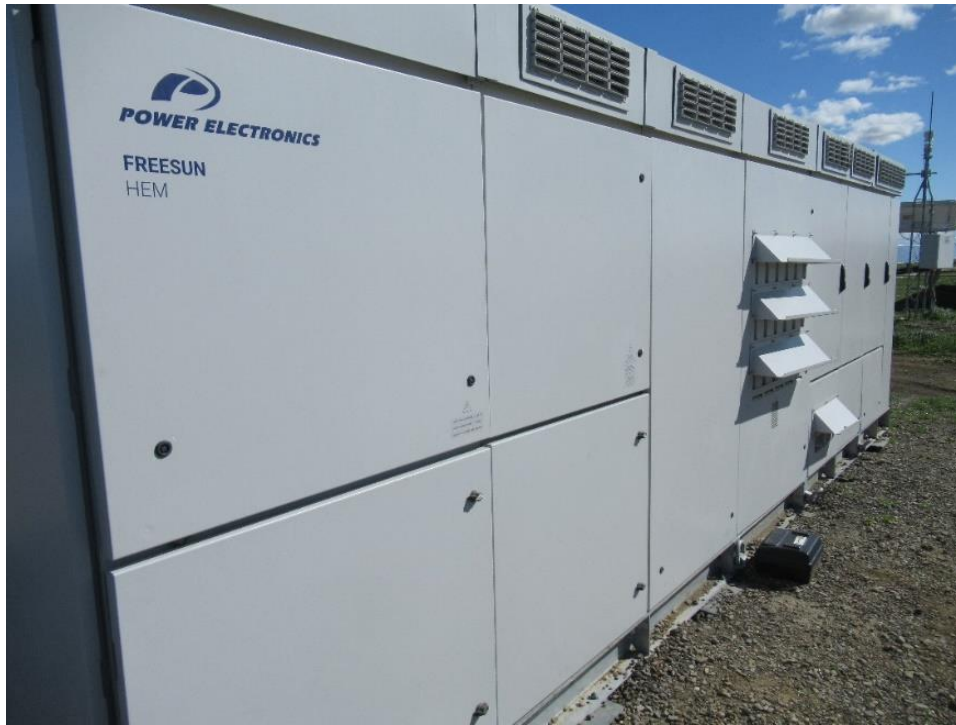
Figure 2: Missing signs/labels on one inverter

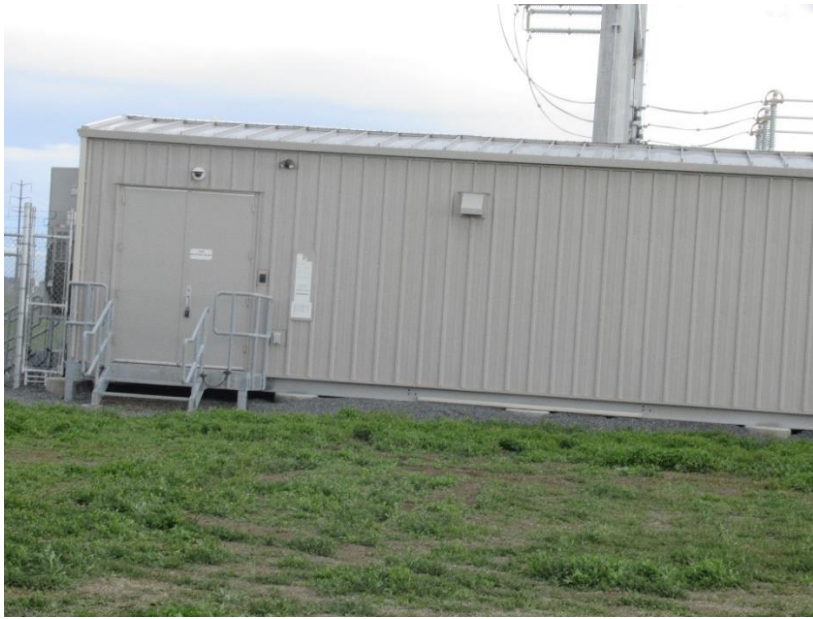
**Finding 2: ESRB staff observed missing National Fire Protection Association (NFPA) Fire diamond signs on substation control room.**

ESRB staff observed missing NFPA sign (the fire diamond) on the control room of the Plant substation, where the backup batteries are held. This sign is important to provide information related to hazards that emergency services would need to effectively deal with the emergency.

Figure 3: Missing NFPA sign (fire diamond) near entrance of control room
