**Report on Southern California Edison Company's
Compliance with the Malibu Area Safety Enhancements
Protocol and Remediation Requirements in Decision 13-
09-028**

**Safety and Enforcement Division
California Public Utilities Commission**

December 2022

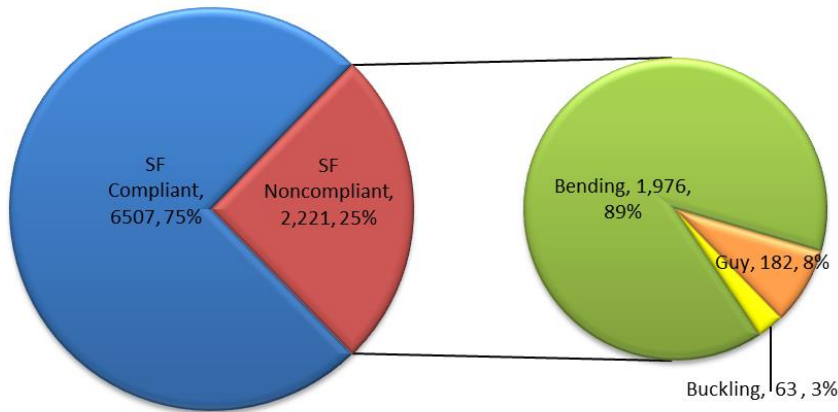
The Overall Safety Factor Noncompliance Rate chart has been updated to reflect the most recent analysis.

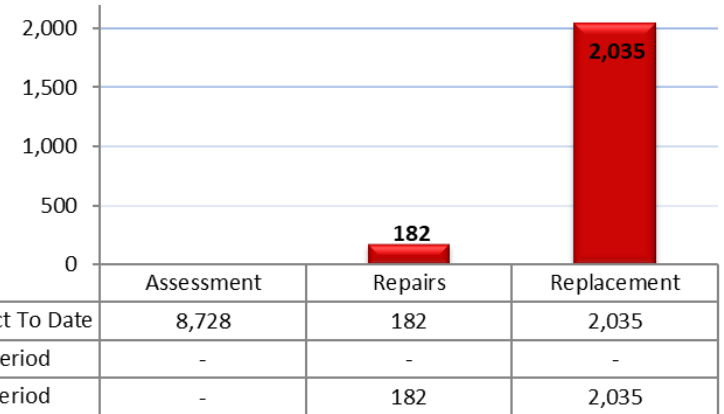
Completed Poles

Pole replacement counts are now based on SCE's Pole Tracker database system, which provides a more real time accounting of completed poles.
