FILSINGER ENERGY
P A R T N E R S

PG&E
INDEPENDENT SAFETY MONITOR STATUS UPDATE
REPORT

October 6, 2023

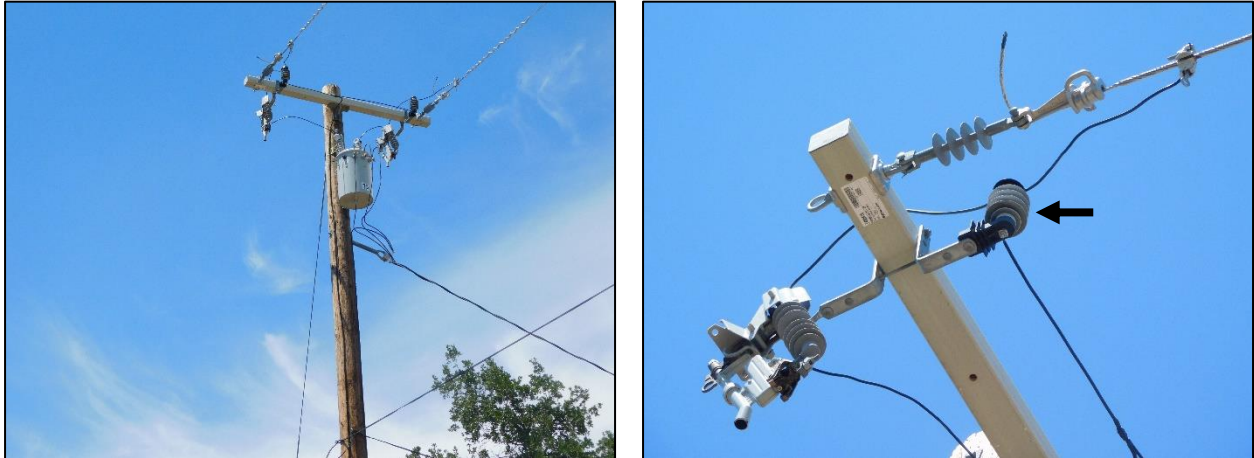
Figure 9: New Pole/New Equipment/Non-Exempt Lightning Arresters

During the current ISM reporting period while conducting distribution inspections, the ISM observed cases where old poles had new equipment installed (including non-exempt equipment¹²) as well as new poles that have all new equipment (including non-exempt equipment). As an example, as seen in Figure 9, the ISM observed a new pole with new equipment installed but still had non-exempt lightning arresters on the pole.

The ISM has an open data request regarding PG&E's policies related to equipment replacement when 1) new equipment and/or poles are installed; and 2) determining factors for installation of animal protection when upgrading poles/installing new equipment.

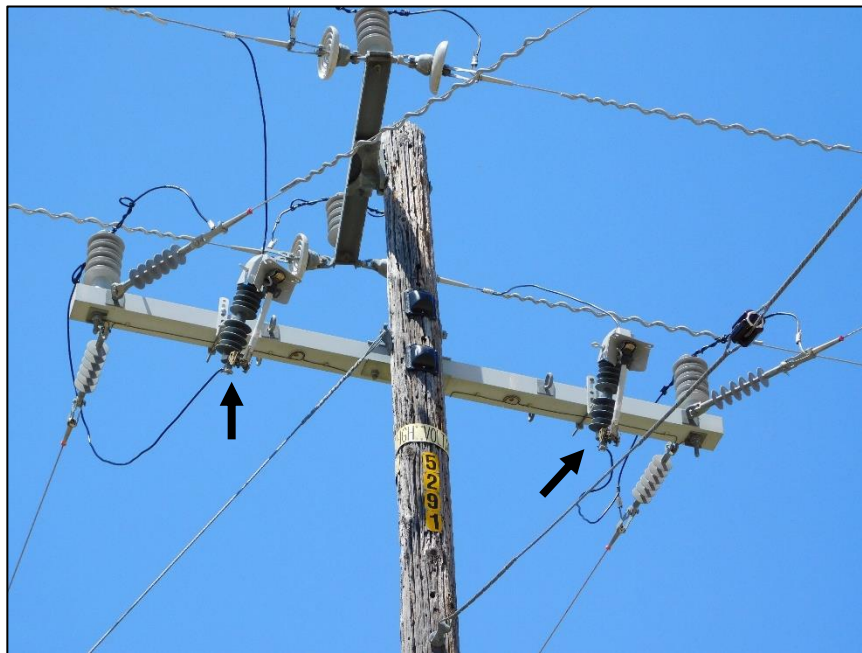
Figure 10: Old Pole/New Crossarms/Non-Exempt Fuses

Another example, as shown in Figure 10, includes an old pole with new crossarms installed along with non-exempt fuses.

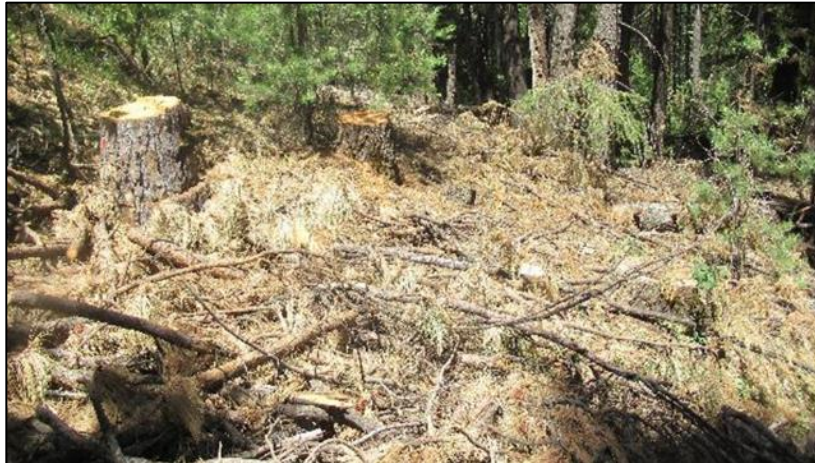
Figure 11: Example of Improper Wood Management

PG&E Best Management Practices (BMP) states, "Woody debris created by chipping, lop and scatter, or brush mowing operations must be left at an average depth of less than 18 inches from the ground surface unless otherwise specified in an easement or landowner agreement."

During the current ISM reporting period, compared to the previous year, the ISM's VM field inspectors observed an increase in out of compliance conditions regarding the extent of wood management – specifically an increase of large wood and slash remaining at sites in the field generated from recent tree work not consistent with the BMP. Figure 11 is representative of these observations.

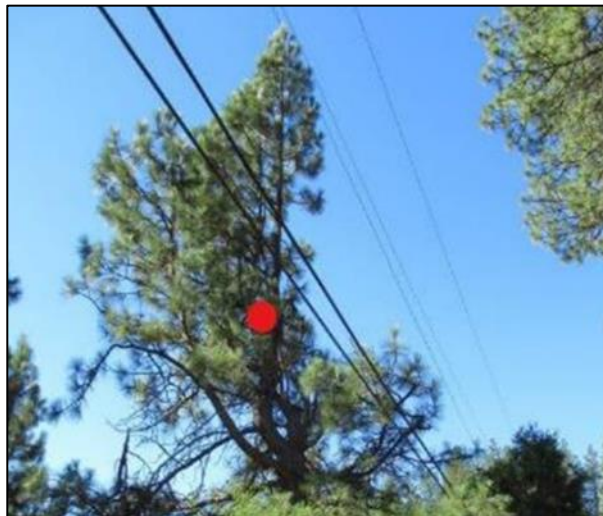
Figure 12: Example of Improper Pruning Practice²⁸

The ISM observed that PG&E’s VM procedures include industry Integrated Vegetation Management (IVM) principles (including ISA Best Management Practices and ANSI A-300 Pruning Standards); however, the ISM observed these industry standards, such as proper pruning practices, are not consistently adhered to in the field. Accordingly, Figure 12 is an example of an improper pruning practice.

²⁸ The tree pictured is a Conifer. The primary top of the tree, commonly referred to as the leader, has been topped/cutoff forcing a secondary branch (which would typically grow horizontally) to turn upward and become the new leader. The new leader is structurally weaker and therefore poses a higher risk of failure/breakage.
