## PUBLIC UTILITIES COMMISSION

GI-2015-09-PGE13-02A

SUBJECT: General Order 112 Gas Inspection of PG&E's Sacramento Division

**SUMMARY OF INSPECTION FINDINGS**

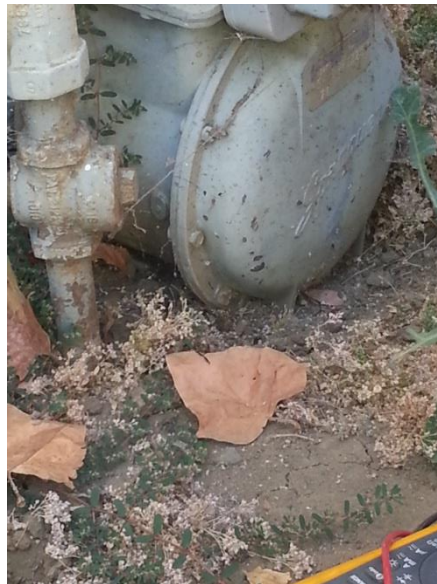
On 9/23/15, SED and Division visited the locations given in Table 2 and recorded the following P/S reads which did not meet the minimum  $-0.85$  Volts (V) criteria.

Location	P/S Reading (mV)
630 Elm Street, Woodland (SAP# 42699507)	-730 mV at Riser
23 East Main Street, Winters (SAP# 42729911)	-839 mV at Riser Note: Buried Meter at location see Photo 1
E/S Blue Ravine Rd. 175' S/O Riley St., in El Dorado Hills:	-809 mV at ETS DFM
9080 Elm Avenue., Orangeval, Yearly ETS	-780 mV Yearly ETS
8680 Central Avenue, Orangeval	-740 mV Yearly ETS

Photo 1. Buried meter at 23 Elm Street, Winters

Please inform SED of the corrective actions for the deficiencies identified above.
