## PUBLIC UTILITIES COMMISSION

GA2013-27

Subject: General Order 112-E of Pacific Gas and Electric Company's Stockton Division

## Summary of Audit Findings

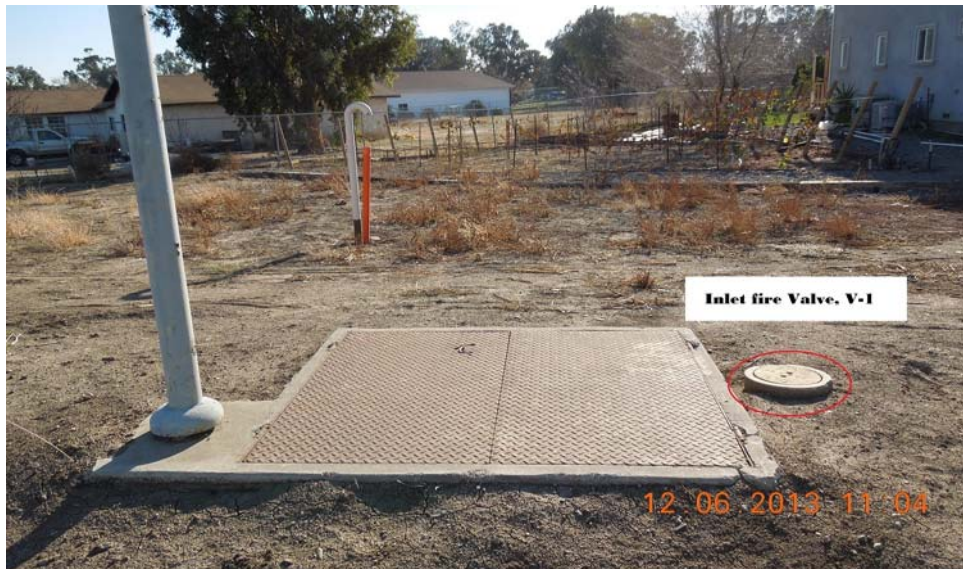
Division created a valve maintenance card for the outlet fire valve V-3 on 12/28/2011. SED reviewed the regulator station records for TY-HP-01 and noted that Division observed the same deficiencies regarding the locations of both fire valves and hard to turn fire valve V-1 during the annual maintenances conducted on 4/11/12 and 4/15/13 for both stages.

SED and PG&E visited the regulator station on 12/6/13 and observed the following:

SED also noted that Division must relocate both inlet and outlet station fire valves shown in Photos 1 & 2, according to its design requirement of minimum spacing of 20 feet from the Station equipment which is required by H: Regulator and Relief Valves, Gas Regulator Stations:

Photo 1- Location of the inlet fire valve located at the first stage

Additionally, PG&E must take corrective action for inlet fire valve V-1 since it is still very hard to turn.

Please inform SED with the corrective actions taken for this station.

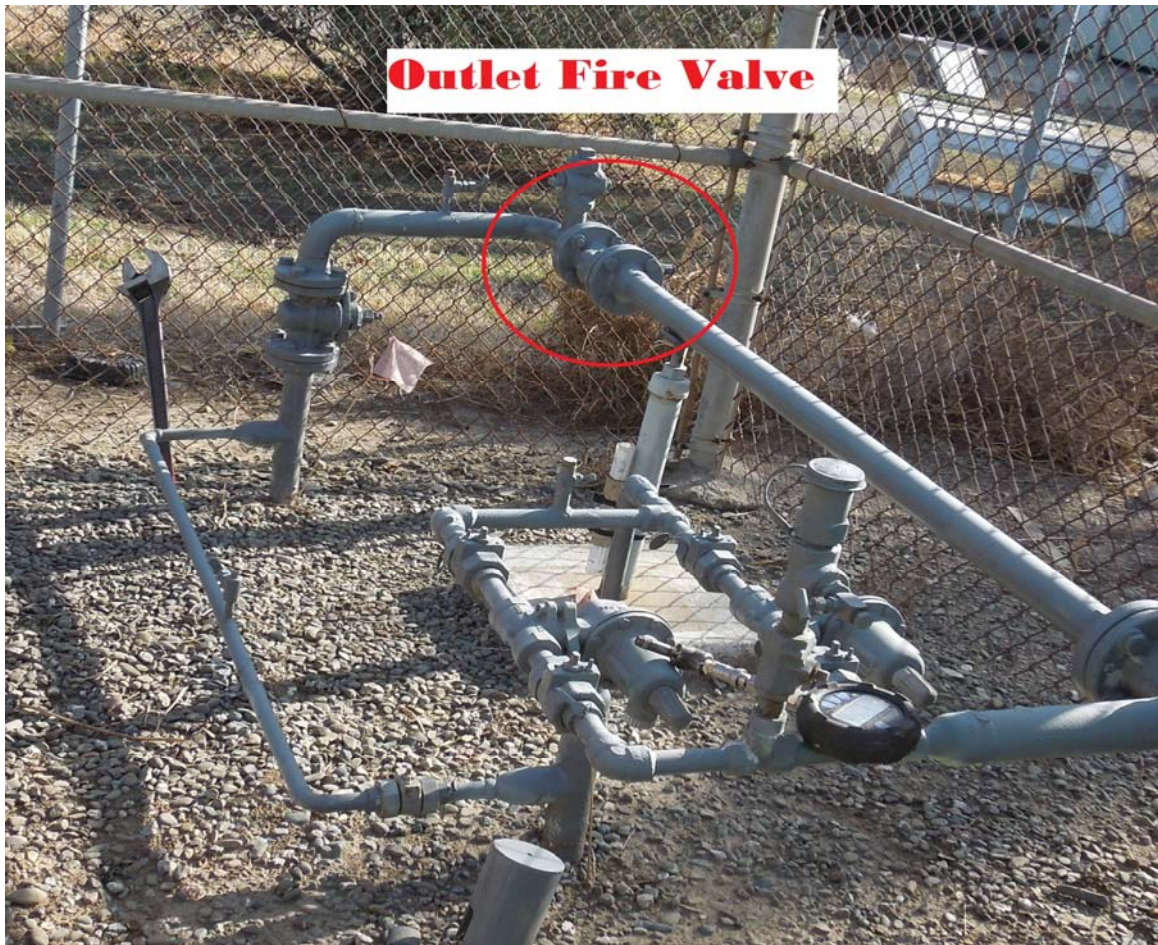
Photo 2- Location of the exit fire valve located at the second stage
