**CALIFORNIA PUBLIC UTILITIES COMMISSION
Safety and Enforcement Division
Electric Safety and Reliability Branch**

Incident Investigation Report

**Incident No. E20201009-01
June 2, 2022**

Utility Facilities Involved: Girvan 1101, 12 kV Circuit

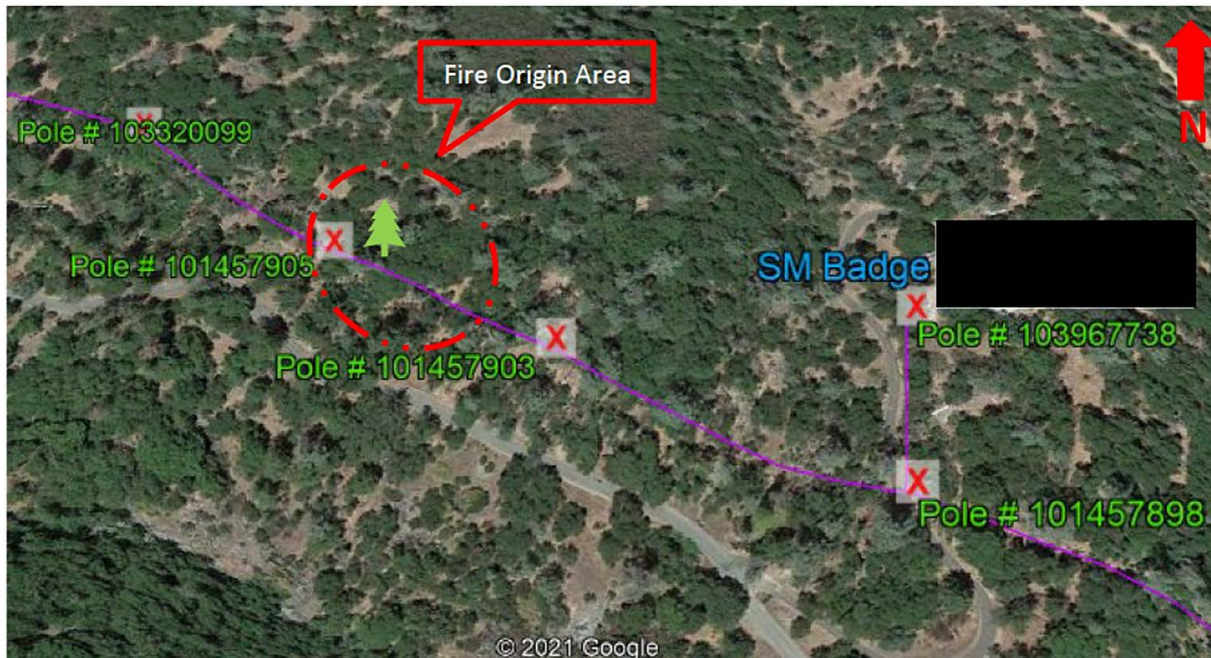
Figure 1: Fire Origin Area/Incident Location.⁵ Boxes with a red X indicate approximate pole locations. The purple lines indicate approximate conductor path which continues west and east in both directions but is not marked.

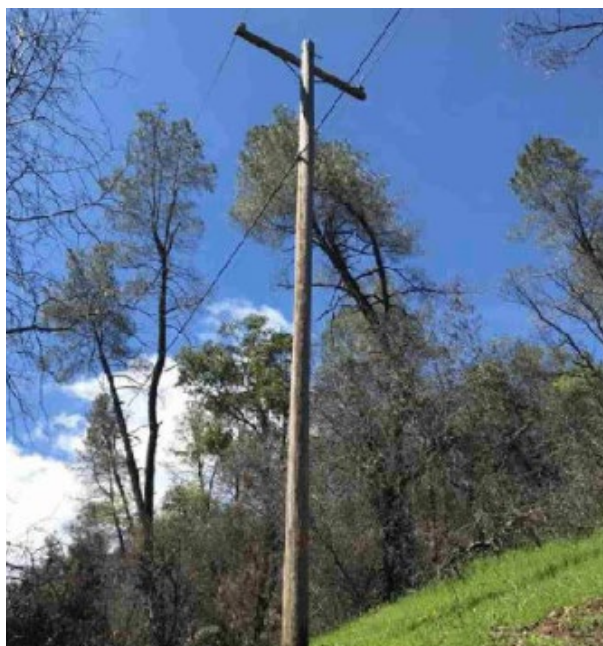
Figure 2: Pole SAP ID 101457903

- On April 16, 2019, PG&E conducted a WSIP inspection of the pole that identified no abnormal conditions.⁹ See Figure 2 below for a photo of the pole.

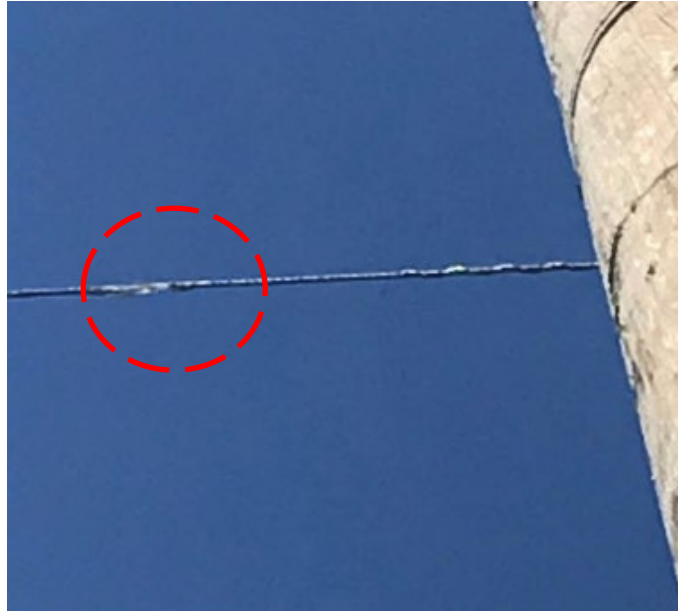
- On April 16, 2019, PG&E conducted a WSIP inspection that identified a damaged primary conductor on the pole (See

Figure 3).¹⁰ In addition, see Figure 4 below for a photo of the pole. PG&E created Electric Corrective (EC) notification #117043330 to replace the damaged conductor no later than April 16, 2020.¹¹ However, PG&E did not replace the conductor until after the Zogg Fire. Because PG&E did not replace the conductor prior to its required completion date, EC notification #117043330 was past due. See the section “Past Due EC Notifications” below for further details on past due EC notifications in the Zogg Mine Road area.¹²

Figure 3: Damaged Conductor¹³

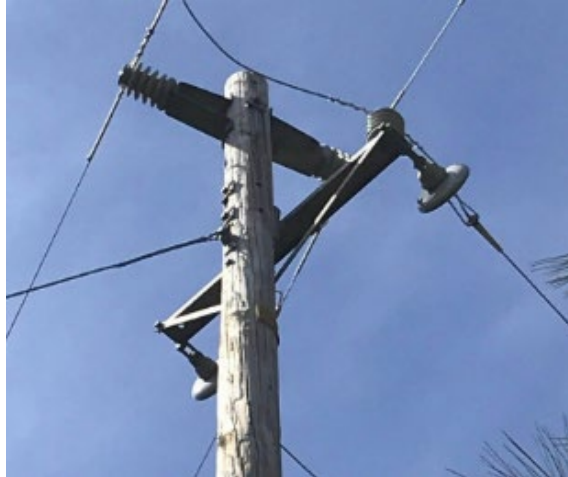
Figure 5: LAPP Insulators¹⁷

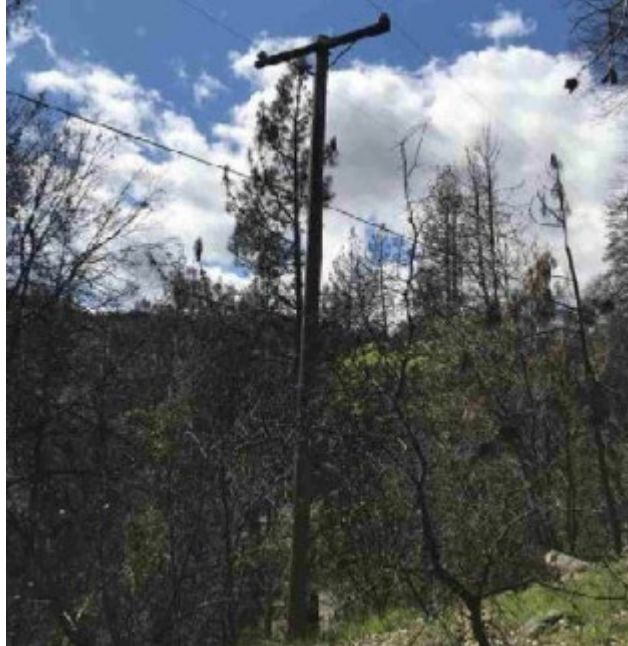
Figure 7: Pole SAP ID 101457905²⁰

- On April 16, 2019, PG&E conducted a WSIP inspection of the pole that identified no abnormal conditions.¹⁹ See Figure 7 below for a photo of the pole.

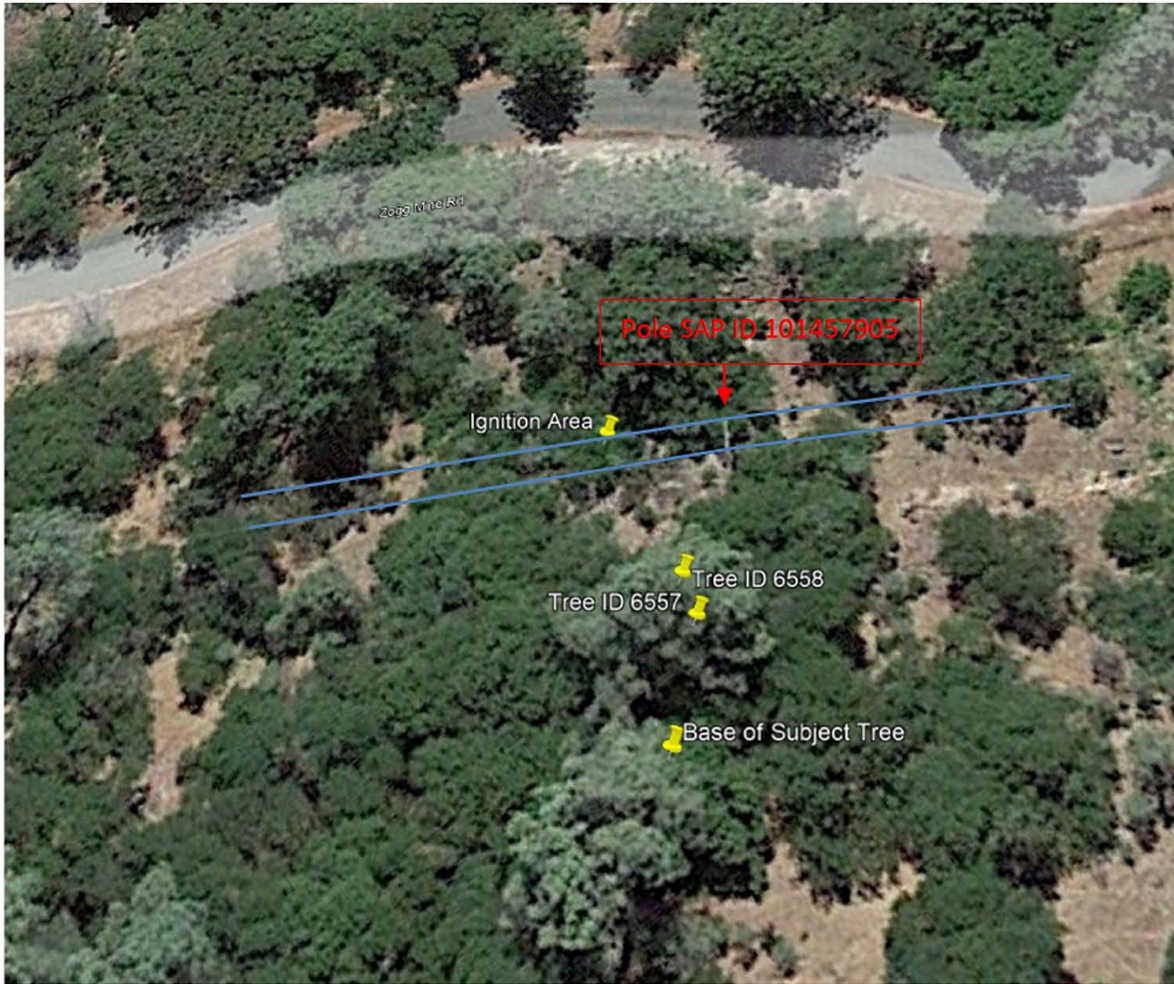
Accordingly, PG&E believes the Subject Tree may have identified for removal (but not removed) since the two Gray Pine trees have a location consistent with the Subject Tree. PG&E did not specify why it failed to remove the two Gray Pines. However, PG&E also stated that it has not been able to confirm if the Subject Tree was one of the two Gray Pines because there were three other Gray Pines located near the Subject Tree.⁴⁴

Figure 8: Diagram of the Subject Tree, Tree ID 6557, Tree ID 6558, Ignition Area, and PG&E Facilities.⁴⁵ Note that the lines marked in blue show approximate conductor path and continue east and west in both directions.

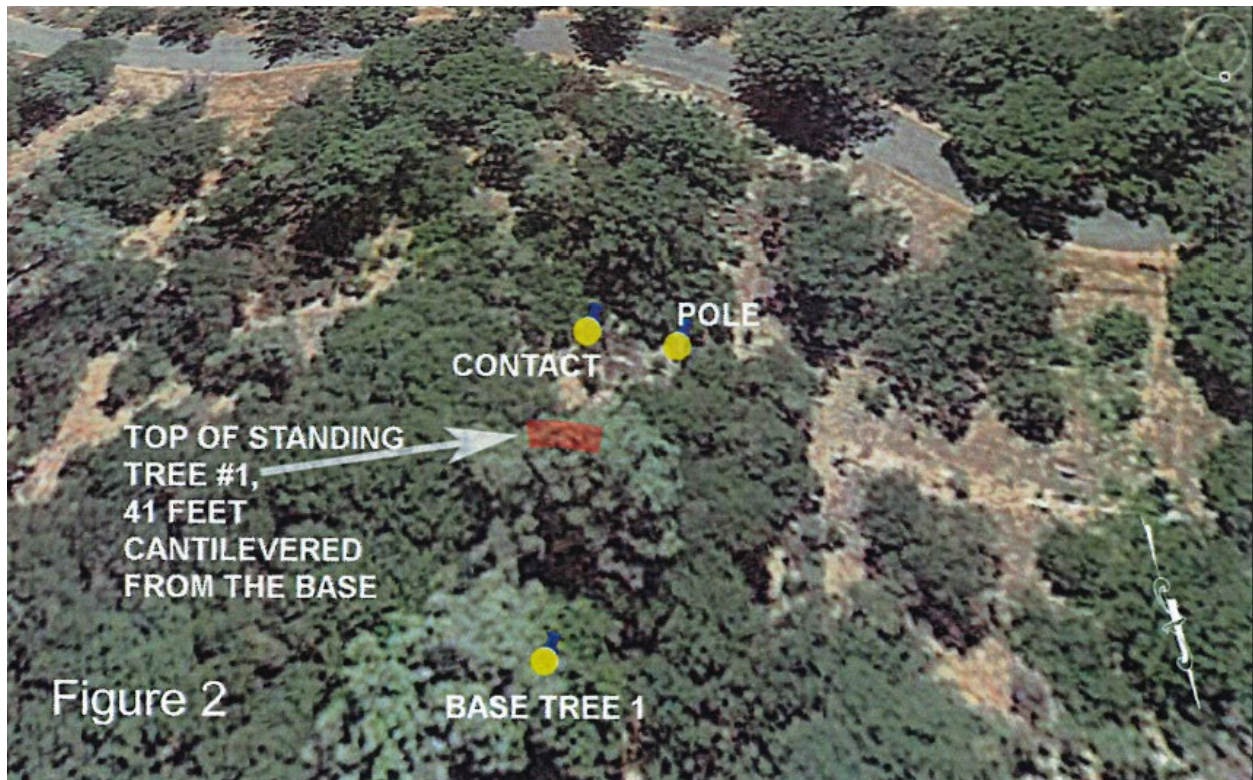
Figure 9: Diagram of Subject Tree, point of contact, and Pole from the Vegetation Analysis.⁴⁶

Based on SED’s review of PG&E’s and Mountain G’s records pertaining to the post-Carr Fire VM work and SED’s analysis of the location of the Subject Tree, SED determined that Mountain G identified the Subject Tree for removal, but for reasons not currently specified PG&E failed to remove the Subject Tree. Per GO 95, Rule 31.1 (refer to Attachment F), PG&E is required to properly maintain its facilities to ensure safe and reliable service. Because PG&E failed to remove the Subject Tree after identification for removal during the post-Carr Fire VM work, the Subject Tree failed and fell onto PG&E’s 12 kV conductors causing the Zogg Fire. Therefore, SED found PG&E in violation of GO 95, Rule 31.1 for failing to properly maintain its facilities by not removing the Subject Tree.

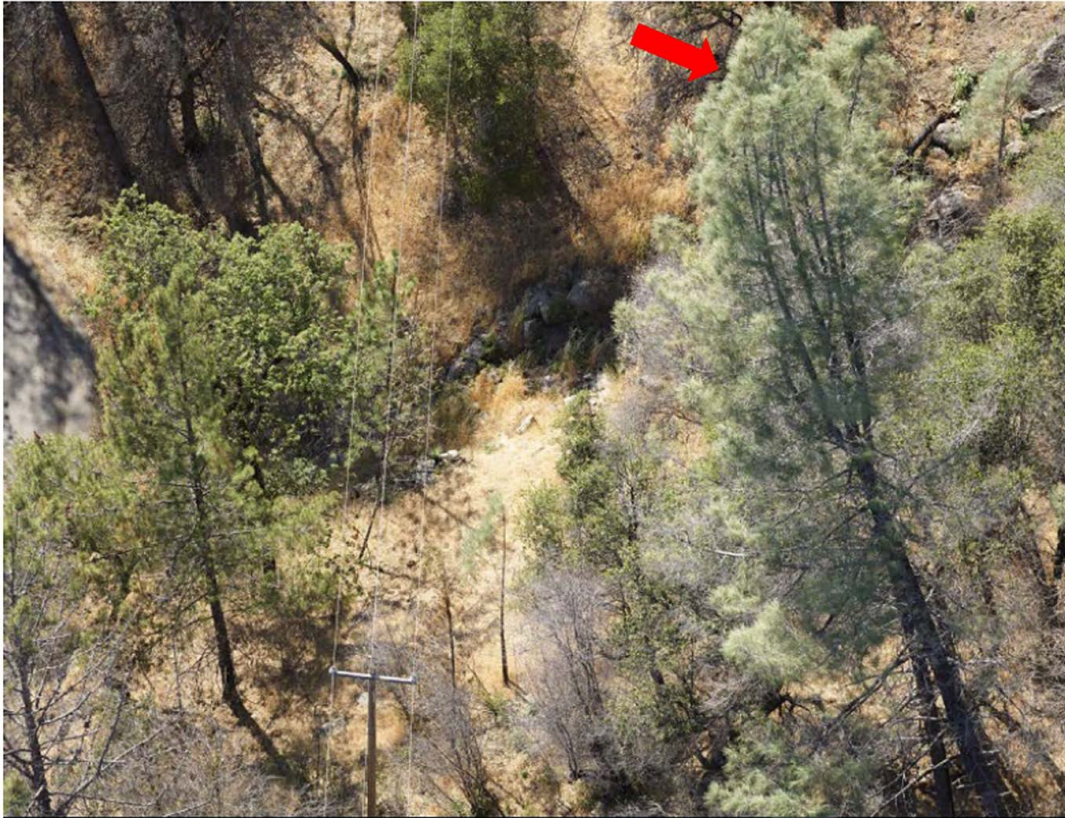
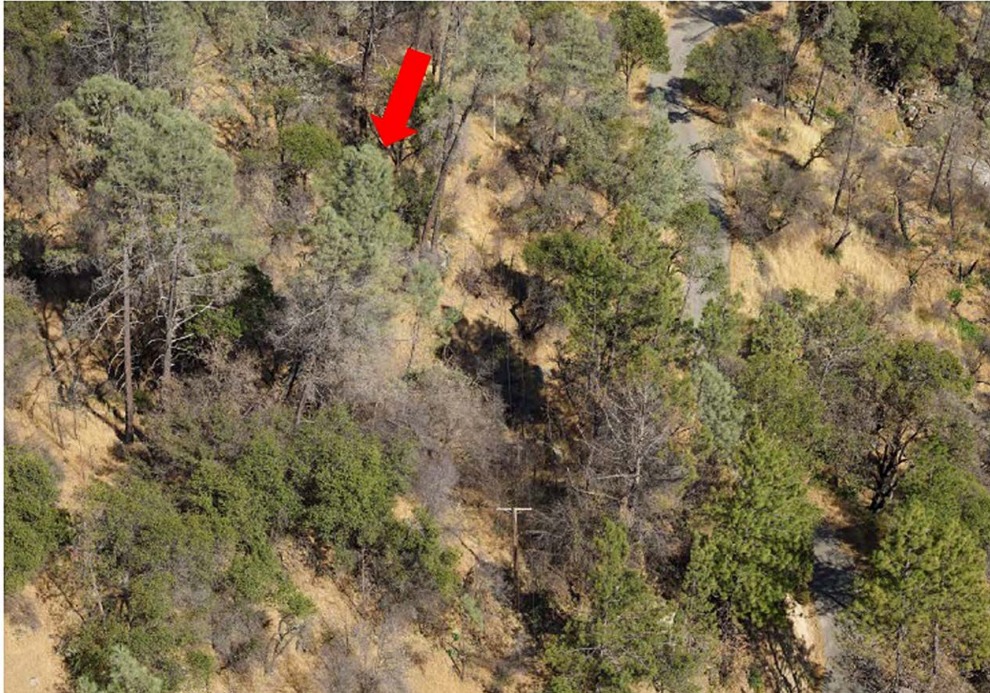
PG&E VM took aerial photos of the Subject Tree in July 2019 (See Figures 10 and 11). Regarding the photos, PG&E stated that "...as depicted in these photos, the Gray Pine of interest displayed a full, green canopy and, based on the limited information available in these photographs, did not display any apparent signs of disease, decay or fire damage."⁵¹ Based on Figures 10 and 11, the Subject Tree shows a green canopy and noticeably leaned towards the Subject Conductors. CAL FIRE determined the Subject Tree had a lean of 23 degrees from vertical towards the Subject Conductors.⁵²

However, the photos do not provide a detailed view of the trunk, trunk base, or individual limbs/branches which could have shown signs of decay, disease, or damage. The condition of the Subject Tree prior to the fire is described in the Vegetation Analysis section below.

Figure 10: Aerial Photo of Subject Tree⁵³

Figure 11: Aerial Photo of Subject Tree⁵⁴

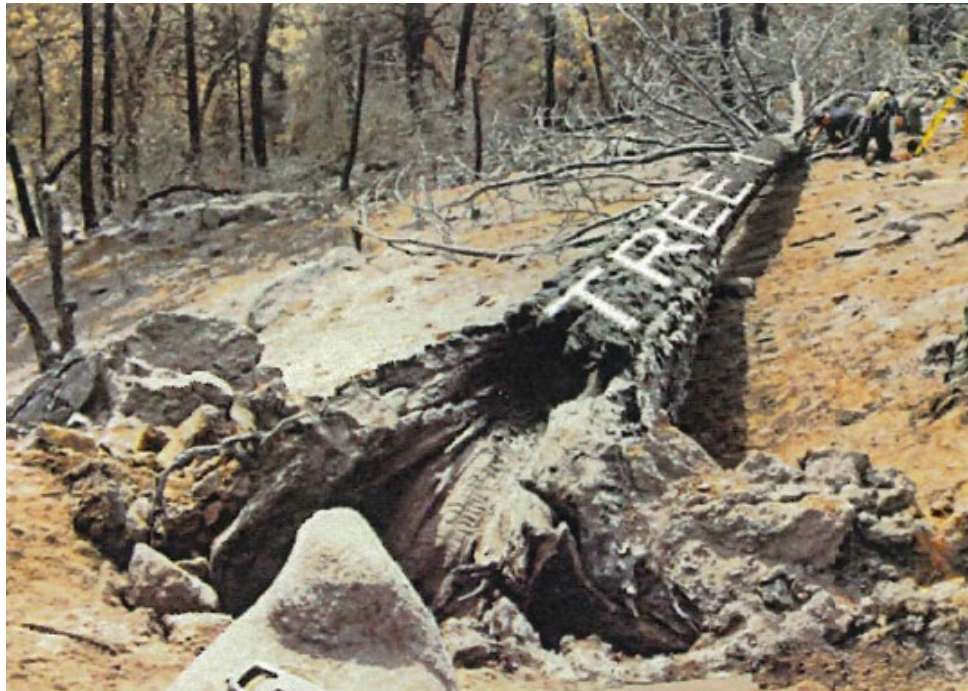
The arborist observed a large cavity on the uphill (north) side of the Subject Tree (See Figures 12, 13, and 14). The arborist measured the cavity to extend 14 to 15 inches into the trunk and approximately 4.5 feet up the trunk from the ground (See Figure 14). Per the Analysis, the cavity was too large to be the result of the Zogg Fire or Carr Fire; therefore, it existed sometime prior to the Carr Fire. Furthermore, the Analysis determined the large roots east and west of the trunk were integrated into the side of the cavity which indicates the cavity and large roots developed concurrently over many years.

Figure 12: Subject Tree on the Ground⁵⁶

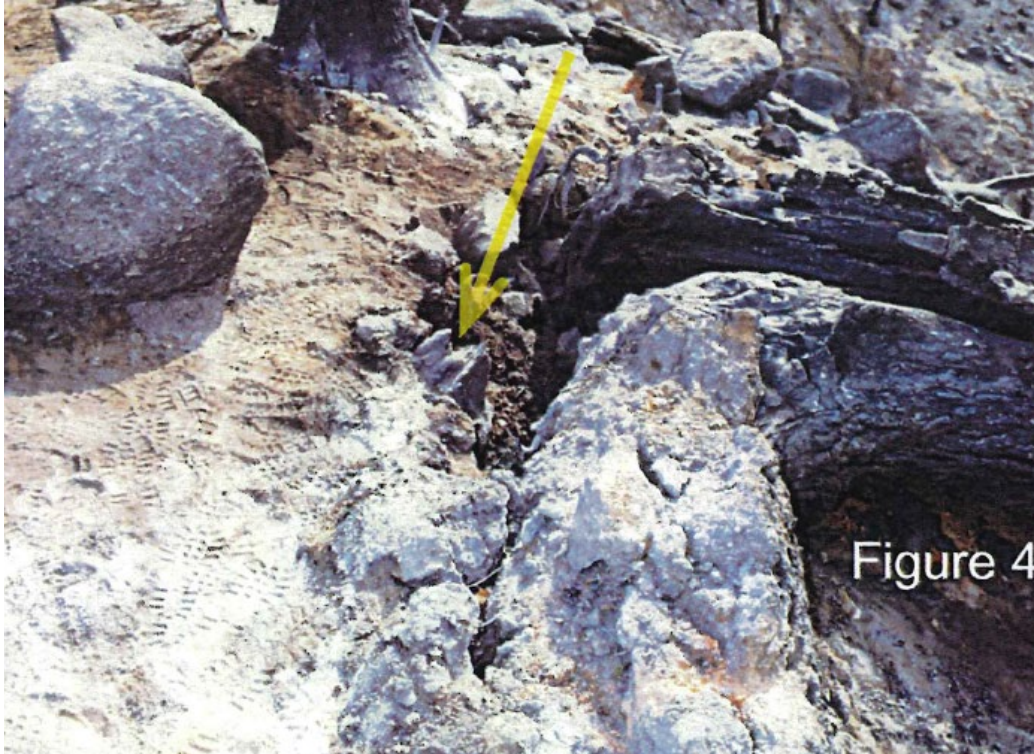
Figure 13: Lack of Roots and Boulder on the Uphill Side of Subject Tree⁵⁷

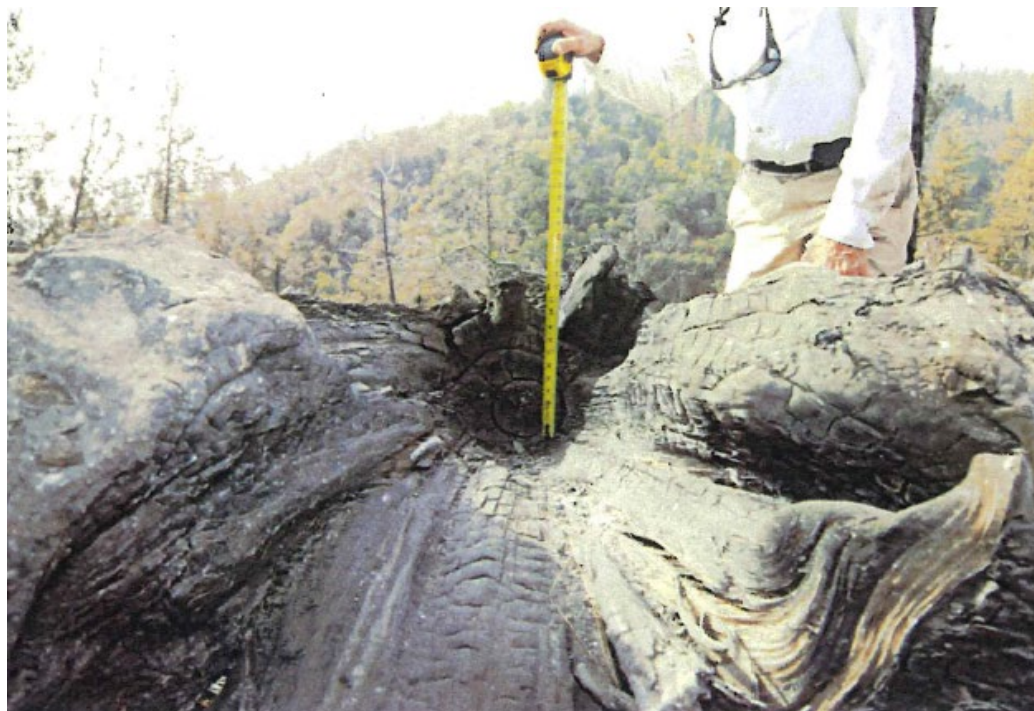
Figure 14: Large Cavity in Subject Tree⁵⁸

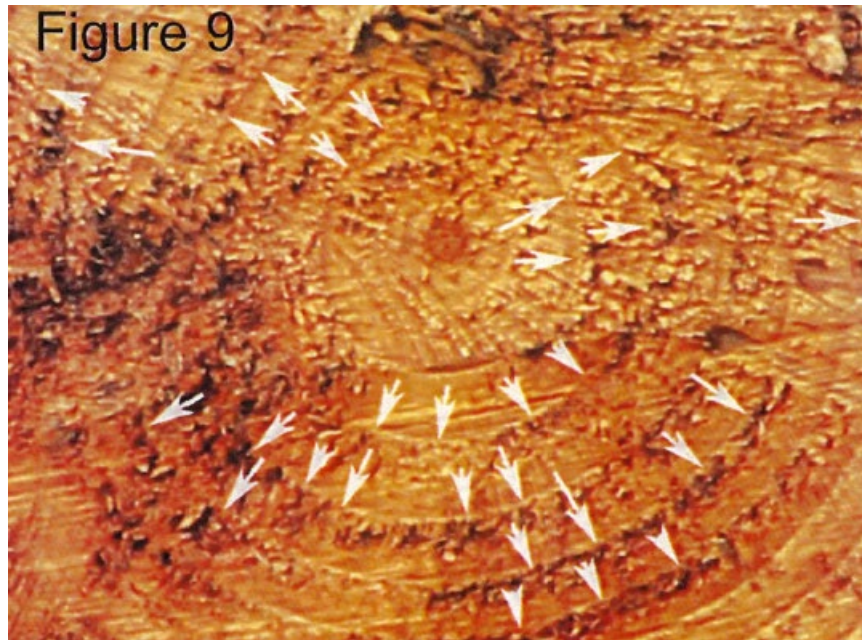
The arborist observed pulled out fibers on a portion of the top of a 12.5-foot cross-section of the Subject Tree trunk CAL FIRE had cut with a saw (See Figure 15). Per the Analysis, healthy wood cuts cleanly; therefore, the Subject Tree was partially internally decayed. The Analysis stated that since the majority of the foliage was located on the upper half of the tree, it increased stress at the base of the tree.

Figure 15: Pulled out Fibers on Trunk⁵⁹

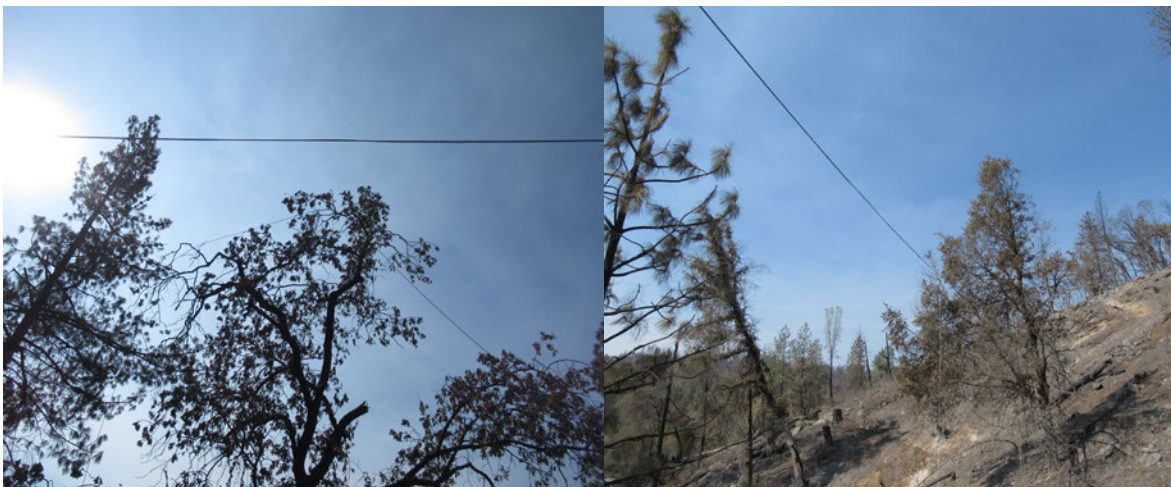
On October 7, 2020, at 0930 hours, SED conducted a field investigation with CAL FIRE and Shasta County DA investigators. At the Incident Location, SED observed that PG&E primary 12 kV conductors had snapped midspan due to contact with the Subject Tree and were lying on the ground and suspended in trees (See Figures 16.a. and 16.b.). The Subject Conductor span, installed in 1957, was #4 ACSR (Aluminum Conductor – Steel Reinforced). At approximately 30 feet south of the pole (SAP ID 101457905) located closest to the Subject Tree, SED observed the remains of two broken primary insulators and the supporting crossarm (See Figure 17). In addition, the pole top that held the crossarm appeared to have failed (See Figure 18). SED also inspected the next pole (SAP ID 103320099) located one conductor span northwest. The base of the pole showed signs of ground disturbance (See Figure 19) and the primary crossarm was broken in half (See Figure 20).

Figures 16.a. and 16.b.: Conductors at the Specific Origin Area⁶⁰

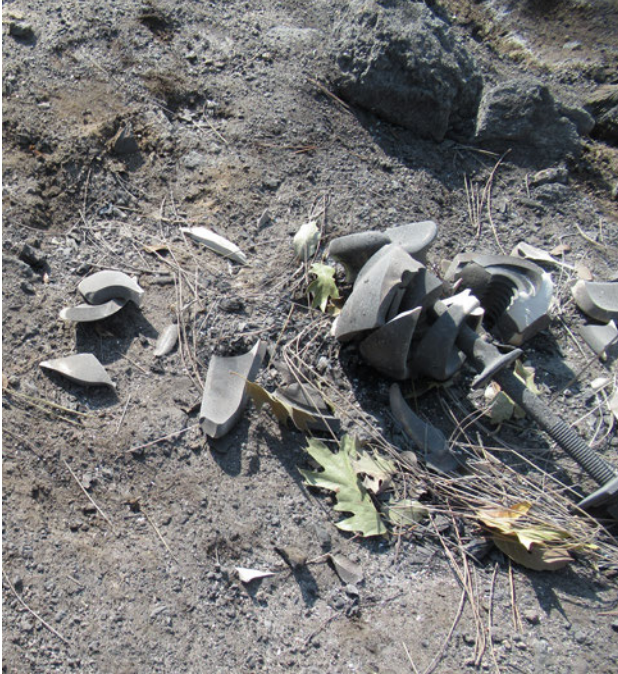
Figure 17: Insulator Remains

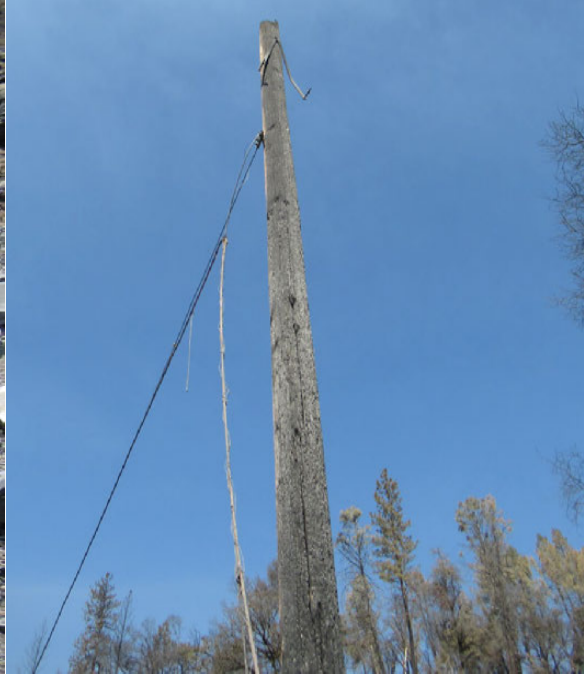
Figure 18: Failed Pole

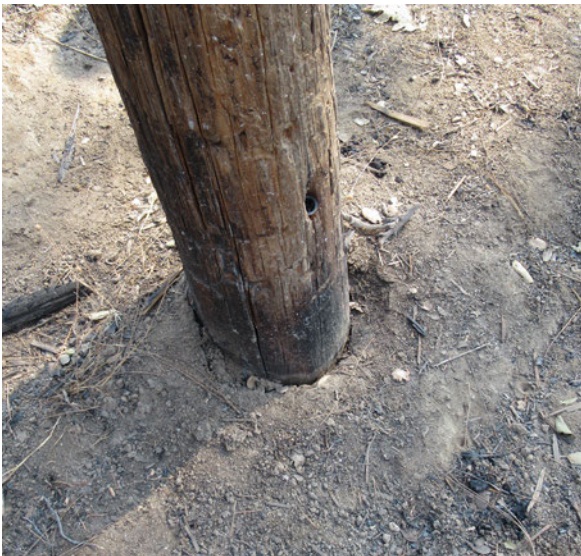
Figure 19: Ground Disturbance

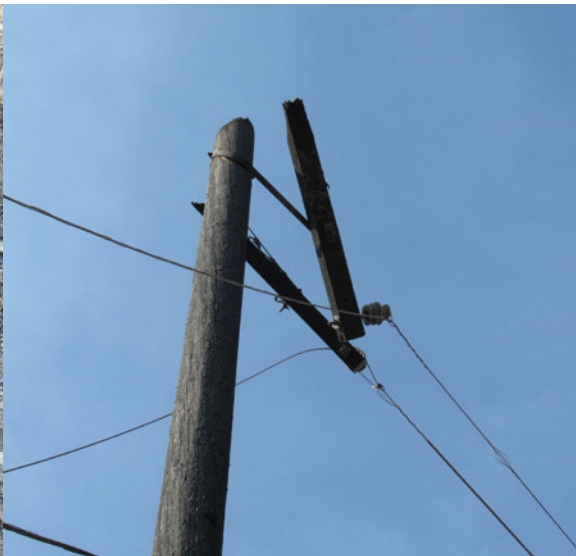
Figure 20: Broken Crossarm

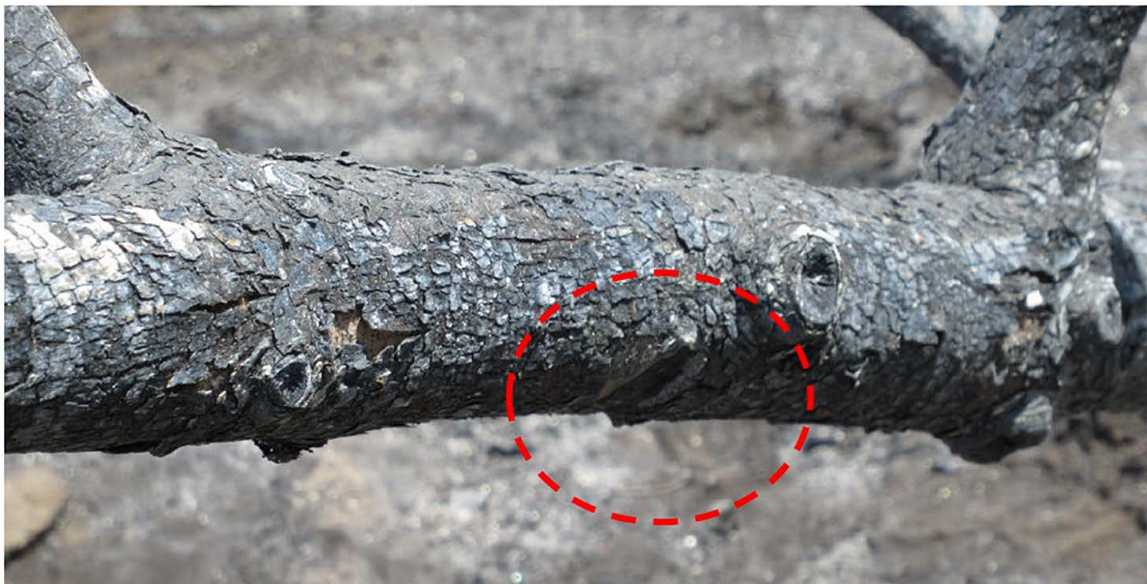
During SED's field investigation on October 7, 2020, at the Incident Location, SED observed the remains of a tree stump from the Subject Tree and its fallen trunk.⁶⁵ SED estimated that the stump was rooted approximately 60 feet north and uphill of PG&E facilities. SED also noted that the stump appeared burned and had a large open cavity at the north side of the trunk, away from PG&E facilities. Since the large open cavity was on the north-facing side of the trunk, it was not visible when standing from the south where PG&E's facilities were located. Furthermore, SED observed a tree branch from the fallen trunk with an indentation and burn marks potentially caused by contact with an energized conductor (See Figure 24).

Figure 24: Tree Branch with Indentation Marks⁶⁶

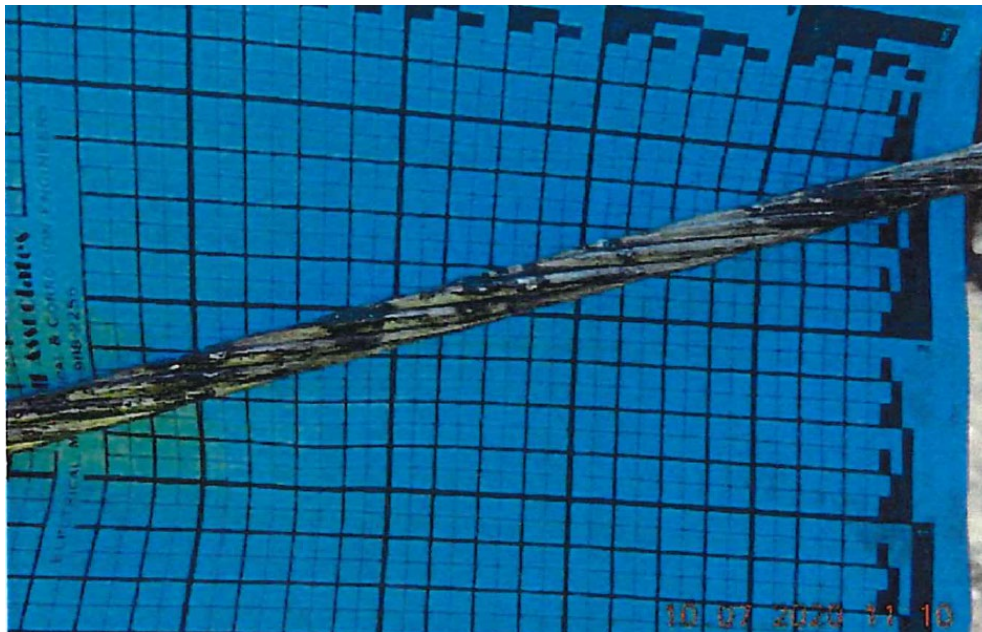
JHNolt Associates observed fire damage and mechanical damage to the conductors on the west side of the fallen Subject Tree. Additionally, JHNolt Associates observed fire damage, mechanical damage, and electrical arc fault damage to the conductors on the east side of the Subject Tree (See Figure 30). JHNolt Associates determined the mechanical damage to the Subject Conductors is a result of failure due to excessive tension which is consistent with the conductors breaking due to the Subject Tree falling on them. JHNolt Associates found the electrical arc damage to the conductor on the east (source) side to be consistent with the conductor being energized for a few minutes after the Subject Tree fell (See Figure 30). JHNolt Associates indicated the Subject Tree branches showed clear evidence of contact with at least one, possibly two conductors (See Figure 31). Furthermore, JHNolt Associates concluded the electrical arc damage on the trunk and branches indicates the Subject Tree fell onto the Subject Conductors while they were still energized.

Figure 30: Electrical Arc Damage on East Conductor⁷²

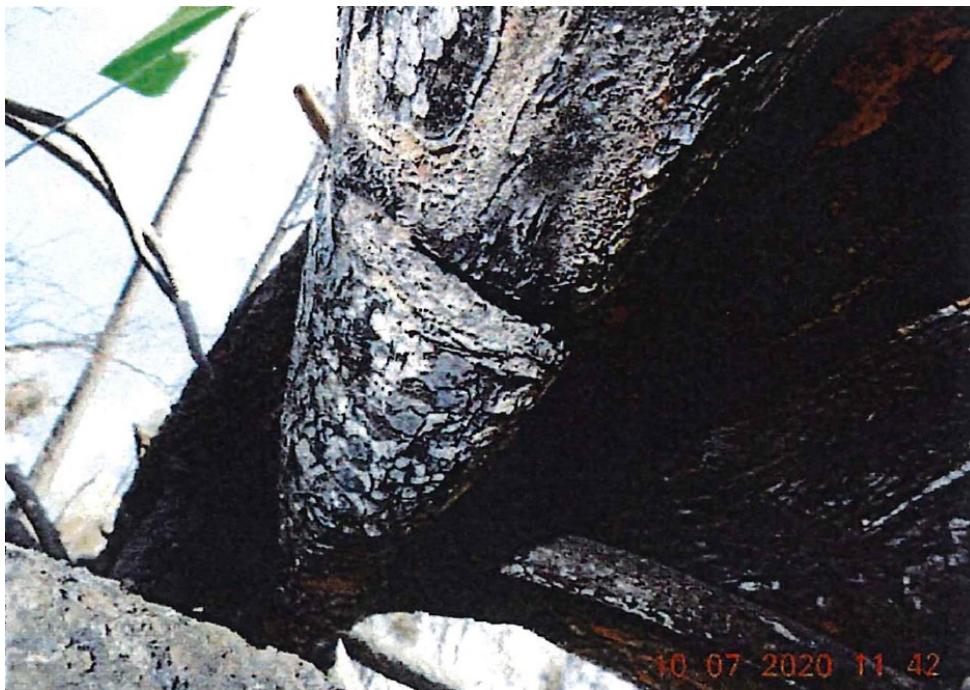
Figure 31: Tree Branch with Electrical Arc Damage from Conductor⁷³
