**ANNUAL RAILROAD SAFETY REPORT
TO THE
CALIFORNIA STATE LEGISLATURE**

**November 30, 2017
for
Fiscal Year 2016 - 17**

**CALIFORNIA PUBLIC UTILITIES COMMISSION
SAFETY AND ENFORCEMENT DIVISION
OFFICE OF RAIL SAFETY
RAILROAD OPERATIONS AND SAFETY BRANCH**

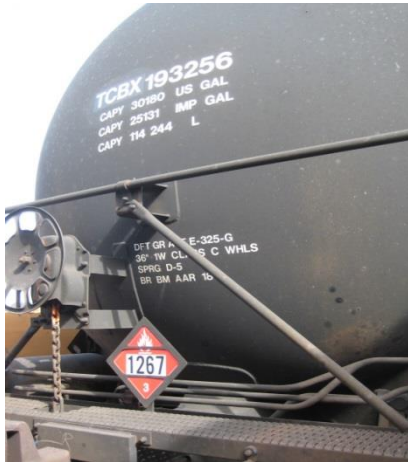
Crude oil tank car without retrofitting

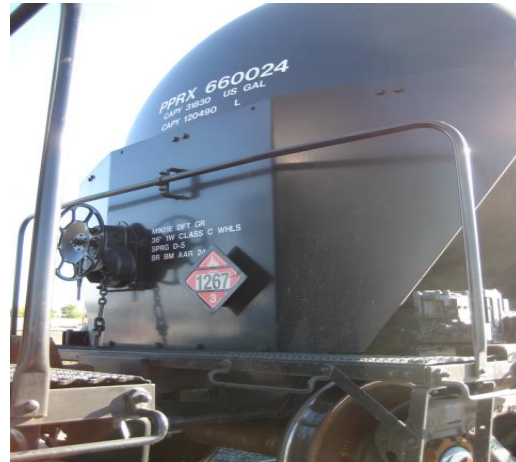
Crude oil tank car with enhanced or retrofitted material applied to the bulk head (end of car)

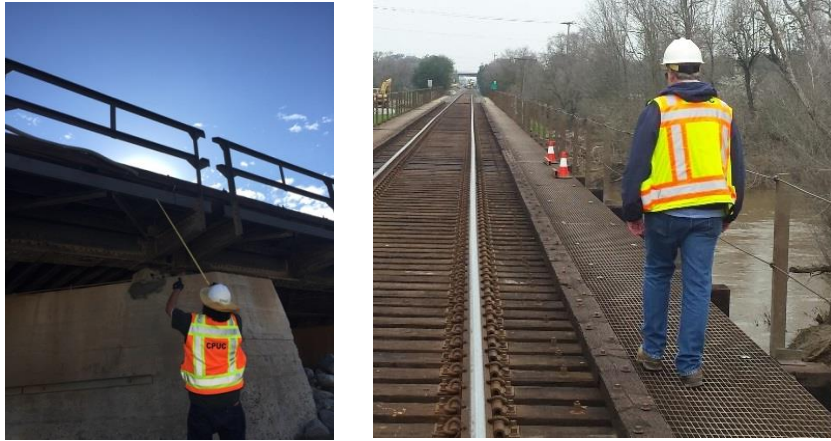
CPUC railroad safety bridge inspectors review bridge structure integrity and associated potential risks during field inspections

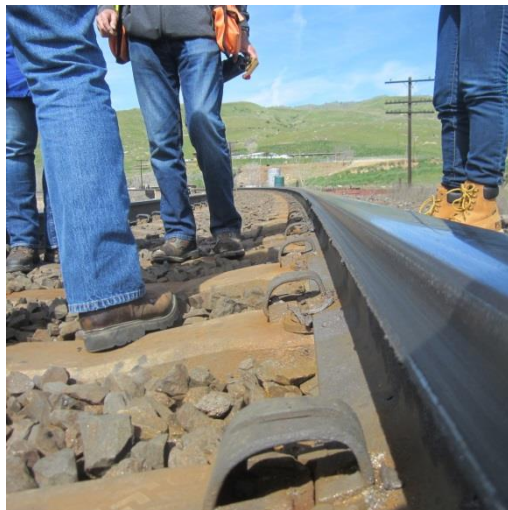
CPUC staff examining worn rail on a curve

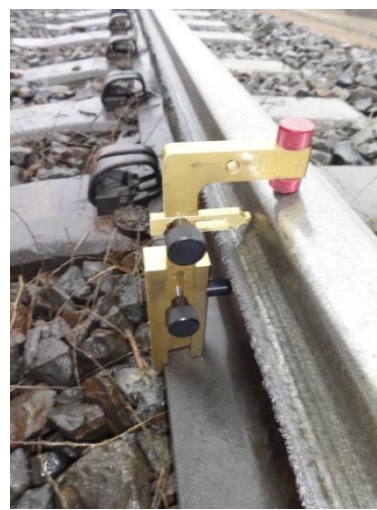
Rail head wear gage depicting 22/32" wear loss

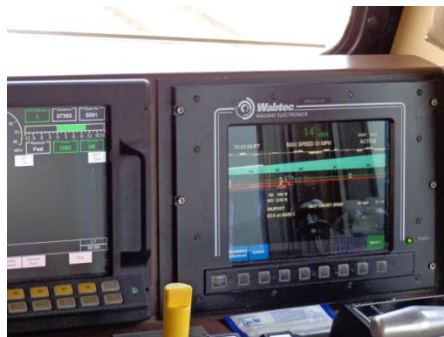
A BNSF locomotive with PTC screen

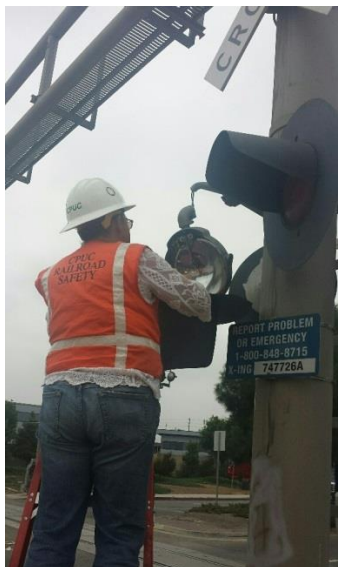
A CPUC Signal & Train Control inspector during an at-grade crossing inspection

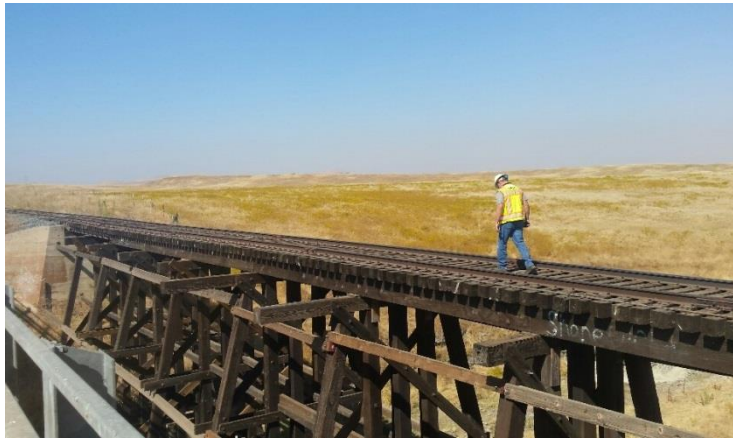
A CPUC track inspector inspecting track over an open deck bridge

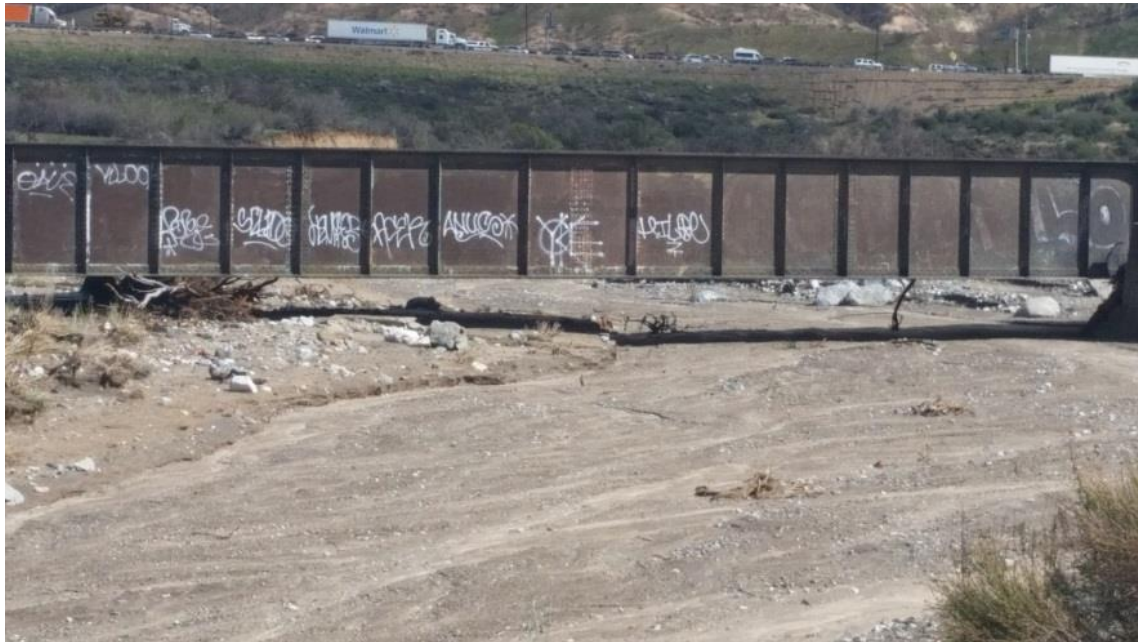
Due to recent heavy rains and flash flooding throughout the area, a large amount of silt had collected under the bridge. This silt collection had risen to a point where there was minimal clearance between the stream bed and the bottom of the bridge.

BNSF Railway Bridge at Cajon Creek, showing poor separation between the stream bed and the bottom of the bridge

BNSF Railway understood the concerns conveyed by the CPUC bridge inspector's RMSR and made arrangements to dredge the area around the bridge.

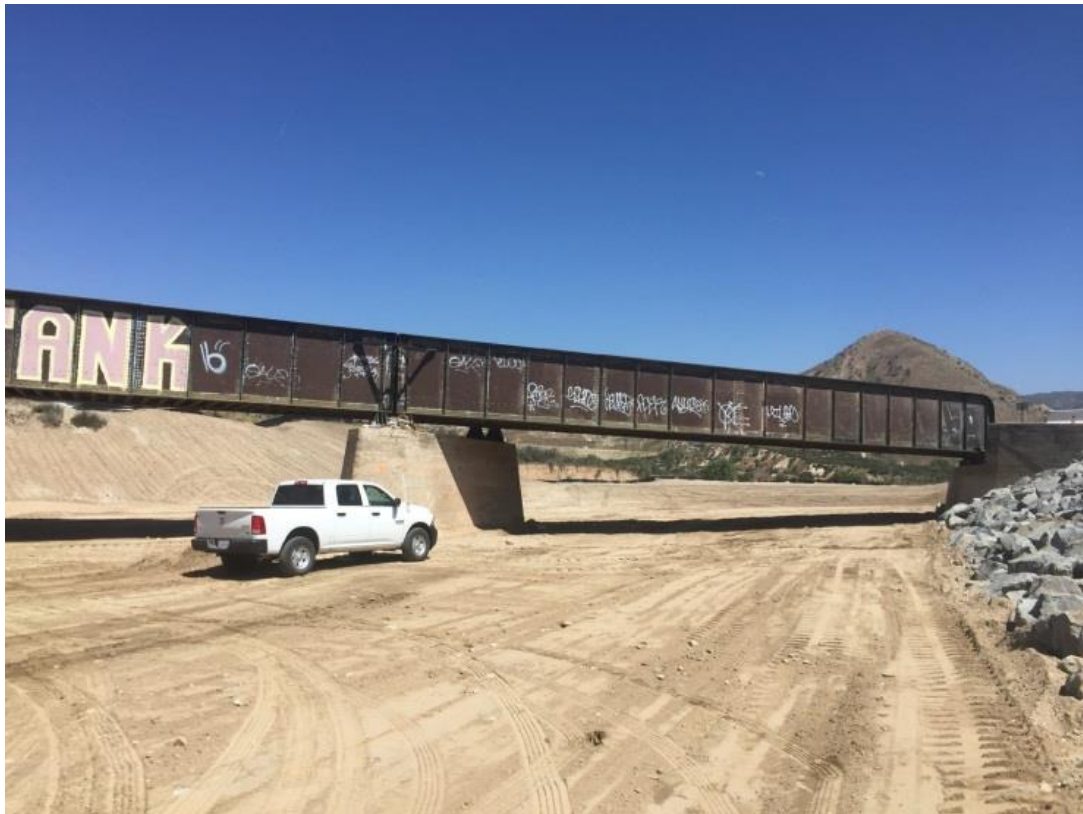
The same bridge after the BNSF Railway dredged out the silt to allow for more adequate water flow

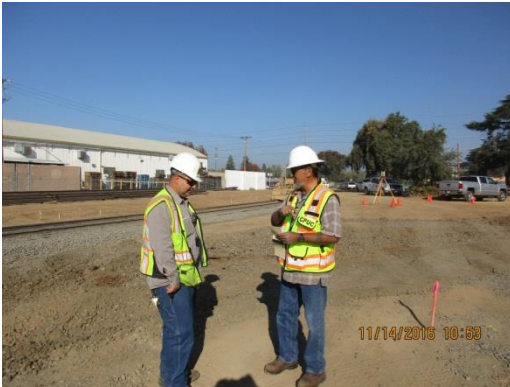
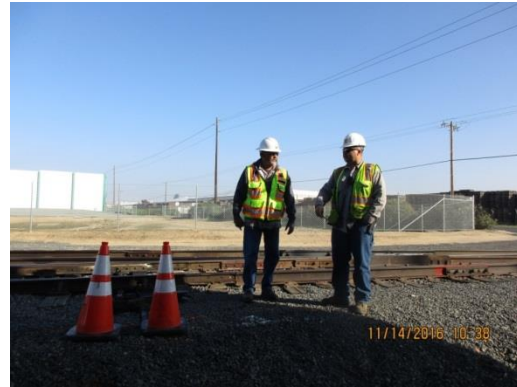
The inspectors informed the M&ET representative that the barrier wall would not be in compliance with General Order 26-D, which requires at least an 8' 6" clearance area from the track center. The 8' 6" side clearance is required to provide railroad employees riding the side of a rail car adequate clearance from obstructions that could knock the employee off the rail car and potentially cause injury or death.

CPUC inspector and M&ET Manager of Track Maintenance inspect the area of proposed barrier wall construction

The M&ET track supervisor removed the existing construction markers and placed new markers and painted new lines on the ground to show where to safely construct the barrier wall in compliance with CPUC requirements.

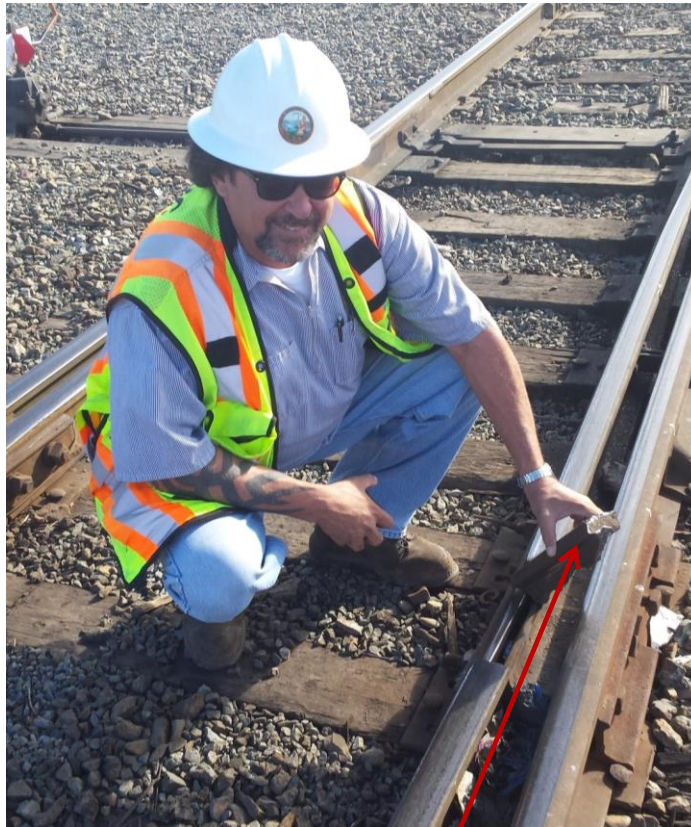
A CPUC inspector holding the broken rail piece

movements over the broken rail. The USS Posco manager immediately removed the track from service and replaced the rail the same day.

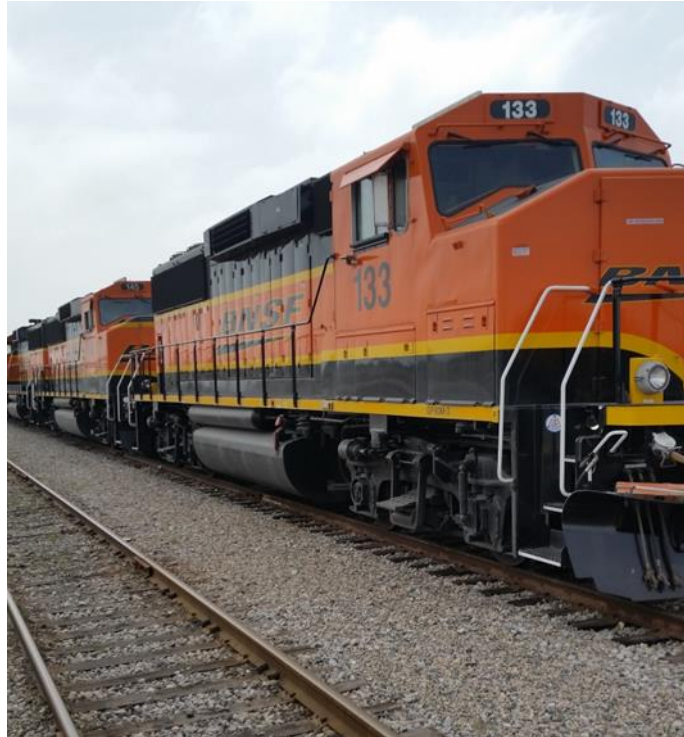
December 1, 2016: Two CPUC inspectors performed a routine inspection at the BNSF Railway Kaiser Yard, in Fontana, San Bernardino County. The inspectors identified an unattended locomotive that did not have a handbrake applied. Properly securing handbrakes is one of the most critical tasks railroad crews perform. 49 CFR Part 232.103 and BNSF's Air Brake Train Handling Rule 102.1.1 requires all brakes in an unattended locomotive consist to be applied. Kaiser Yard's trainmaster was promptly notified about this defect. It was immediately corrected and the CPUC inspectors performed a follow-up inspection that verified that the handbrakes were properly applied.

Photograph of the BNSF locomotive that did not have an appropriately applied hand brake

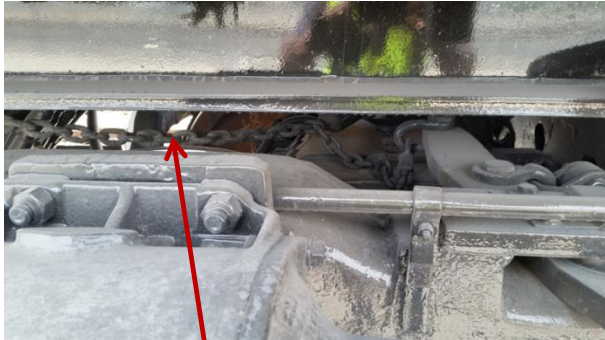
Before: The handbrake is not applied. Note the slack (dangling) in the chain, which indicates the hand brake is not applied

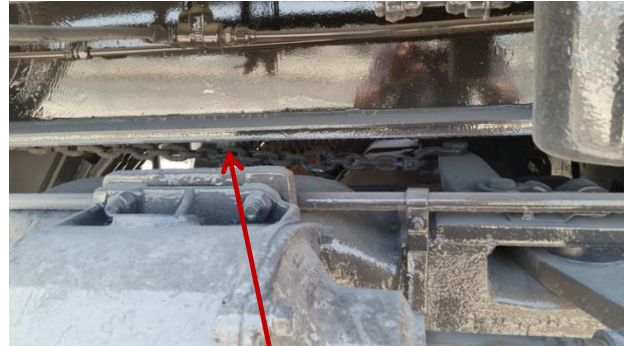
After: The handbrake is applied. The chain is now taut, indicating the hand brake is applied

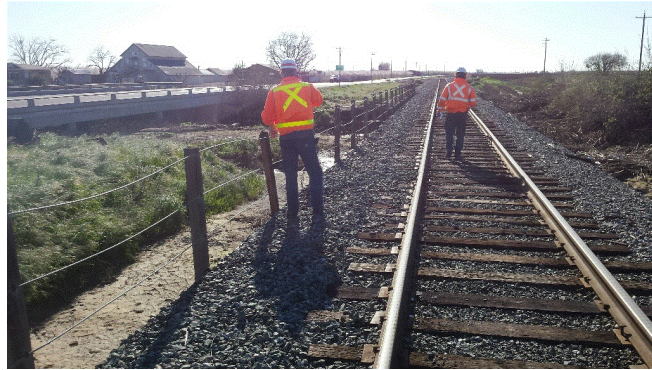
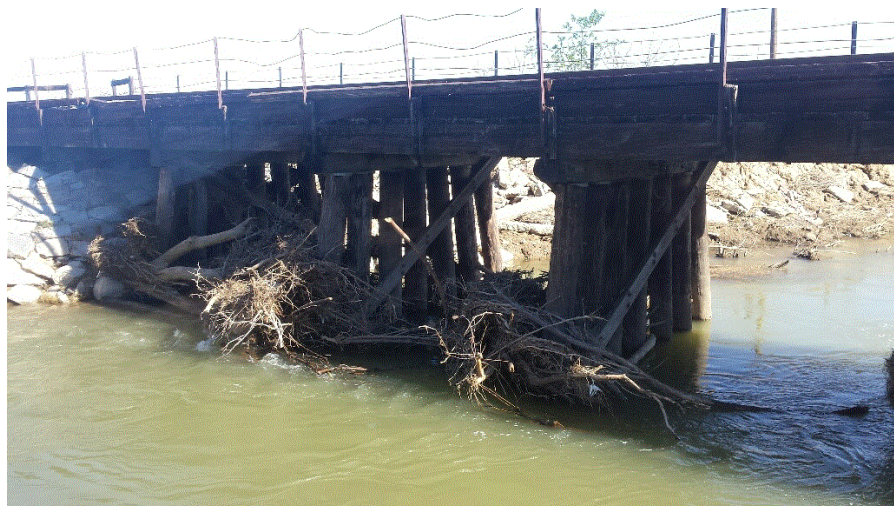
49 CFR Part 213.33 requires water drainage under or adjacent to a track roadbed to be maintained and kept free of obstructions to accommodate expected water flow for the area. The inspectors notified a California Northern Railroad manager of the excessive debris. The Manger made a plan to have the debris removed. A follow up inspection soon after confirmed that the debris had been removed.

Above and below: CFNR main track bridge near Westly, south of Tracy

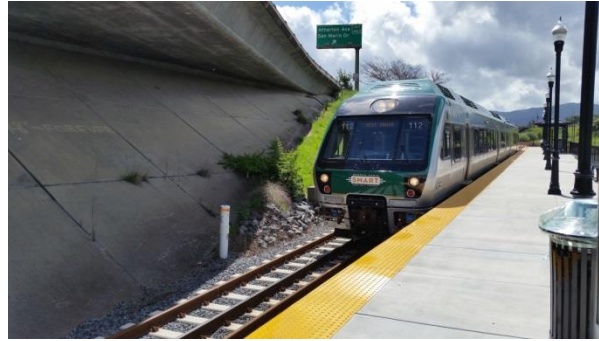
CPUC staff observed SMART personnel testing varying temporary speed restrictions on a specific segment of mainline track, relating to their overall testing of the PTC implementation process.

Sonoma-Marín Area Rail Transit (SMART) PTC Test train at Novato North station in Novato, Marin County

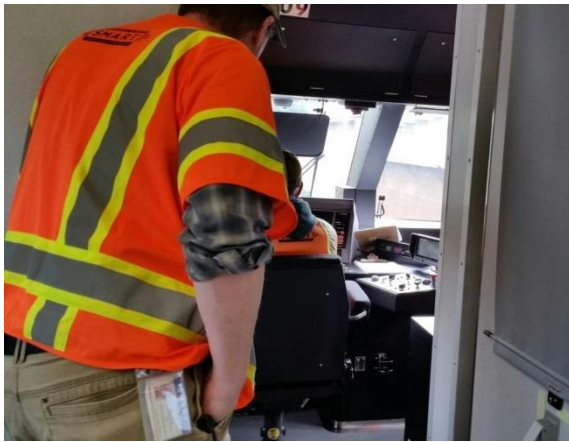
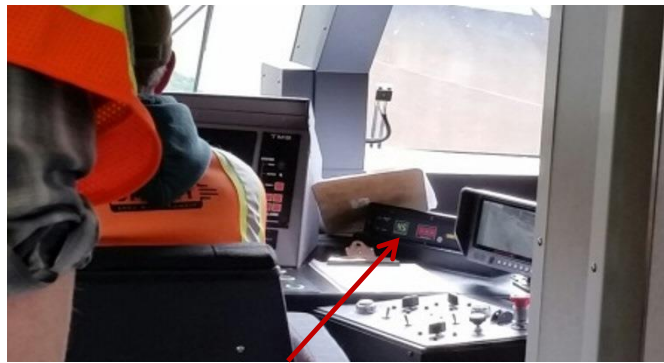
View of operator's cab of SMART PTC test train. The PTC console is a small, slim unit seen to the right of the operator.

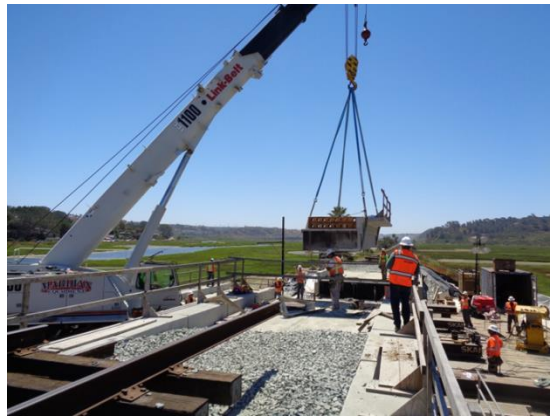
Railroad contractor removing a bridge span

The CPUC railroad safety bridge inspection staff has been working with the railroad contractor and the bridge engineer to ensure that the repairs are appropriate and consistent with safe and acceptable bridge repairs. Due to the significant risks associated with the heavily-used passenger rail, the CPUC inspectors opened a Risk Management Status Report and are engaging in ongoing monitoring of this bridge, as well as three other bridges on the Coaster route.

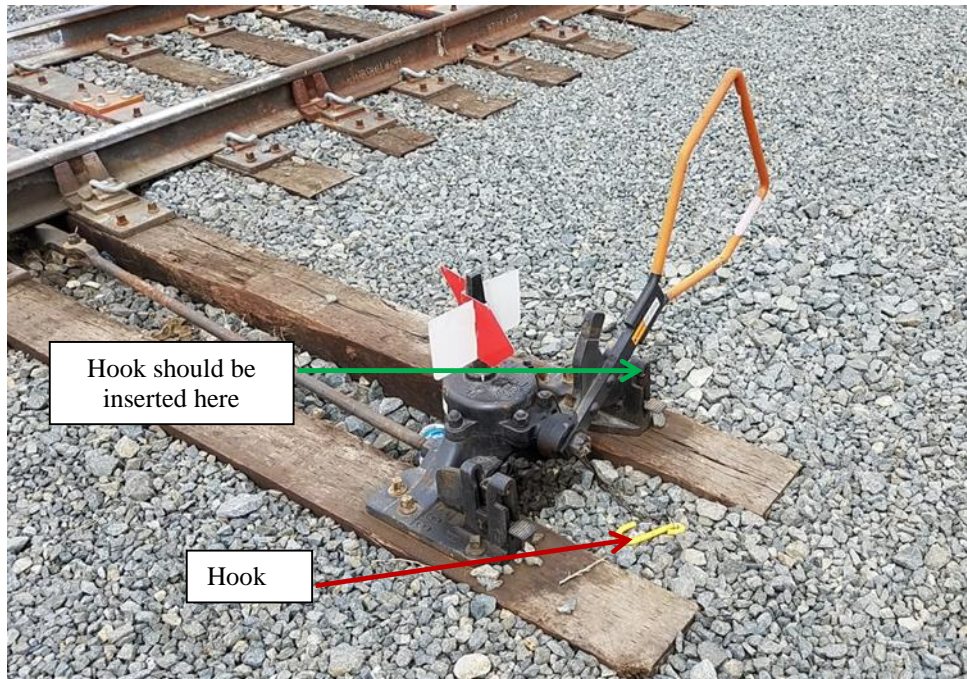
The hook attached to the chain is not in the keeper that secures the handle. This situation can allow the switch to be inadvertently operated under a passing train and could cause a derailment

The inspectors notified a Metrolink manager and the defective condition was quickly corrected by a Metrolink employee. During a prior inspection, the same defect had been observed and recorded on a report provided to the local manager and, consequently, a civil penalty was recommended.

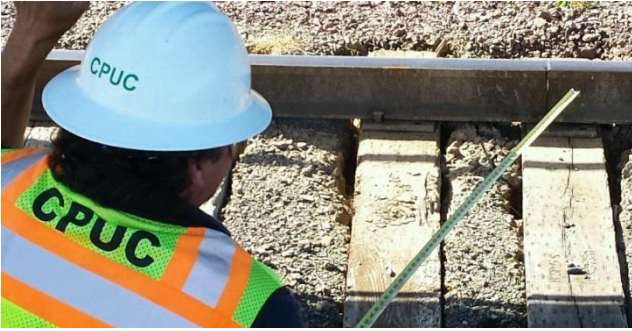
A CPUC inspector pointing at the broken rail

The CPUC inspector notified the BNSF track manager, who immediately briefed all train crews and managers and removed the track from service. The rail was replaced the next day.

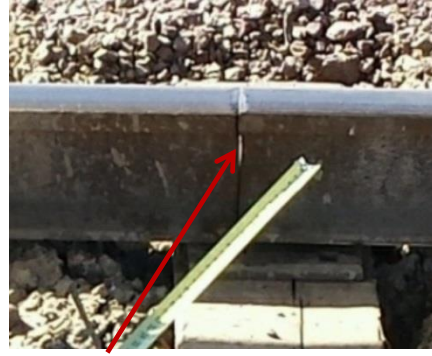
A close up of the broken rail

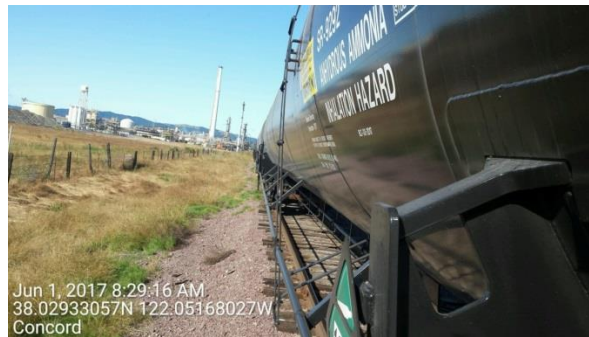
These rail cars carrying hazardous materials are on top of the broken rail

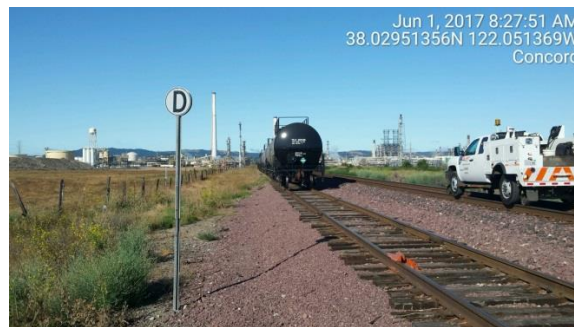
View of the chemical plant track. Tesoro Refinery is on the right and the chemical plant is on the left. The truck is sitting on the BNSF main track between Oakland and Stockton with train speeds of 70 MPH.

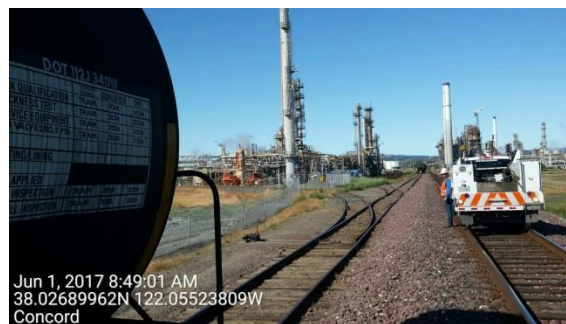
Another view of how close the defective rail was to the BNSF 70 mph main track, and its proximity to the Tesoro Refinery in Martinez

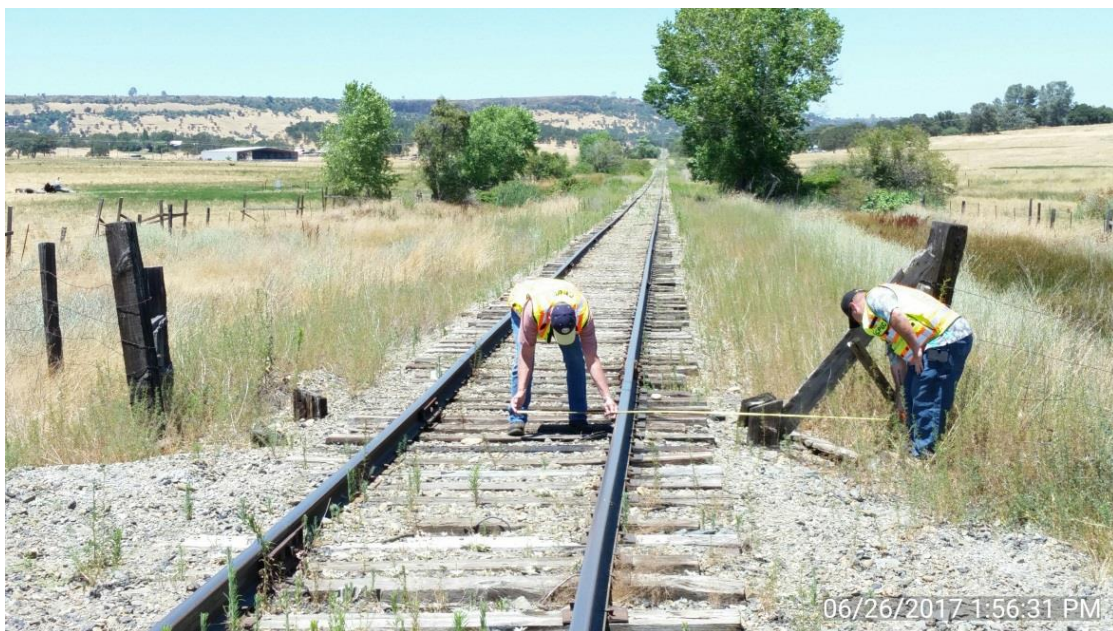
General Order 26-D requires side clearances of 8' 6" from the center of track. General Order 118-A requires railroads to maintain safe walkways, free from obstructions and tripping hazards. CPUC inspectors discussed the defects with a local railroad manager, and the manager agreed that all the defects would be corrected by the end of July.

CPUC inspectors measure for side clearance compliance

On August 10, 2017, the CPUC inspectors performed a follow-up inspection and observed that all side clearances and walkways were in compliance with CPUC General Orders.

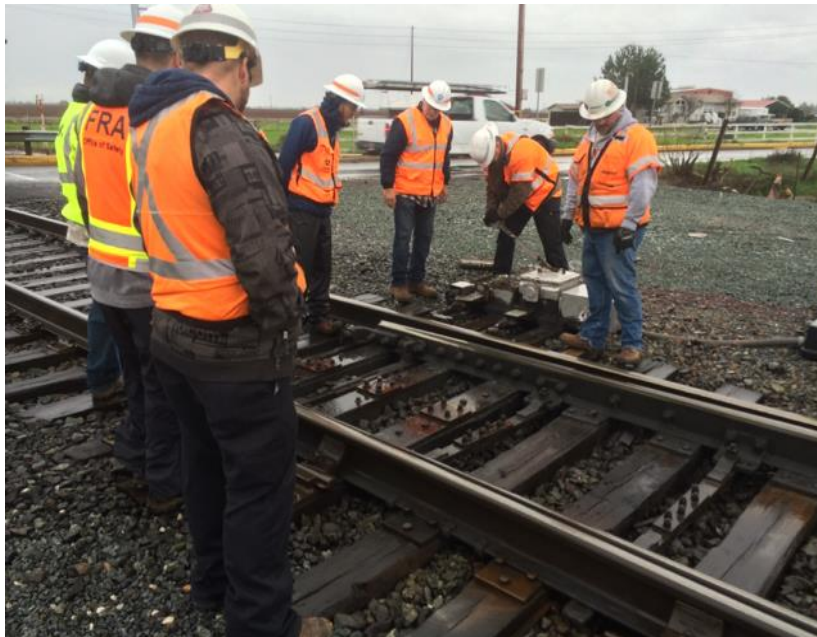
CPUC and FRA inspectors observing a BNSF signal maintainer adjusting a power switch machine

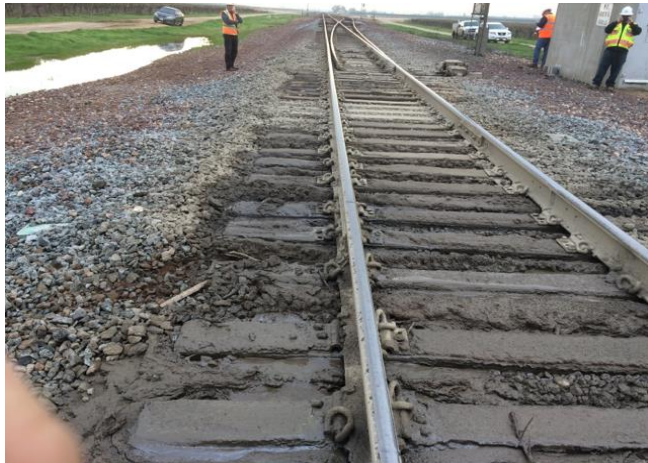
***Before:** The ballast does not provide adequate drainage because it is “fouled” or contaminated with dirt and mud. It cannot provide adequate support for the track and can cause misalignment of the power switch, which could cause a derailment.*

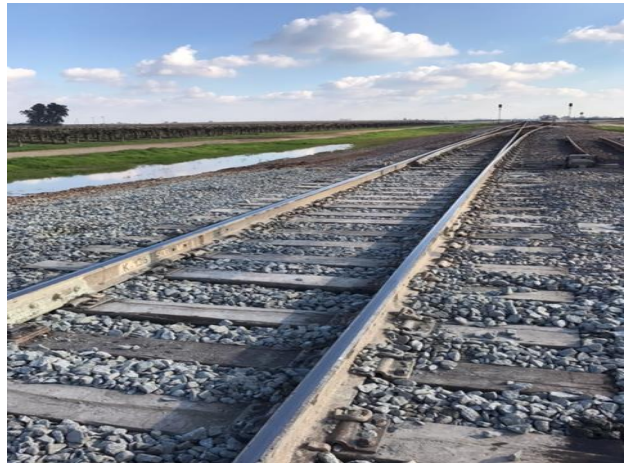
***After:** The ballast was replaced to provide greater stability to the track.*

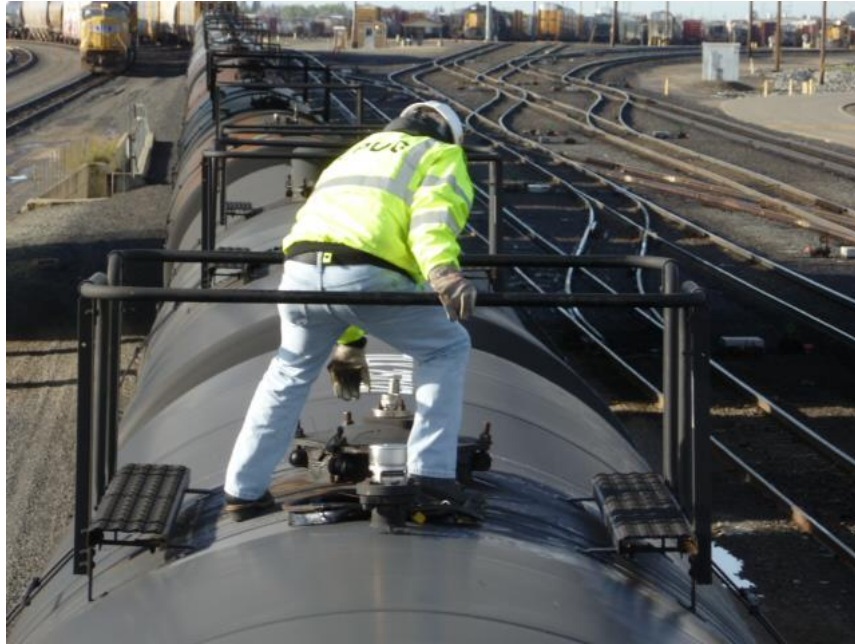
Federal regulations require secure tank car fittings and accurate identification. Loose bolts and unsecured valve handles can result in release of contents due to temperature changes, closure failures, or vandalism. The railroad safety inspection team found 16 tank cars with 21 defects. The defects included missing or incomplete markings, labels, and placards; loose bolts; and unsecured valve handles.

A CPUC inspector inspecting tank cars that carry hazardous materials for secure closures

The railroad safety inspection team notified the UPRR Hazardous Materials Manager and Car Department Supervisor of the defects. The UPRR manager immediately had the loose closures tightened, and UPRR personnel were dispatched to correct the marking/label/placard issues.

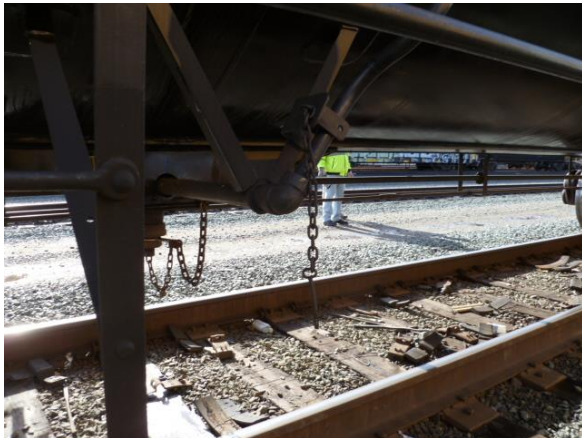
Securement pin found hanging from chain, allowing the valve handle to move to an open position

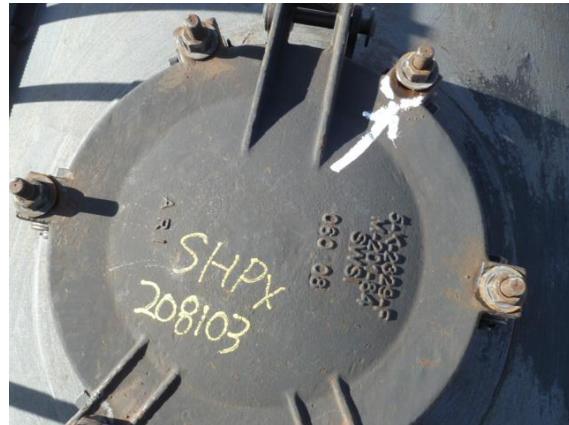
Example of loose bolt marked for tightening

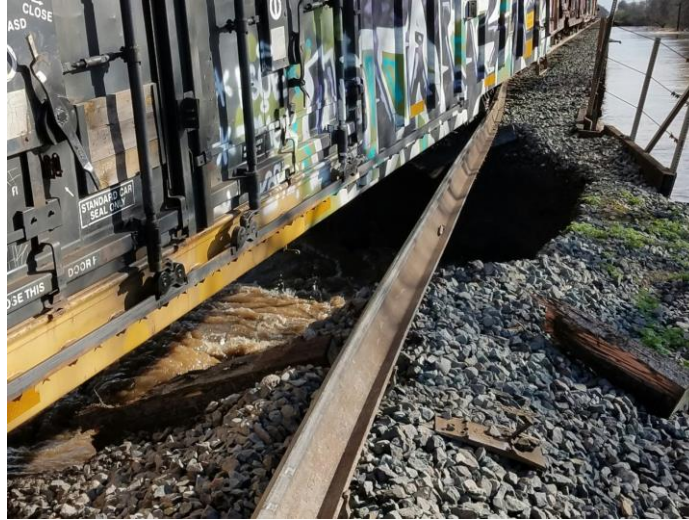
The washout area at UPRR bridge, MP 56.2, near Elk Grove

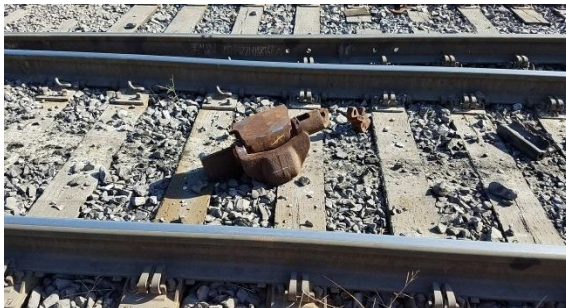
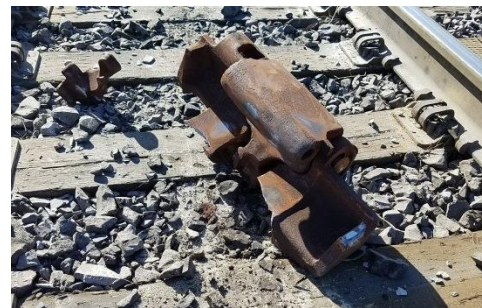
The broken coupler "knuckle" that failed between rail cars 32 and 33

The cause of the accident was a failed coupler assembly, or knuckle, which broke due to functional wear and stresses.

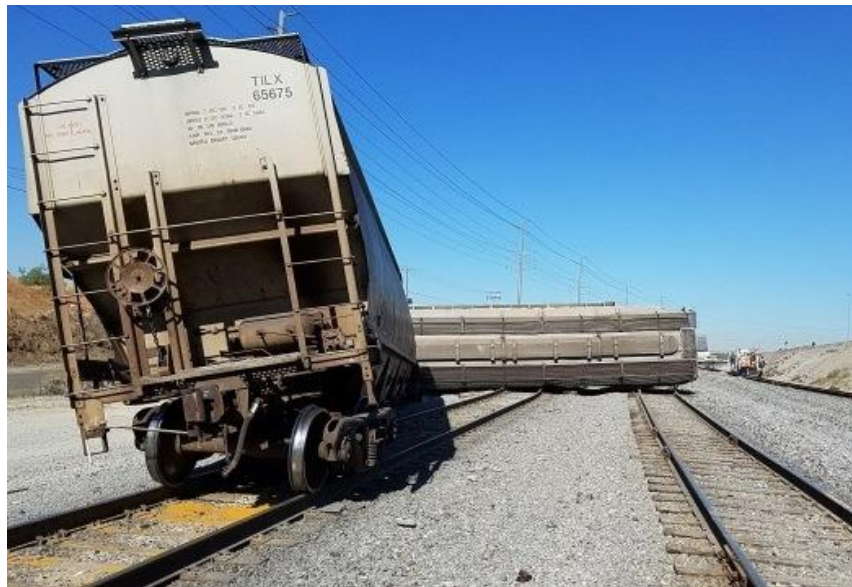
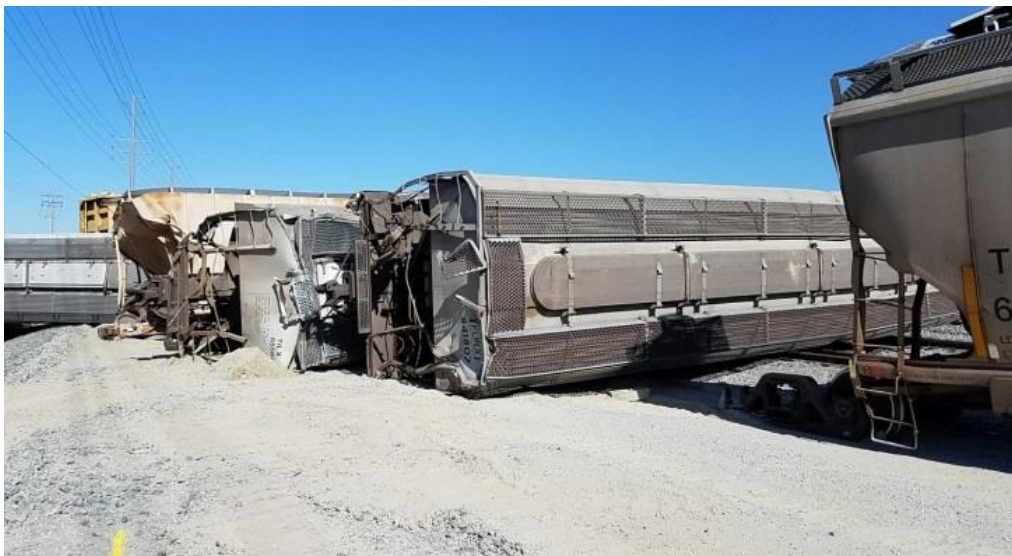
CPUC inspectors viewed the track image recorder footage from the locomotive and examined the locomotive event recorder. They concluded that the stopped head-end portion of the train and locomotives were shoved 49 feet forward from the impact. The derailed equipment spilled onto the adjacent track, fouling the main track. The derailed cars also struck a utility pole which caused a temporary power outage.

Derailment site at UPRR West Colton Yard on June 15, 2017
