CALIFORNIA PUBLIC UTILITIES COMMISSION
Safety and Enforcement Division
Wildfire Safety and Enforcement Division

Incident Investigation Report

Incident Number: E20210825-01 (Mule Fire)

Regulated Utility Facilities Involved: Girvan 1101, 12kV Circuit

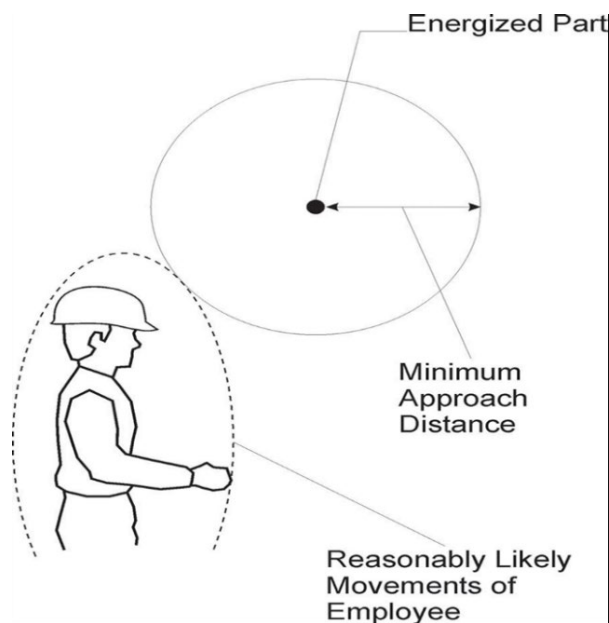
Figure 10: Depiction of Minimum approach distance

PG&E requires its contractors to follow the “California Safety Manual Code of Safe Work Practices Accident Prevention Rules (Red Book).”^{44, 45} The Red Book details safe work practice procedures. Section 2.05 of the Red Book specifies the “minimum working distance from energized conductors or apparatus, which are not properly covered with approved protective equipment. This includes extended reach, falling, and material or equipment whether insulated or not.” For 50 to 300 volts, the minimum working distance is specified as “Avoid Contact.” Figure 10 and Figure 11 are both from the Red Book and depict the Minimum Approach Distance.⁴⁶ Figure 11 shows that the minimum approach distance starts at the end of a conductive object,

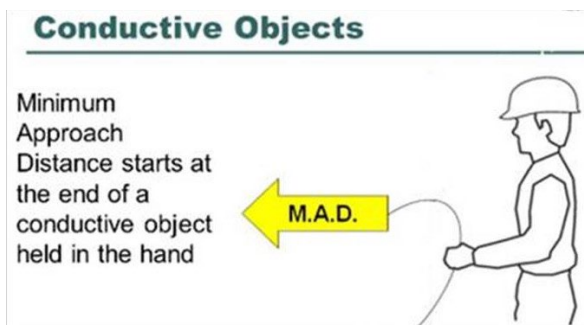
Figure 11: Depiction showing that the minimum approach distance starts with the end of the conductive object

which in this incident would be the bolt cutters and the neutral. In this case, the requirements would be to avoid contact between energized line, the bolt cutters, and the neutral.

PG&E’s Utility Procedure: TD2360P-01 “Rubber Glove Work Methods, 50 V to 21 kV” has similar requirements as the Red Book. However, Utility Procedure: TD2360P-01’s requirements often exceed the requirements in the Red Book. For instance, Section 3.1.4 states “Always USE approved insulating protective equipment on adjacent conductors where there is a possibility of simultaneous contact by the employee, tools, or equipment.”⁴⁷ This procedure would require installing insulating protective equipment, like an insulating blanket, on the neutral to prevent accidental contact. Utility Procedure: TD2360P-01 is a requirement for PG&E employees but does not apply to PG&E contractors.⁴⁸ PG&E contractors were performing the energized work that led to the Mule Fire so the requirements did not apply. SED notes that following Utility Procedure: TD2360P-01 likely would have prevented the Mule Fire.
